## **Asbestos and Lead Survey Report**

**Report Date:** February 13, 2025

**Project:** Cafeteria Renovation/Modernization Project

**School:** Fillmore High School

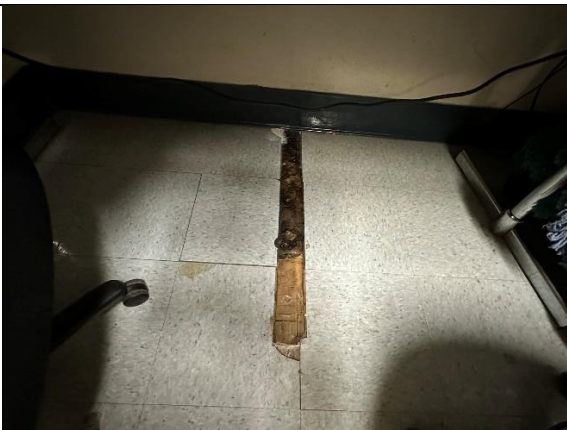
- 12" vinyl floor tile and underlying flooring material from the kitchen is identified as ACM.
  - Beige vinyl floor tile contains 6% Chrysotile asbestos.
    - Beige floor tiles were not identified in all storage room areas but appear to be an original flooring material. ACM flooring may exist throughout the storage rooms project area.
    - No asbestos was detected in blue 12" vinyl floor tile layer (primary flooring).
  - Residual black flooring mastic material contains 3% Chrysotile asbestos.
    - Residual black flooring mastic was not identified in all storage room areas but appears to be part of an original flooring system. Residual floor mastic is likely to exist throughout the storage rooms project area.

<p><i>12" beige vinyl floor tiles and underlying black flooring mastic materials in the storage room areas are ACM</i></p>	
---	--

Based on sample analytical data from samples collected during this survey, ACM was identified in the cafeteria storage rooms flooring system of project area. Project related asbestos abatement is required for the disturbance of ACM in the project area. Asbestos abatement requires the use of a licensed asbestos abatement contractor using only trained and certified asbestos supervisors and workers.

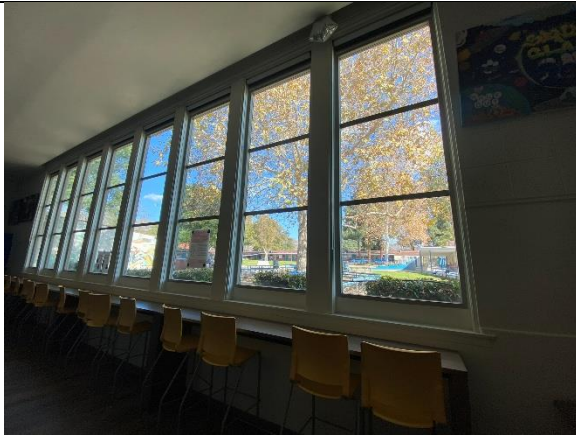
White painted wood window components in the cafeteria contain lead-based paint

Based on sampling performed during this survey, lead-based paint was identified on painted building components in the project area. Project related lead abatement and/or lead safe work methods are required for the disturbance of lead-based paint identified in the project area. Lead abatement requires the use of a licensed contractor using only trained and certified lead supervisors and workers. Lead safe work methods require the use of a licensed and certified EPA Repair, Renovation and Paint (RRP) contractor and supervisor.

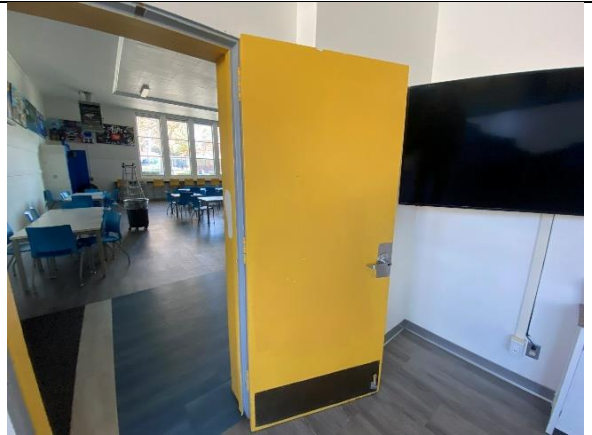
Gray/yellow painted wood door components in the staff lounge contain lead-based paint

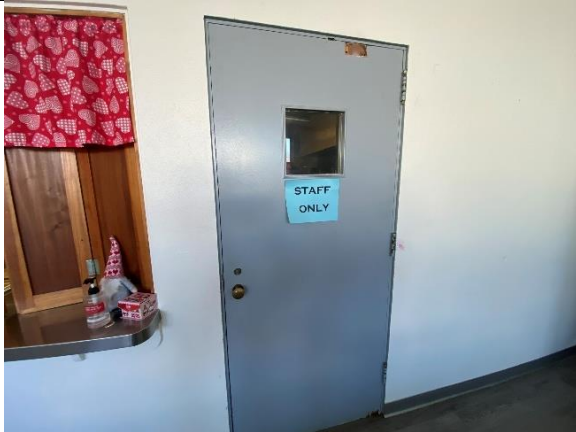
Gray painted wood door components in the staff lounge contain lead-based paint

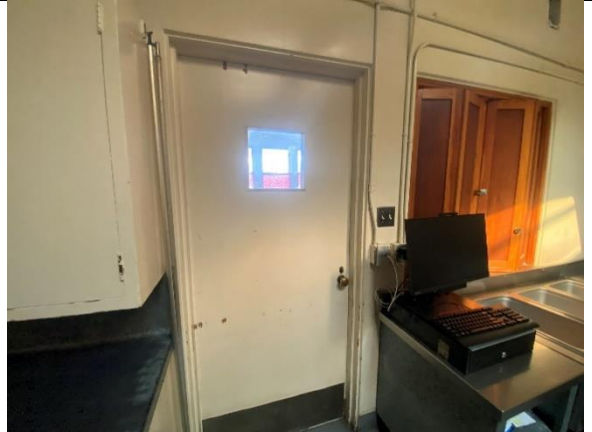
White painted wood door components in the kitchen contain lead-based paint

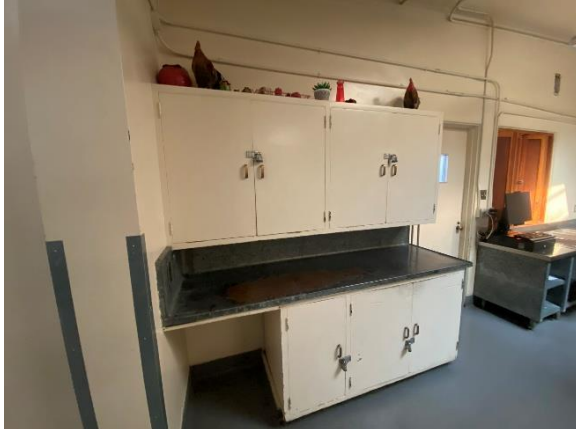
White painted cabinet components contain lead-based paint

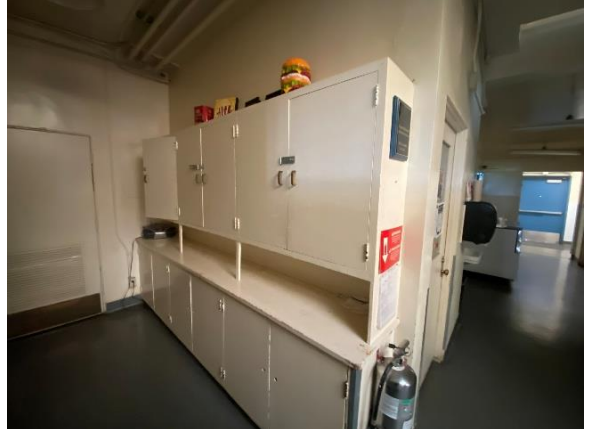
White painted wood cabinet components contain lead-based paint

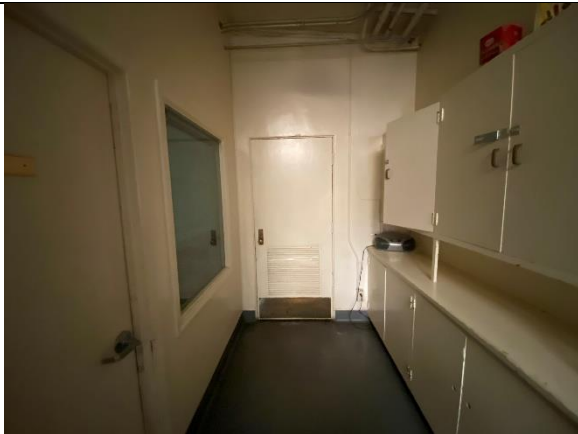
*White painted wood door components on the south entrance of the kitchen contain lead-based paint*

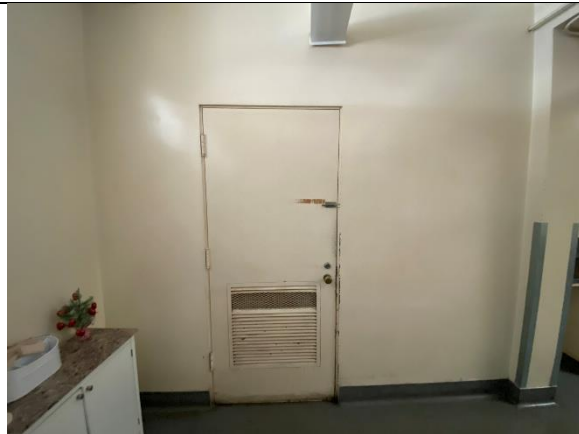
*White painted wood door components on the north side entrance of the kitchen contain lead-based paint*

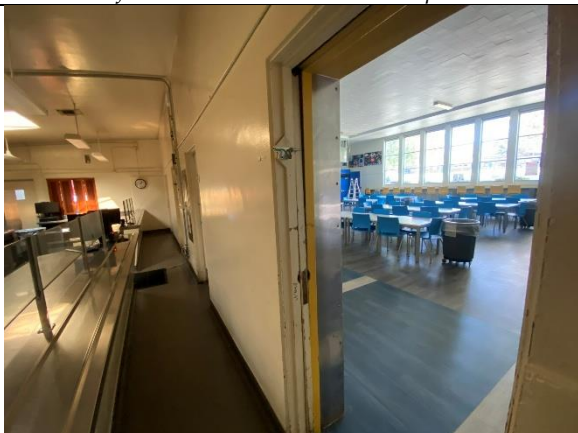
*All white/yellow painted wood door components on the shared wall between the kitchen and cafeteria contain lead-based paint*
