## Daily Construction Observation Report

**Project** Willdan - Ridgecrest, Pinny Pool Demo

**Item Inspected** Native sandy material

**Location(s)** PROJECT: 205 S Warner St, Ridgecrest, CA 93555 DETAIL: Deep end of pool over excavation backfill

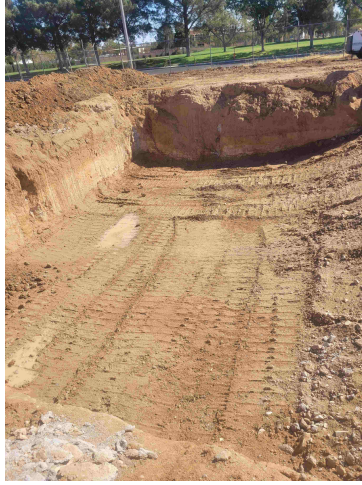
20241002\_105223.jpg

**Observations and Comments** Observation began at 10:30 with the testing of native material at the deep end of the pool at approx. 12' depth from grade. Compaction of native material done with tracking excavator back and for across the deep end section. Took 3 tests at the bottom all results above 90% compaction. Test results indicated that the minimum requirements for compaction were in compliance with the referenced specifications. . Left site at approx. 1130.
