Daily Construction Observation Report

Project Willdan - Ridgecrest, Pinny Pool Demo

Item Inspected Native sandy material

Location(s) PROJECT: 205 S Warner St, Ridgecrest, CA 93555 DETAIL: Deep end of pool

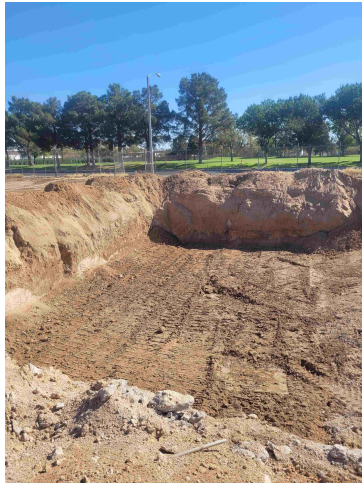
20241003_102532.jpg

Observations and Comments Observation began at 10:00 with the testing of native material at the deep end of the pool at approx. 10.5' depth from grade. Compaction of native material done with tracking excavator back and for across the deep end section. Once the first lift was tested the last lift placed by contractor was done while on site with native backfill material placed by skip loader and compacted with excavator tracking in weight of machine the same as yesterday. Took 2 tests at each lift all results above 90% compaction. Test results indicated that the minimum requirements for compaction were in compliance with the referenced specifications. Left site at approx. 1300.
