**PRE-DEMOLITION ASBESTOS SURVEY &
LEAD-BASED PAINT INSPECTION REPORT**

**BUILDINGS H3 & K3
WASHINGTON UNION HIGH SCHOOL
6041 SOUTH ELM STREET
FRESNO, CALIFORNIA**

MAY 2025

**T. Brooks & Associates,
A Division of
Provost & Pritchard Consulting Group
455 W. Fir Ave.
Clovis, California 93611
(559) 449-2700
Formed 1993**

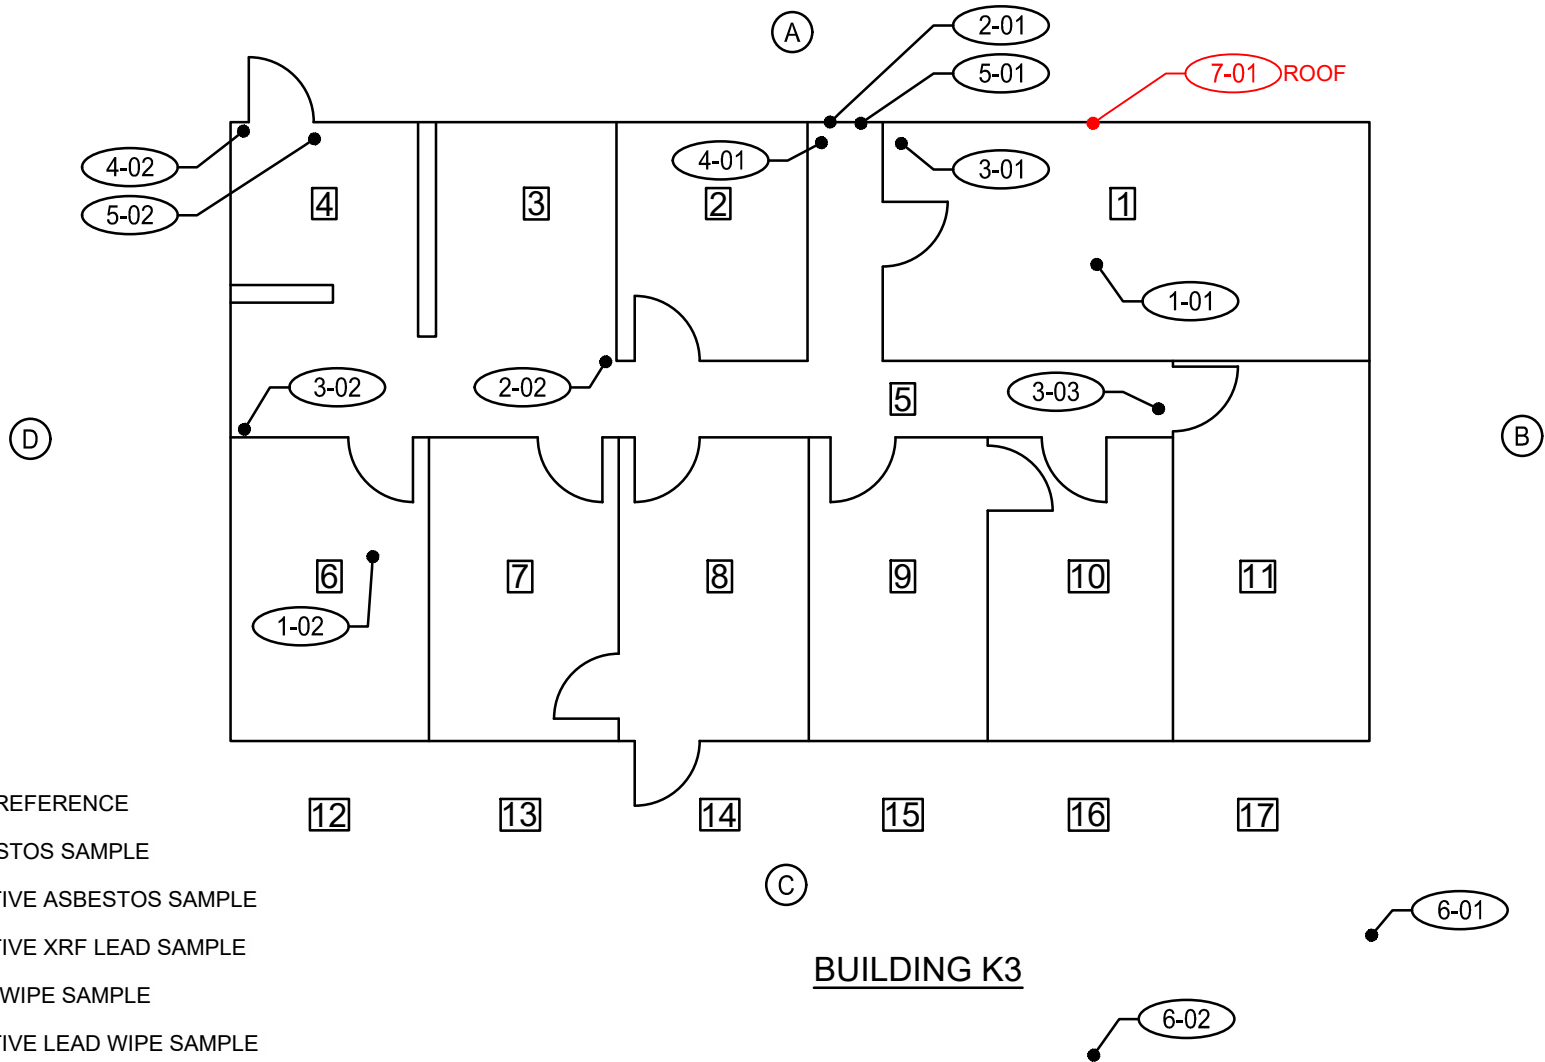
BUILDING K3

Of those samples submitted for analysis, one (1) was found to include one or more layers that tested positive for asbestos in amounts (>1.0%). The sample testing positive for asbestos content in amounts >1.0% included: **Built-up Roofing** (1 sample).

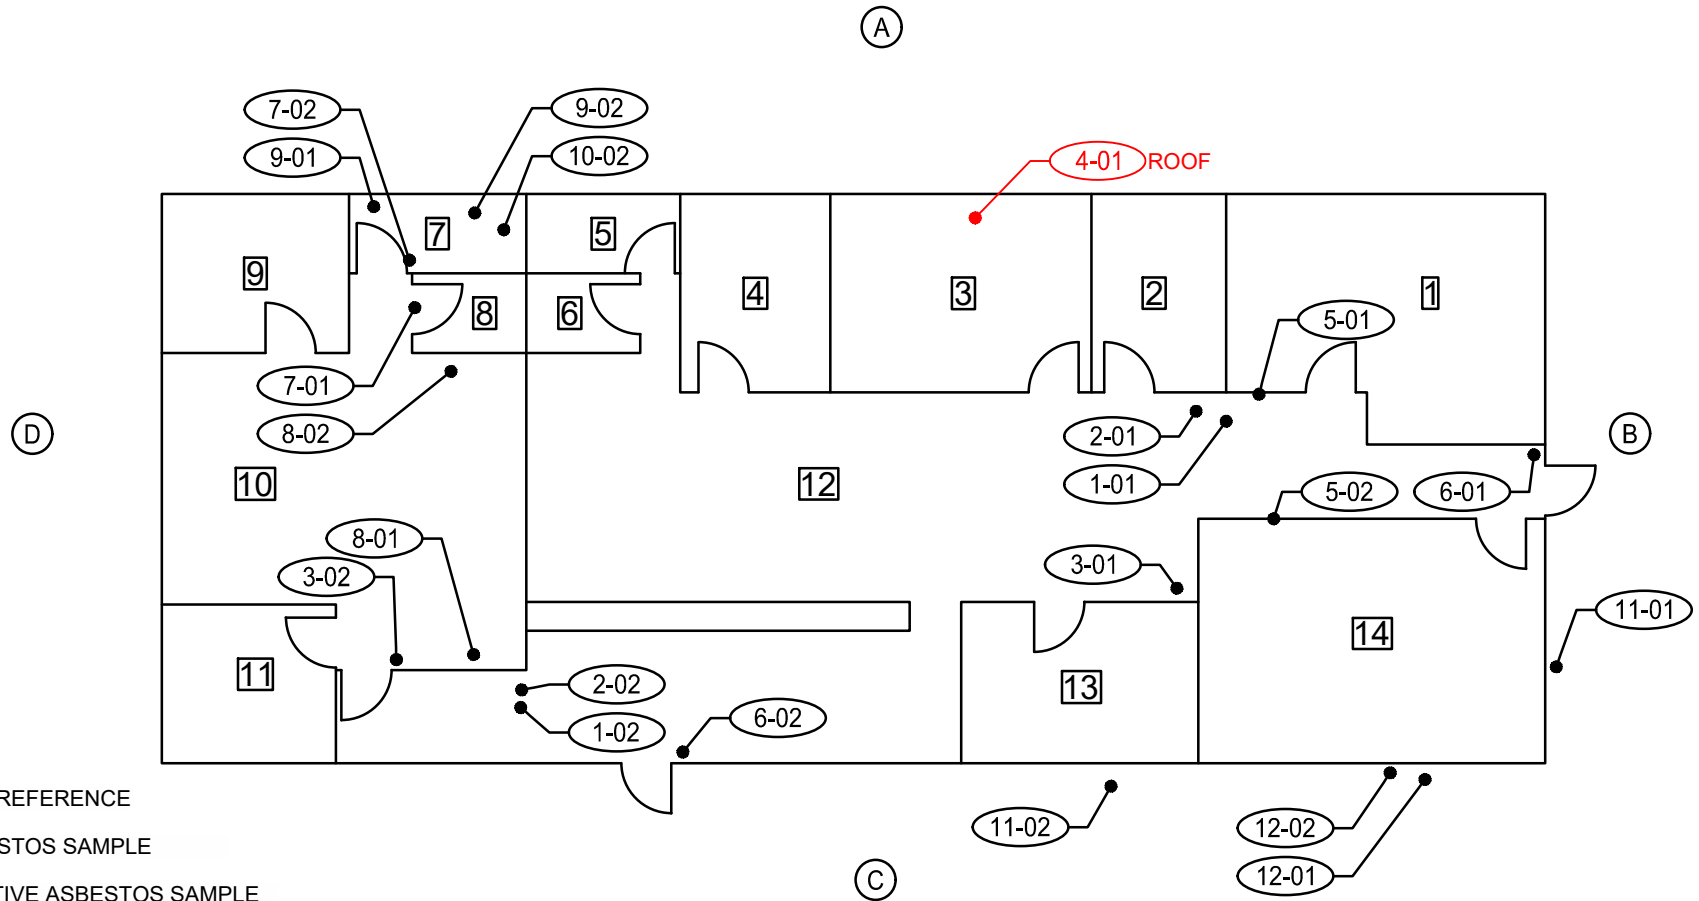
BUILDING H3

Of those samples submitted for analysis, one (1) was found to include one or more layers that tested positive for asbestos in amounts (>1.0%). The sample testing positive for asbestos content in amounts >1.0% included: **Built-up Roofing w/ Silver Roof Coating** (1 sample).
