ADDENDUM #1

FOR  
VON RENNER ELEMENTARY SCHOOL: CLASSROOM BUILDING

**ASBESTOS SAMPLING REPORT**

**Von Renner Elementary School**  
**1388 Patchett Drive**  
**Newman, CA 95360**

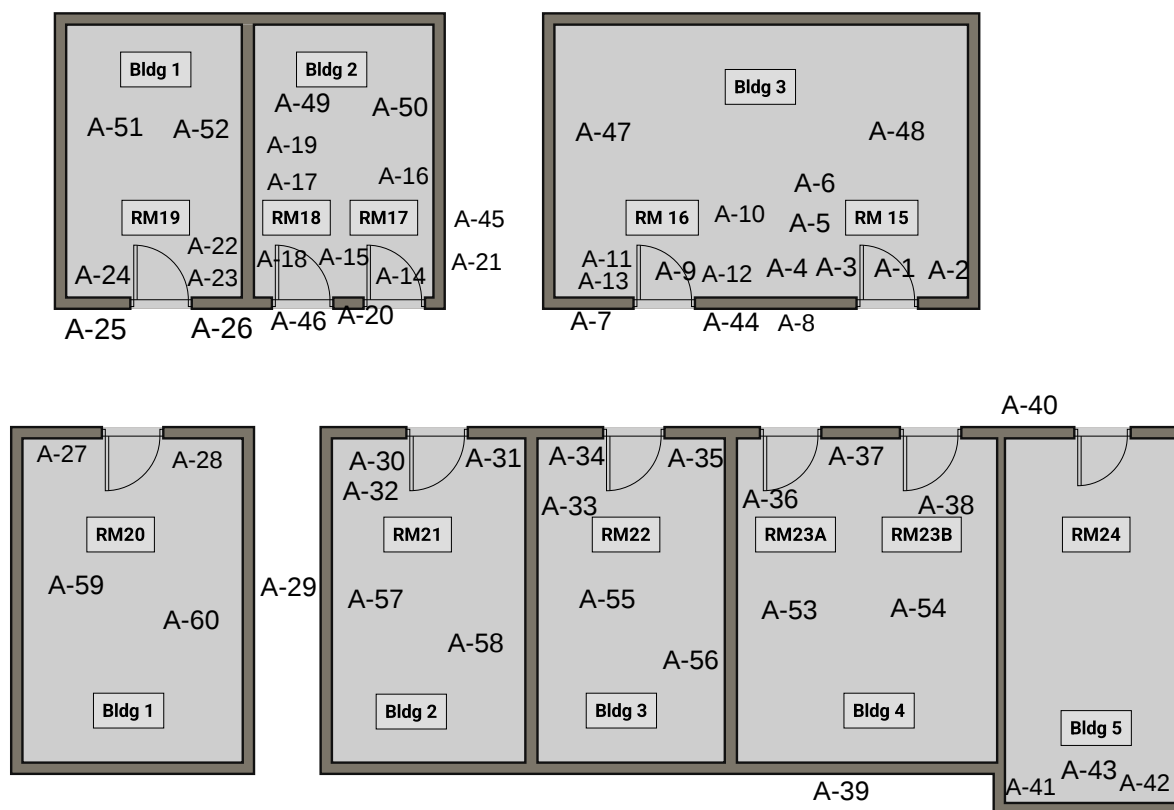
## Asbestos Bulk Sampling Location

| A-51 | Roofing / Bldg. #1 Room #19 / Black | 2% Chrysotile Detected |
| A-51 | Roofing Mineral Cap / Bldg. #1 Room #19 / Brown Gray Black | 30% Chrysotile Detected |
| A-52 | Roofing / Bldg. #1 Room #19 / Black | 2% Chrysotile Detected |

Samples A-51 and A-52 of the following suspected Asbestos containing building material that could be impacted by the by the demolition of the structure was shown by the laboratory analysis to contain more than 1 percent (1%) asbestos as determined by Polarized Light Microscopy (PLM) by an accredited laboratory.

This material is considered Regulated Asbestos Containing Material (RACM) and does need to be handled and disposed of using EPA regulations.

It is a requirement of the San Joaquin Valley Unified Air Pollution Control district that all regulated asbestos containing materials that will be impacted must be removed and disposed of by a properly licensed California abatement contractor prior to the demolition or renovation of the building following all applicable laws and regulations pertaining to the removal and disposal of asbestos containing building materials.

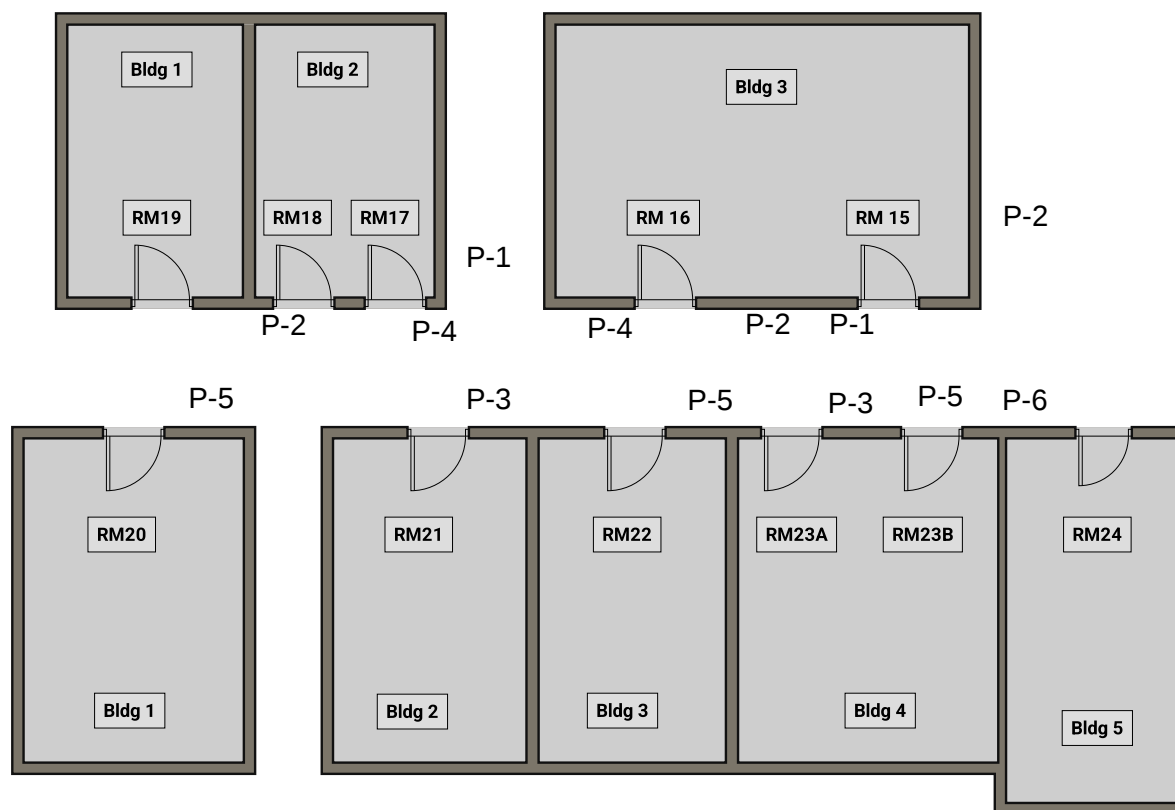
## lead Based Paint Bulk Sampling Location

The laboratory analysis of samples P-1, P-2, P-3, P-4, P-5 & P-6 of surface coating was found by definition not to be lead/based paint.
