## **Asbestos & Lead-Based Paint Survey**

**Anthony Munoz Community Center  
1240 West 4<sup>th</sup> Street  
Ontario, California**

**Converse Project No. 19-16-123-04  
December 18, 2019**

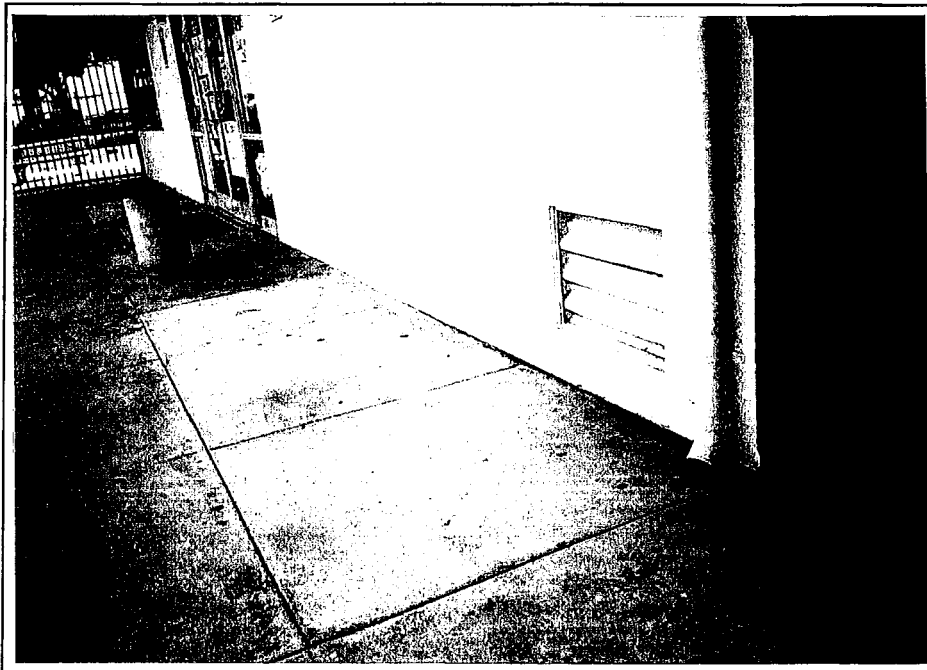
Photo 1: The concrete sidewalk covers or is just below the weep screed at entry wall, and the down spout discharges onto the walkway just below the weep screed

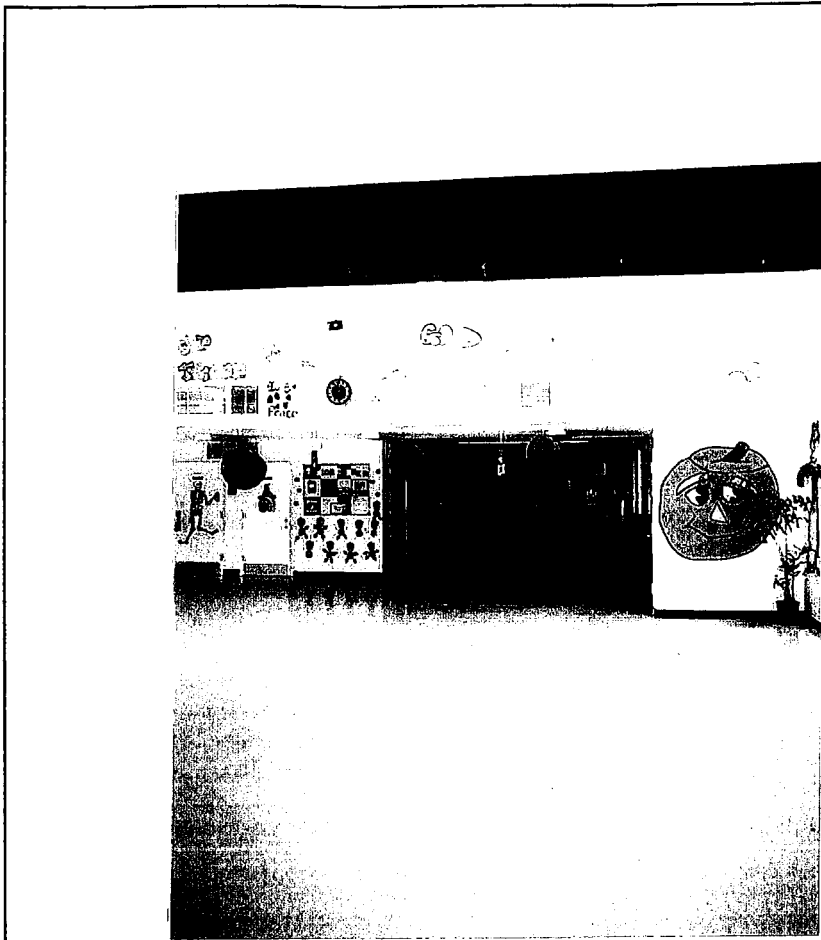
Photo 2: The main hall with 12x12 floor tile adhered with asbestos mastic

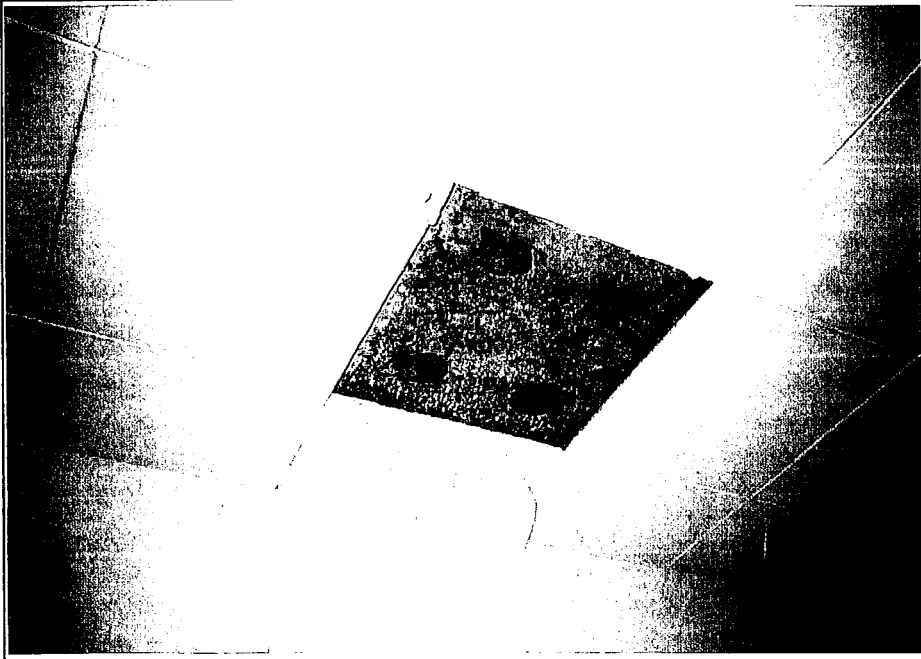
Photo 5: Mold on the drywall above the 1x1 ceiling tile above the refrigerator

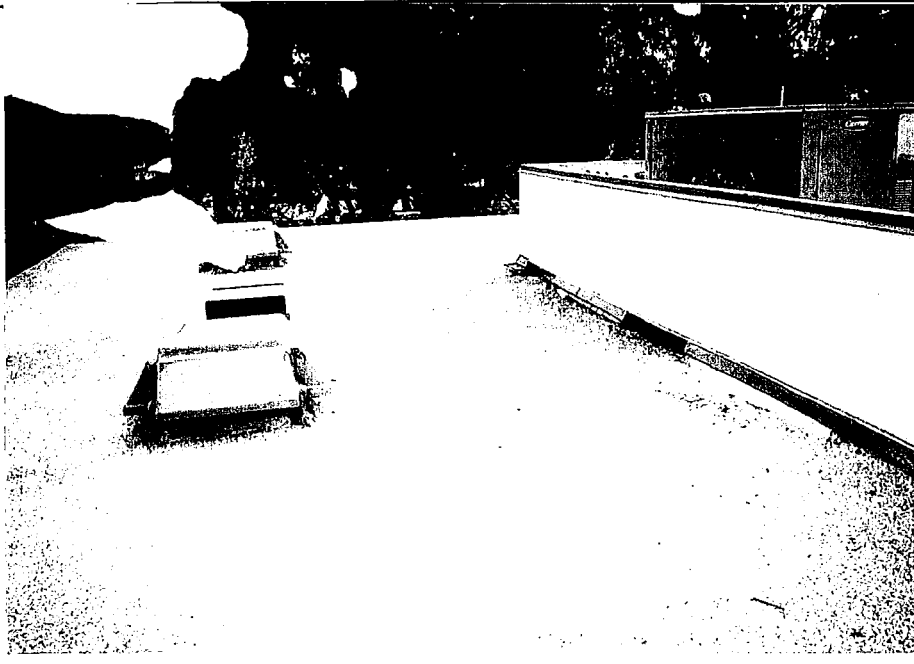
Photo 7: Ponding on the roof

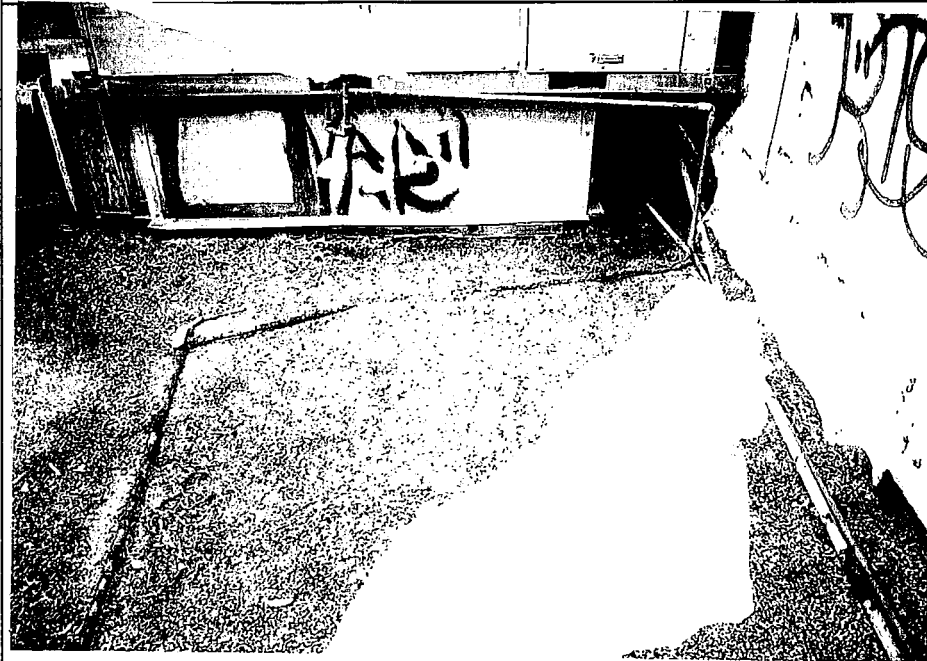
Photo 9: Wet roofing  
inside the HVAC  
closure on the roof
