July 7, 2021  
Kleinfelder Project No. 20210301.001A

**SUBJECT: Summary Report for Construction Observation and  
Special Inspection Services  
Anthony Munoz Community Center (Rehability and Park Project)  
City of Ontario Project No. PS 1314-2  
Ontario, California**

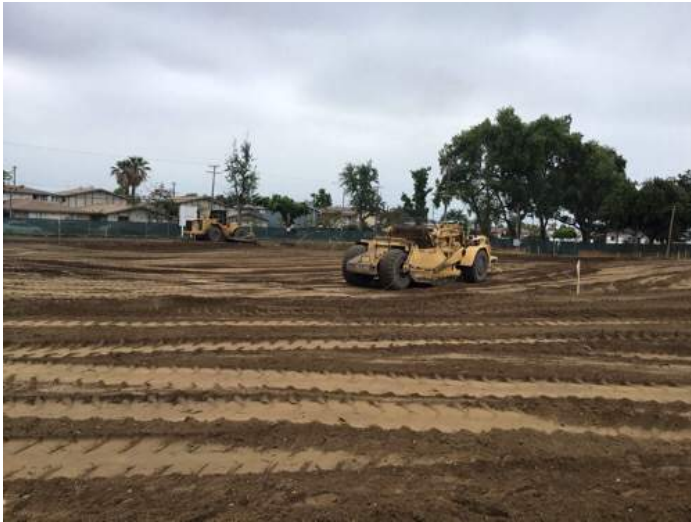
**Fig. 1:** Building foundation over-ex

Ironclad was on site excavating soil for the over-ex for the building foundation. Jeff Waller and I verified contractor was 3 ft beyond the building envelope. Once the contractor reached the bottom of the excavation for the main building the foreman and I verified the elevation. (2) 623 scrapers and a 823 compaction loader was used to achieve compaction for the over-ex bottom. I used a calibrated nuclear density gauge to check compaction and moisture content. 6 tests were taken, 6 tests met minimum specified compaction per plans and specifications. It started raining at 1:00 pm and suspended work for the day.

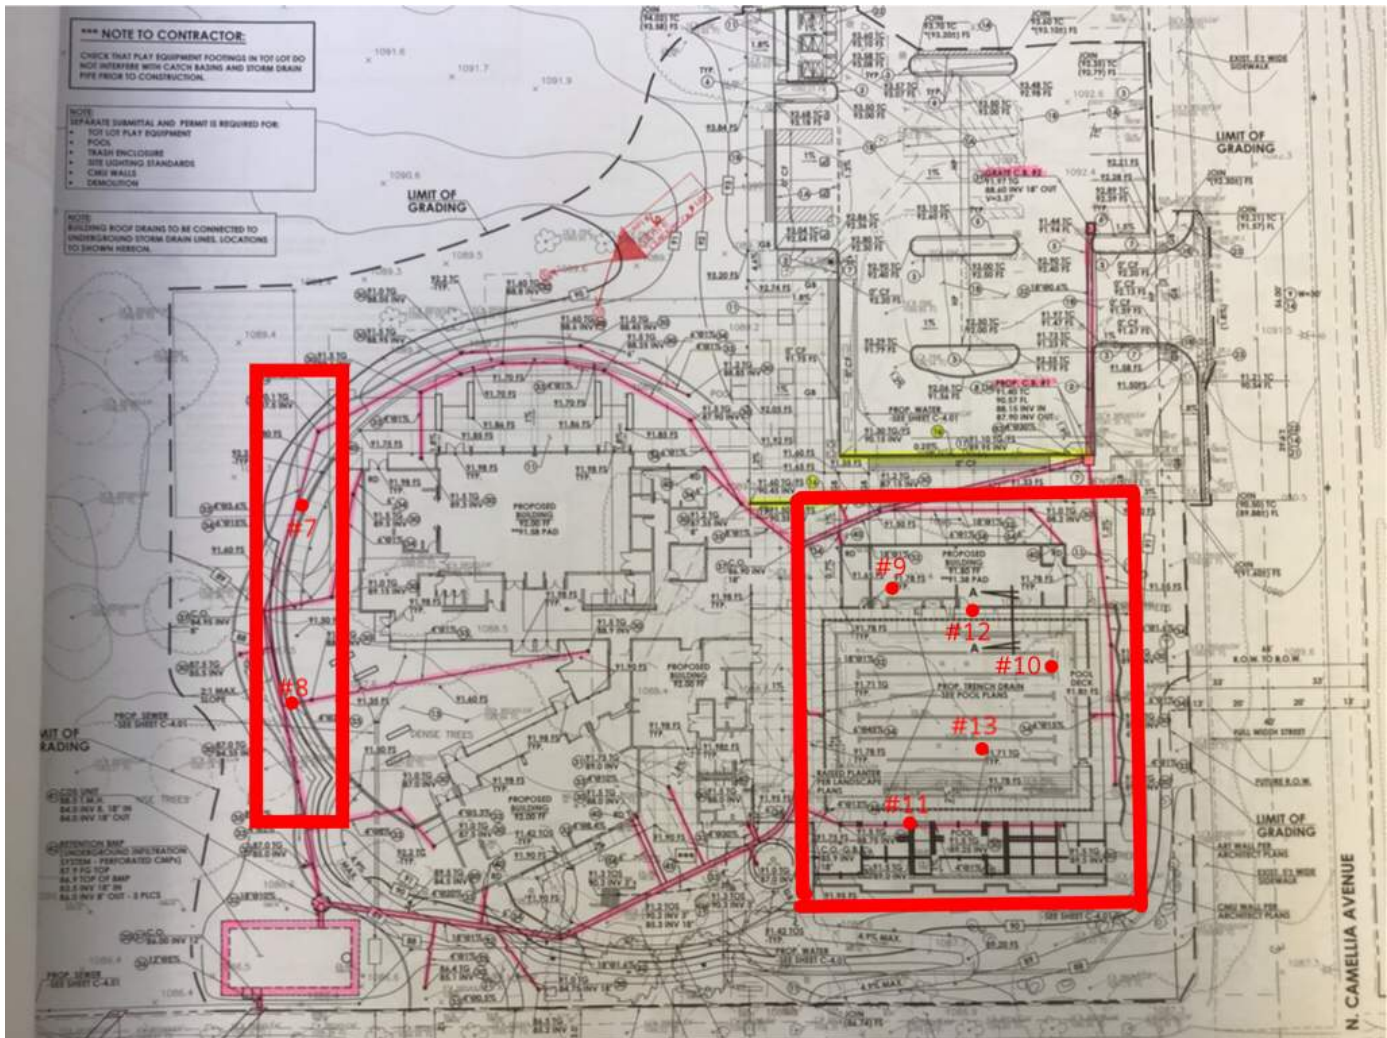
Fig. 1: Compaction (#7-13) plot plan

Ironclad was on site excavating soil for the over-ex at the pool location. The over-ex area was measured to verify the contractor was extending 3 ft beyond the building/pool envelope. Once the contractor reached the bottom of the pool over-ex the foreman and I verified elevation. The bottom was scarified 6" and compacted via (2) 623 scrapers. After bottom was compacted contractor placed soil in 8"-10" loose lifts and compacted via 623 scrapers and 824 compaction loader. I used a calibrated nuclear density gauge to check compaction and moisture content. 7 tests were taken, 7 tests met minimum specified compaction per plans and specifications.

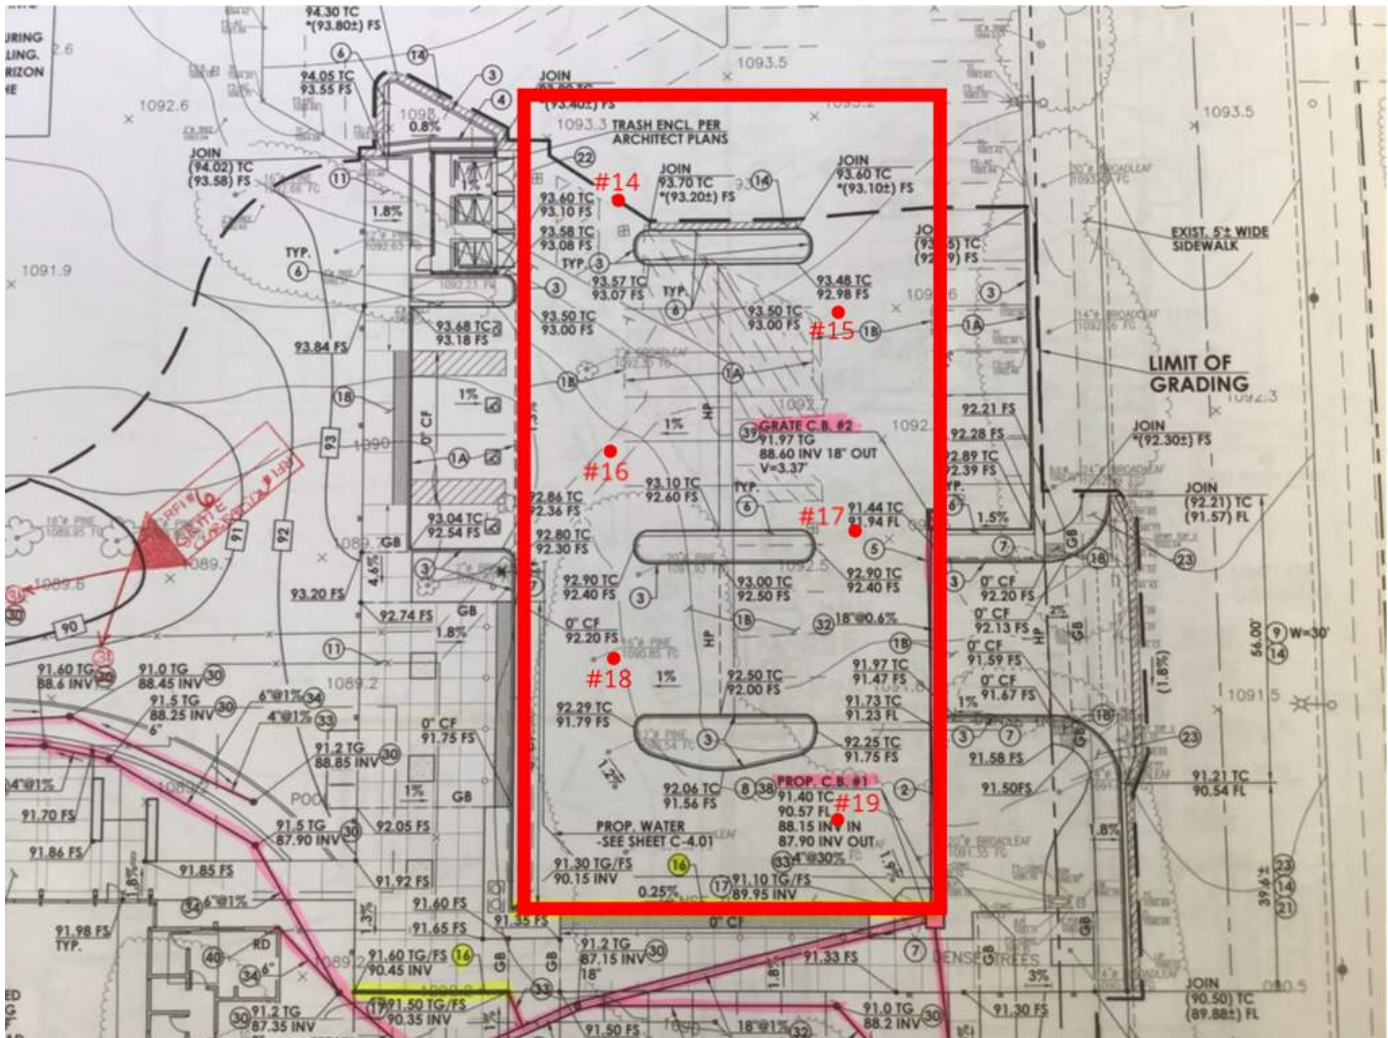
Fig. 1: Parking lot bottom (#14-19) plot plan

Ironclad was on site excavating soil for the parking lot over-ex. Once the contractor reached bottom elevation was verified and compaction efforts were made. Contractor used a CAT 623 scraper was used to achieve compaction. I used a calibrated nuclear density gauge to check compaction and moisture content. 6 tests were taken, 6 tests met minimum specified compaction per plans and specifications.

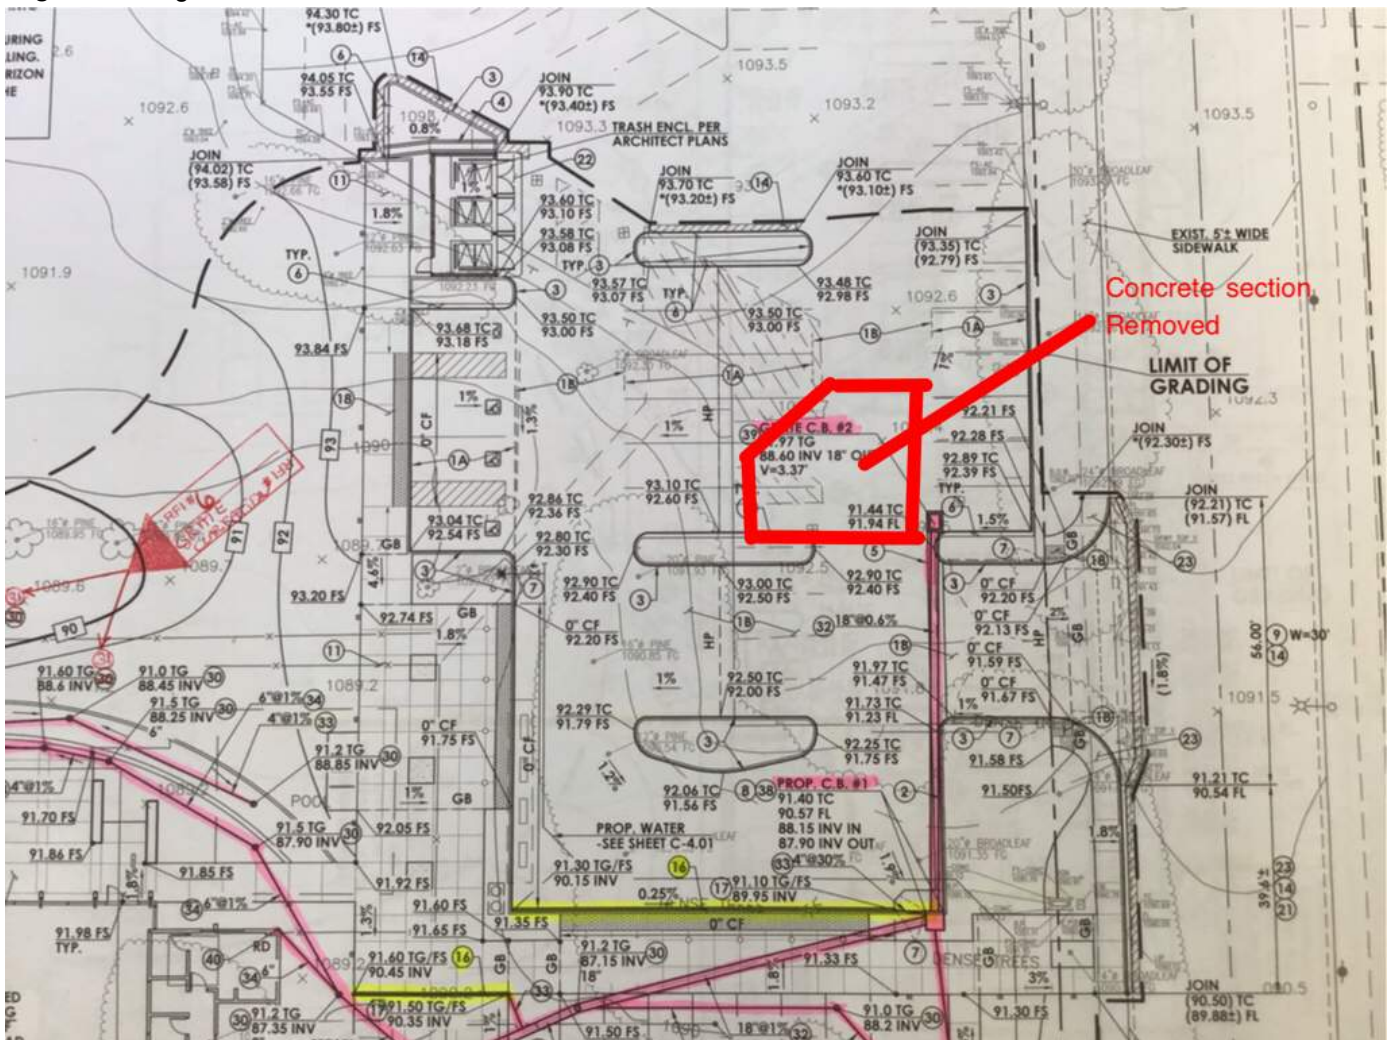
Ironclad removed an existing concrete section that was underlying the existing demoed asphalt. Contractor removed the concrete and broke the material up to a 3" minus and spread the material out for fill in the building foundation.

Fig. 2: Existing concrete section removed

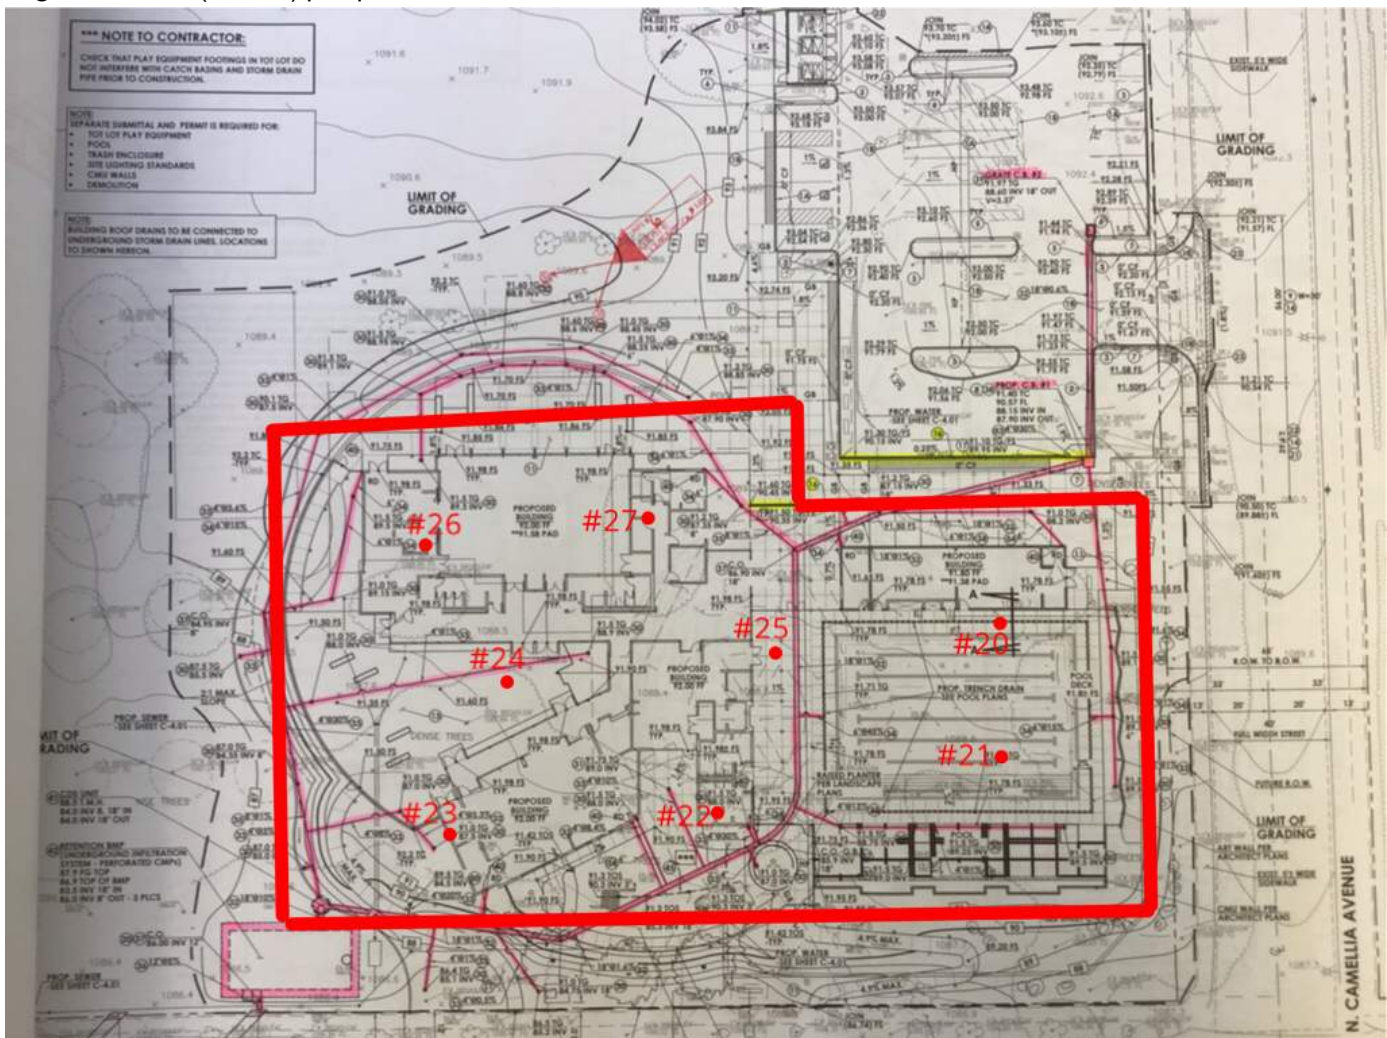
**Fig. 1: Over-ex (#20-27) plot plan**

Ironclad was on site over-excavating the community center building and pool section. Ironclad had approved imported fill delivered from ontario airport. The delivery trucks placed soil from bottom dumps and the CAT 824G was used to spread soil in 8"-10" loose lifts and made 6-8 passes for compaction. I used a calibrated nuclear density gauge to check compaction and moisture content. 8 tests were taken, 8 tests met minimum specified compaction per plans and specifications.

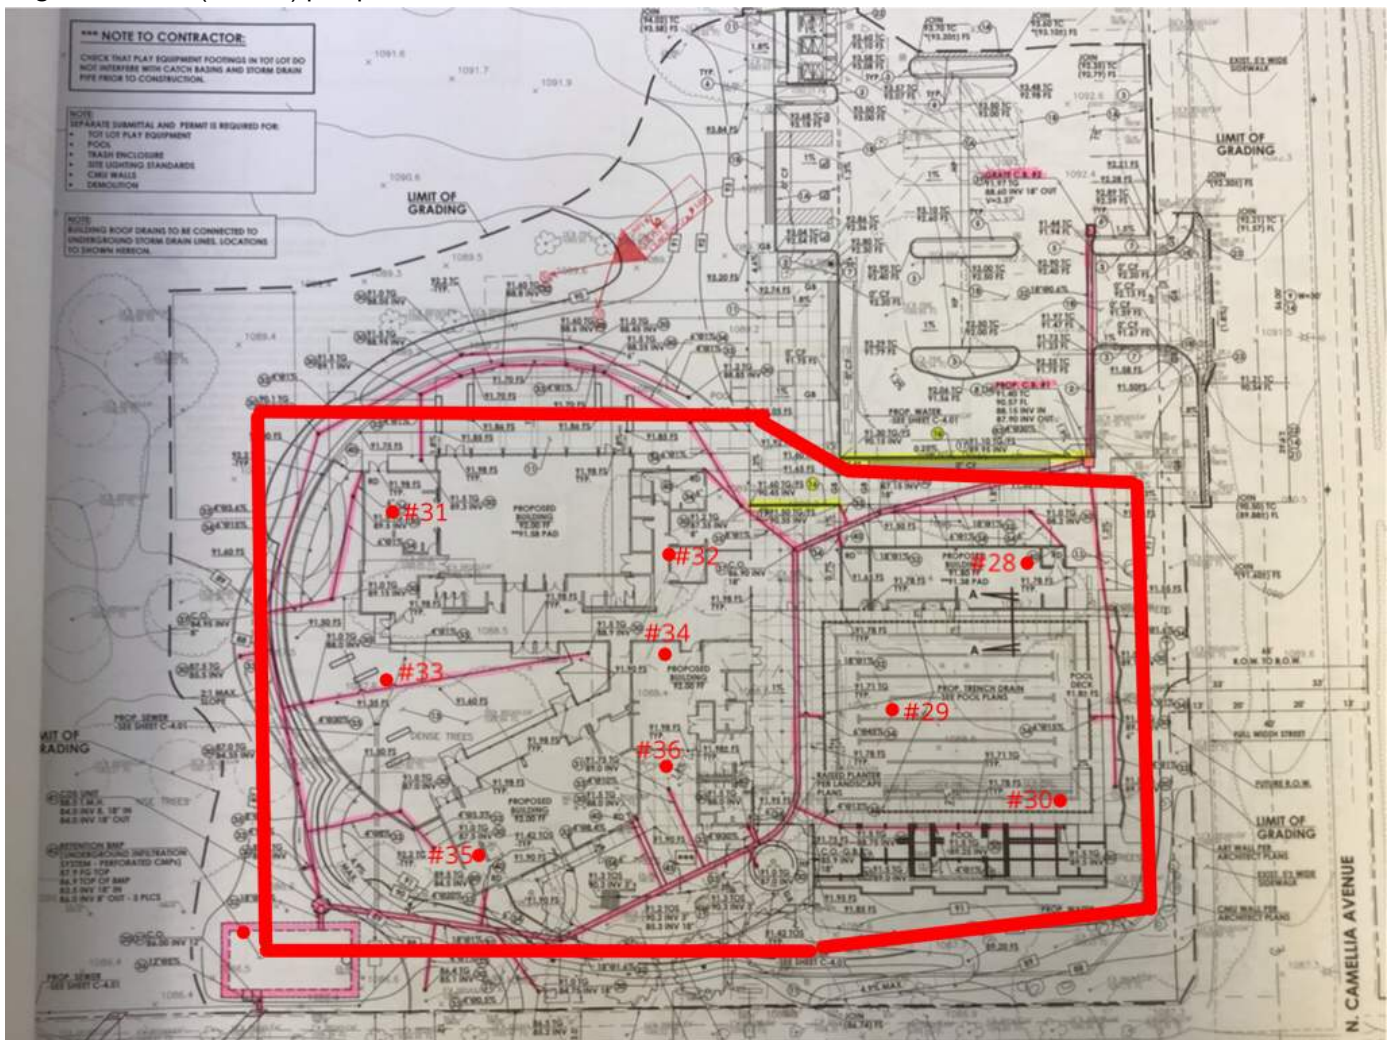
**Fig. 1:** Over-ex (#28-36) plot plan

Ironclad continued work with over-excavating the community center building and pool area for the Anthony Munoz project. Contractor has approved soil imported from the ontario airport project. Once the soil was delivered the 824 compactor spread the soil out in 8"-10" loose lifts. During placement and compaction the soil was moisture conditioned via water truck. I used a calibrated nuclear density gauge to check compaction and moisture. 9 tests were taken, 9 tests met minimum specified compaction per plans and specifications.

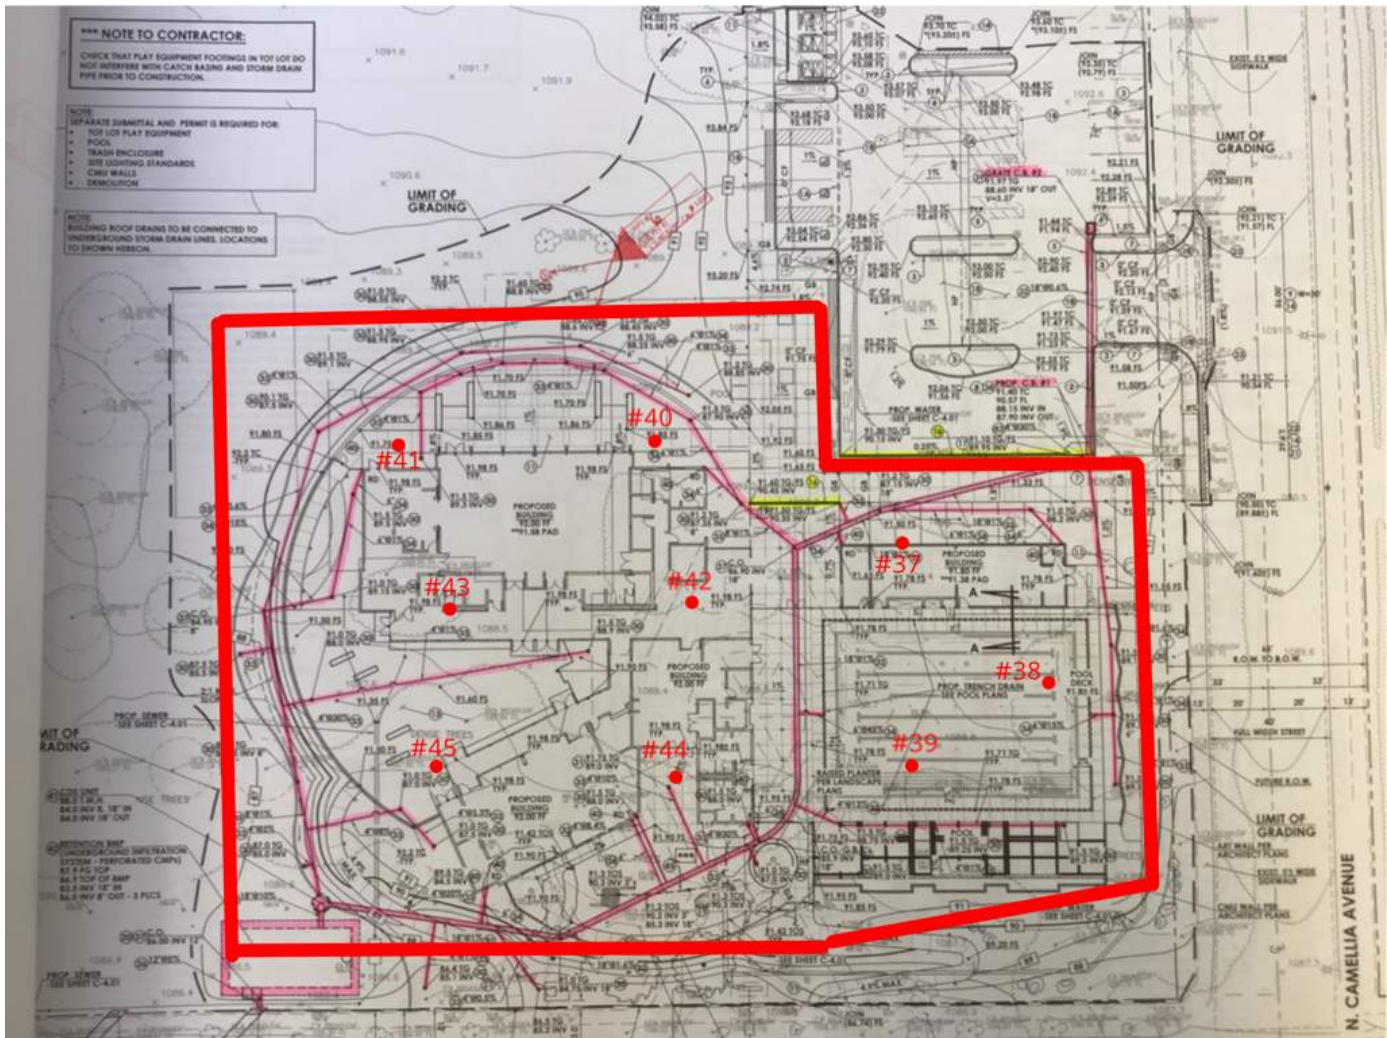
Fig. 1: Over-ex (#37-45) plot plan

Ironclad continued work with over-excavating the community center building and pool area for the Anthony Munoz project. Contractor has approved soil imported from the ontario airport project. Once the soil was delivered the 824 compactor spread the soil out in 8"-10" loose lifts. During placement and compaction the soil was moisture conditioned via water truck. I used a calibrated nuclear density gauge to check compaction and moisture. 9 tests were taken, 9 tests met minimum specified compaction per plans and specifications.

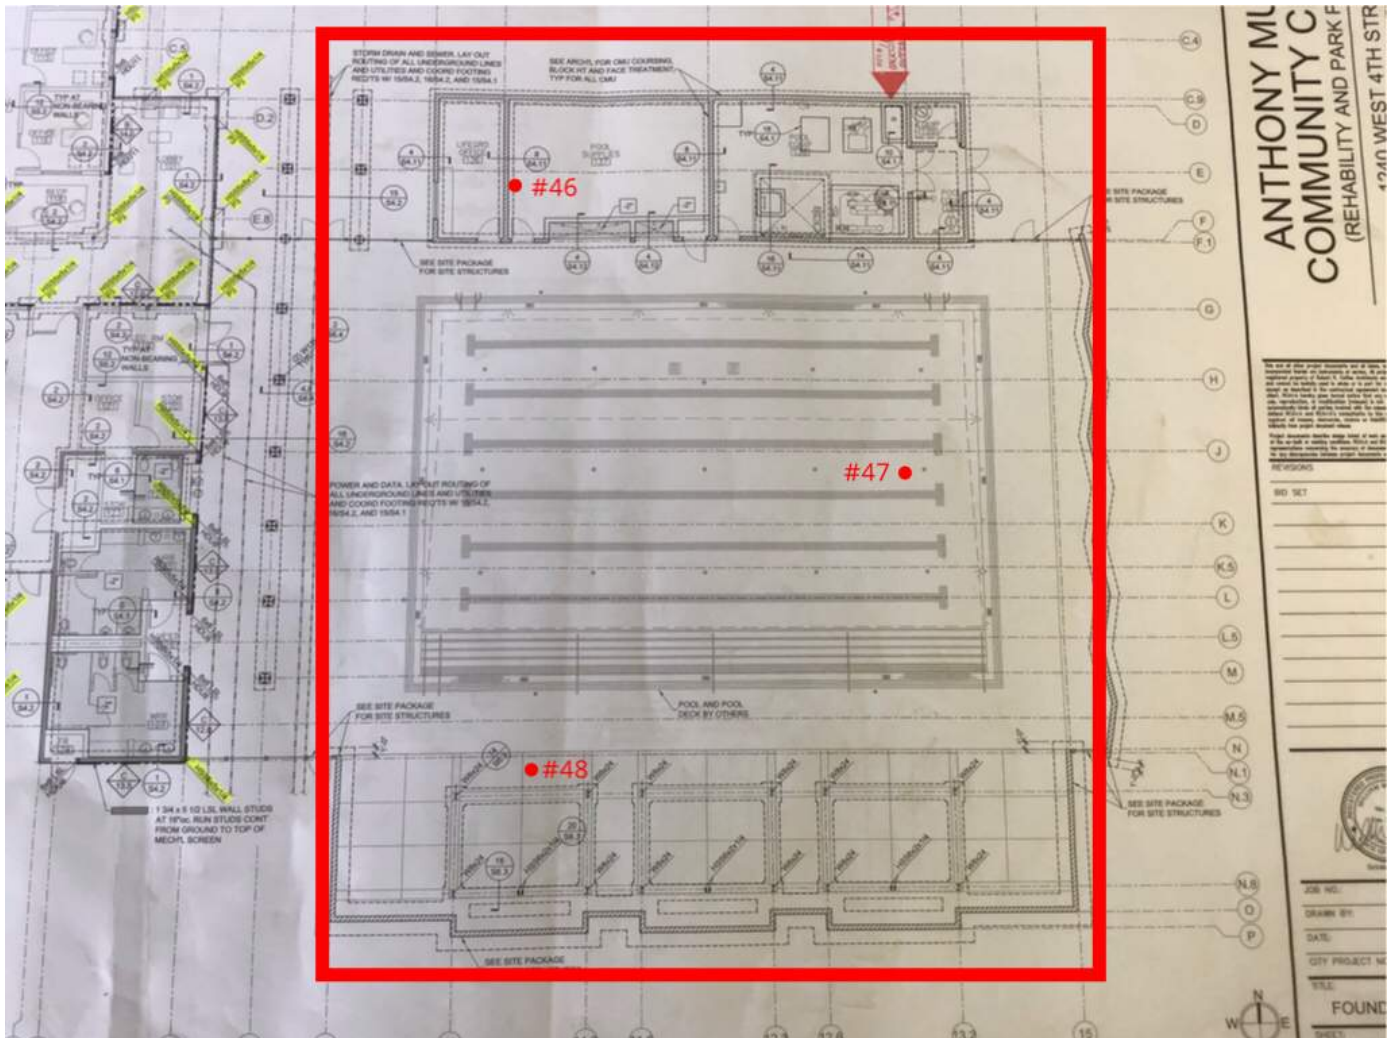
Fig. 1: Pool (#46-48) plot plan

Ironclad was on site final grading the building and pool foundations. Contractor used a CAT 14H blade and CAT 623 scraper to final grade the foundations. The contractor had a laborer pay extra attention to the top 12" of fill for small boulders and debris. The water truck made passes throughout the day to moisture condition the soil. The CAT 623 scraper was used to achieve compaction. I used a calibrated nuclear density gauge to check compaction and moisture content. 9 tests were taken, 9 tests met minimum specified compaction per plans and specifications.

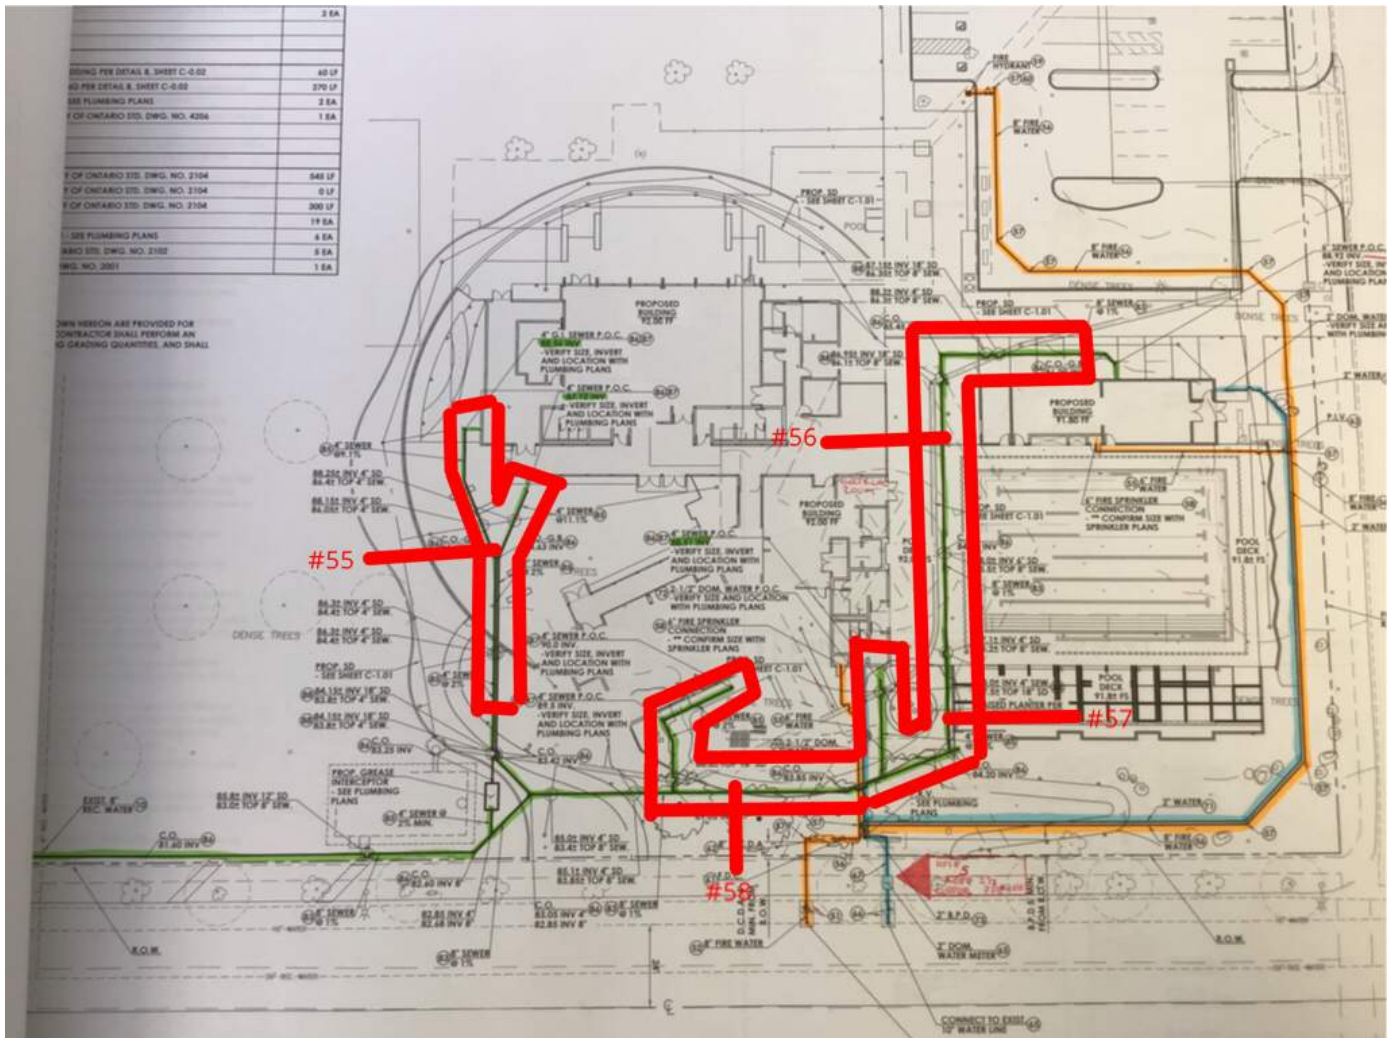
**Fig. 1: Sewer line (#55-58) plot plan**

JPI was on site shading and backfilling the main sewer line. Contractor used sand for bedding (6" below pipe) and used native soil for shading and backfill. Contractor used a loader to place soil and the excavator spread the soil in 8"-12" loose lifts. The soil was moisture conditioned in stockpile and during placement. (2) Deere 250G excavators with sheep's foot were used to achieve compaction. I used a calibrated nuclear density gauge to check compaction and moisture. 4 tests were taken, 4 tests met minimum specified compaction per plans and specifications.

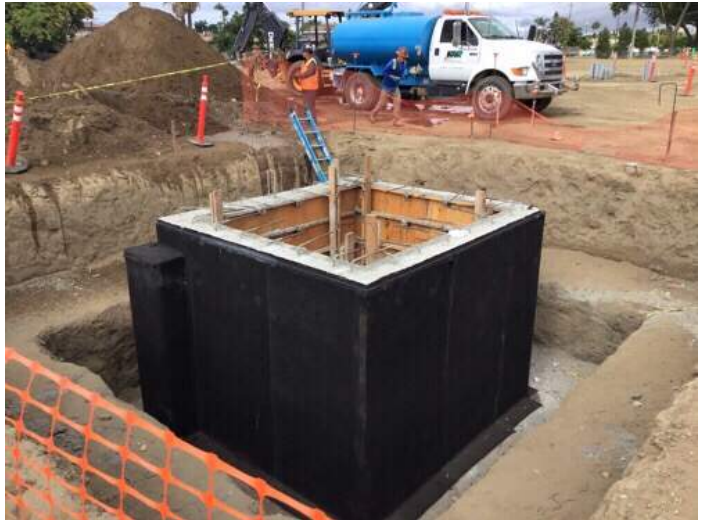
**Fig. 2:** Pool surge pit area of back fill

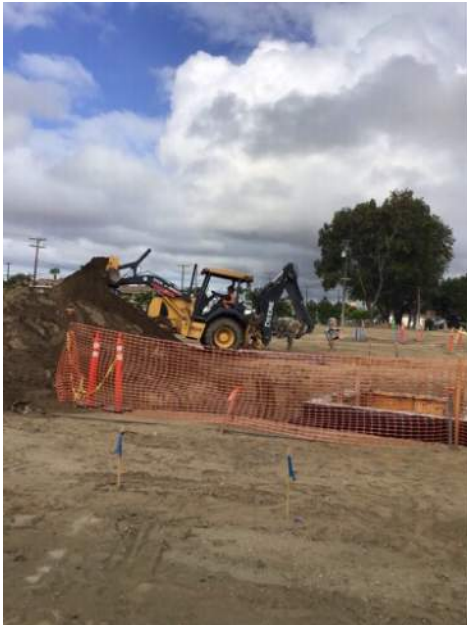
**Fig. 3:** Moisture conditioning and mixing stock pile

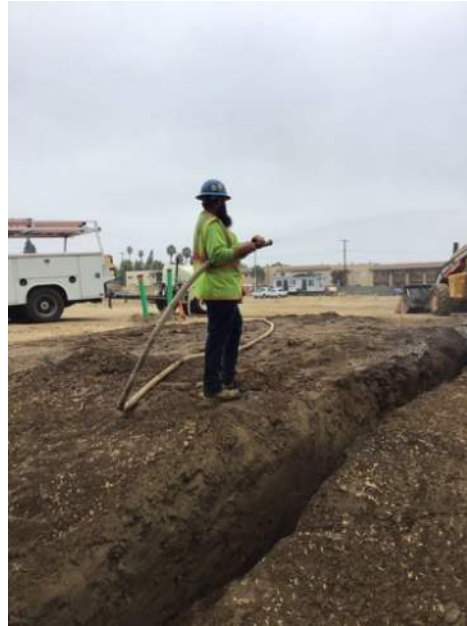
**Fig. 2:** Moisture conditioning performed before and during placement

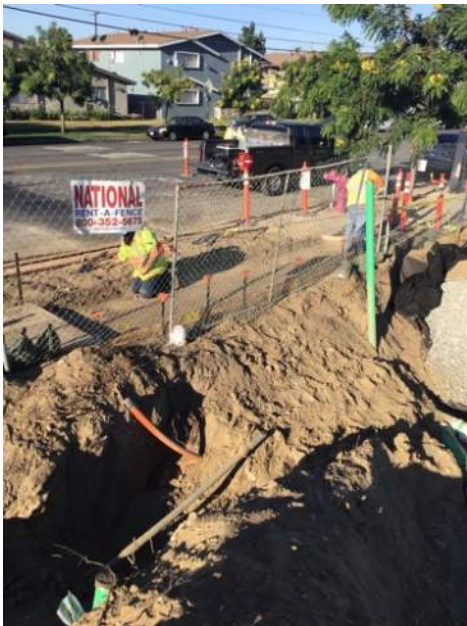
**Fig. 1:** BAC (electrician) sidewalk replacement
