ASCE 41-13 SEISMIC EVALUATION Of

City of Inglewood Civic Center -Library

101 W. Manchester Blvd Inglewood, CA 90301

Nabih Youssef Associates

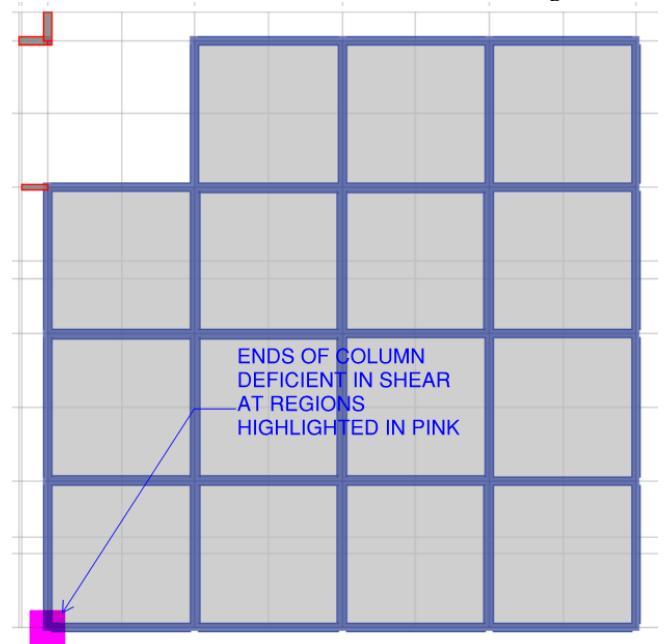
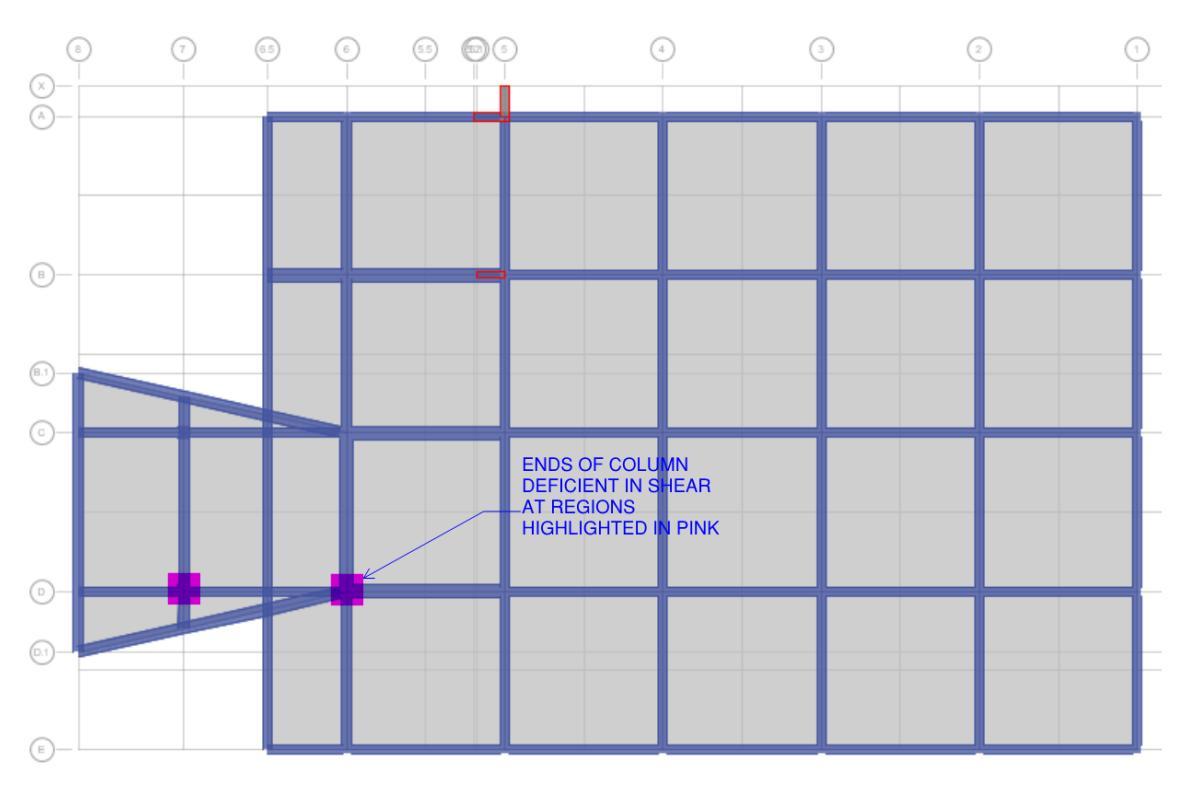
BELOW 2ND FLOOR PLAN

- All columns are sufficient in flexural strength under all load combinations.
- Few columns at first two levels are deficient in shear strength at column ends. More columns at all levels are deficient in shear strength at mid-height.

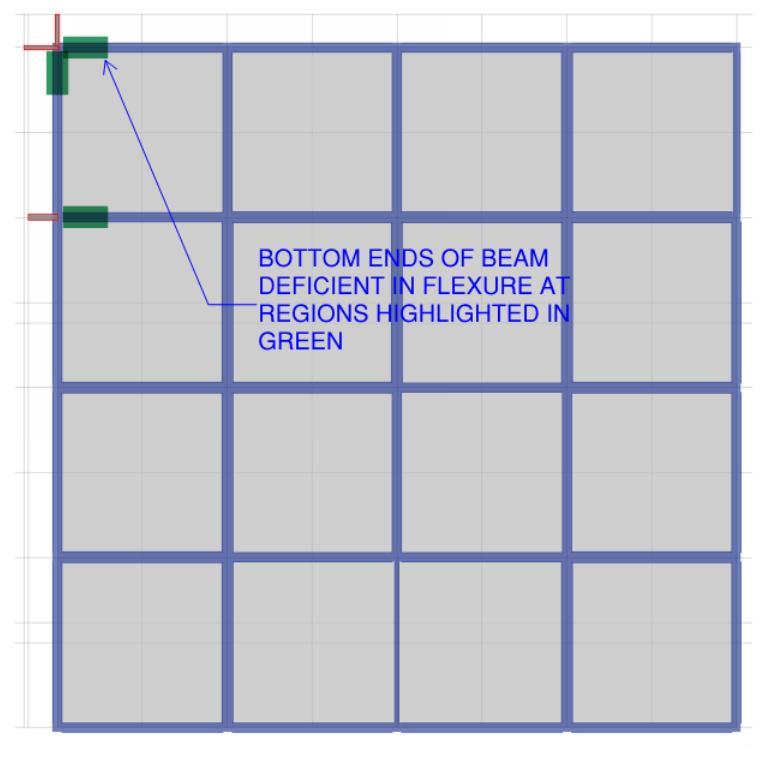
ROOF PLAN

• Several beams at roof adjacent to narrow wall piers near main entrance of the library are deficient in flexure at member ends.

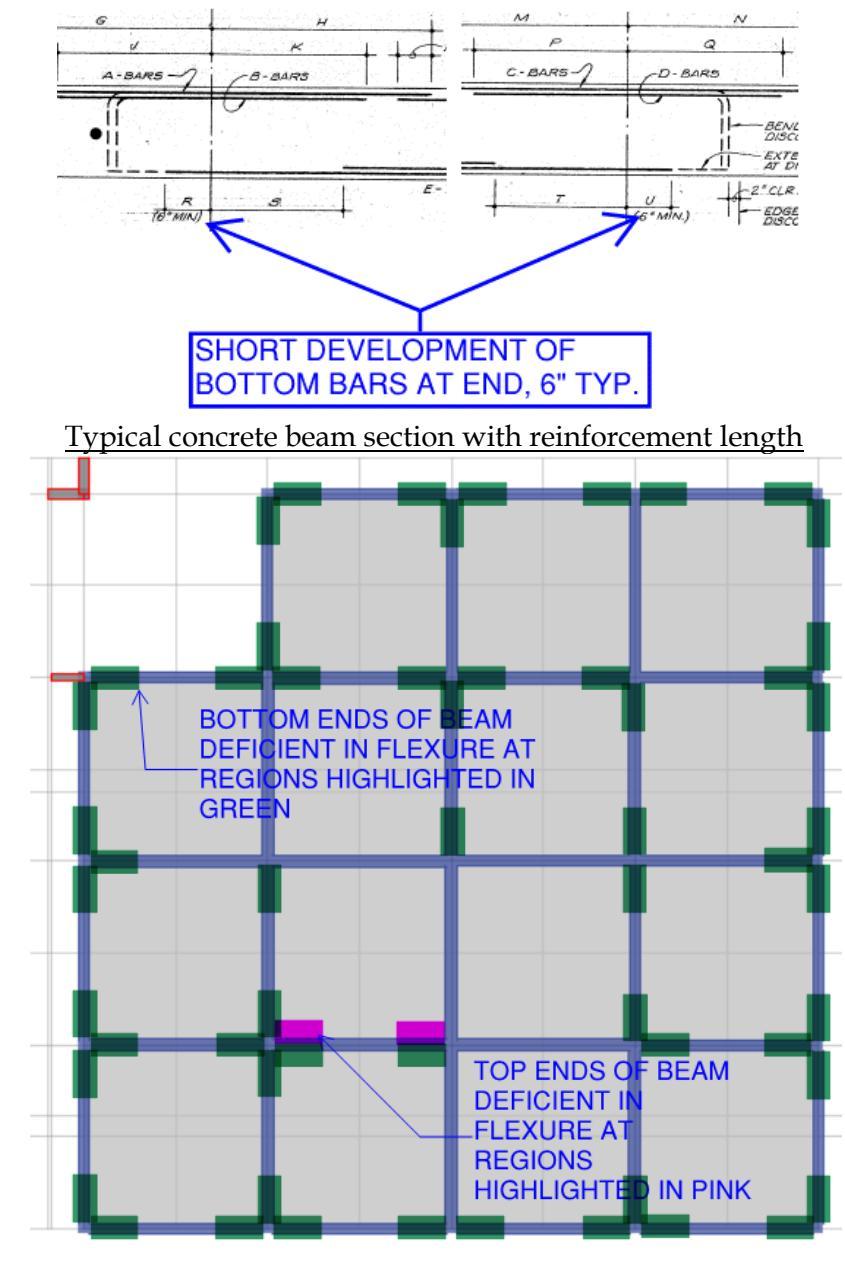
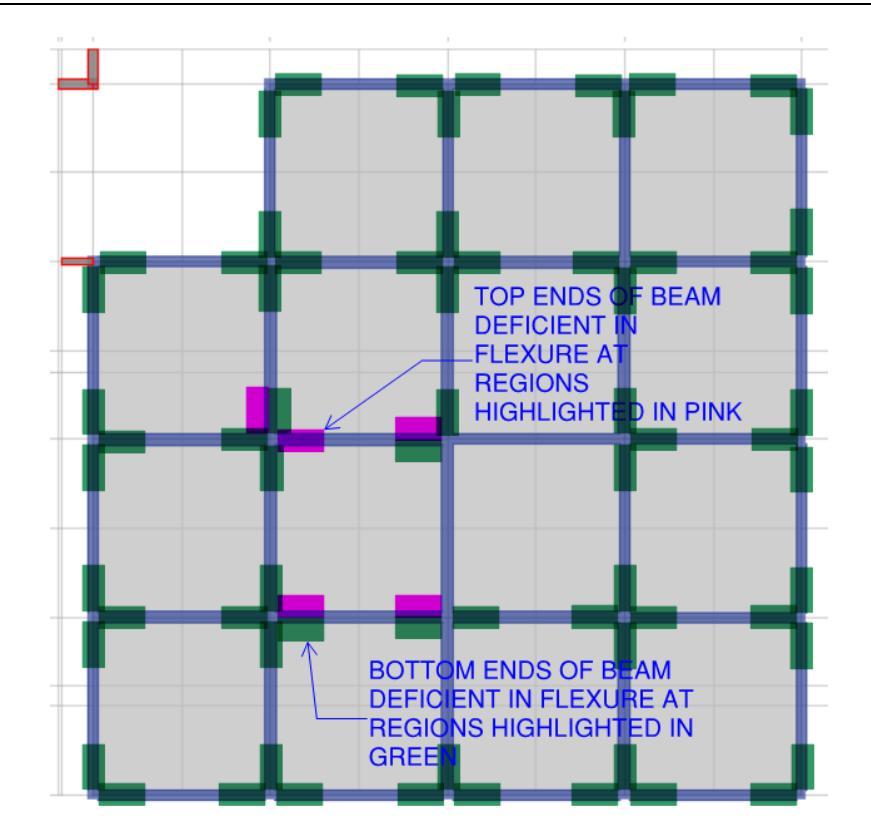
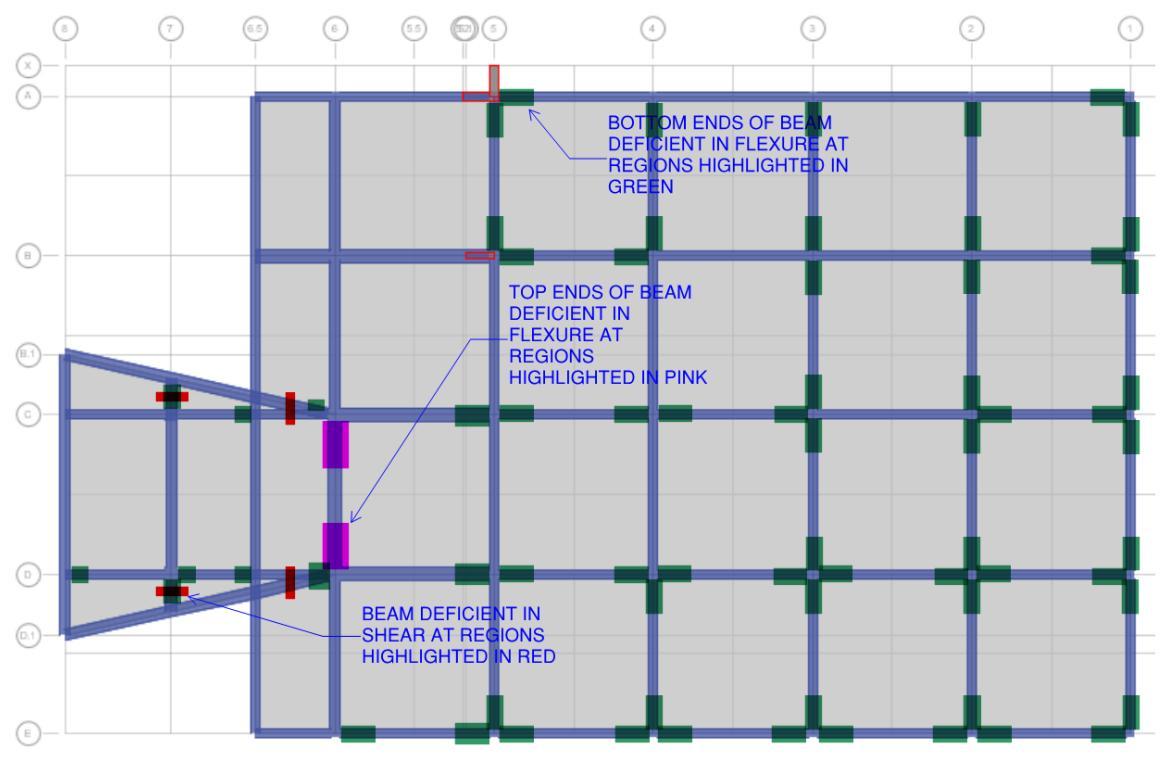
- Most of the exterior and interior beams are deficient in flexure at member ends as the beams were not originally designed for seismic demand in the frames. All beams have bottom longitudinal bars that extend 6" beyond the column centerline, causing the reinforcement not being able to develop in tension.
- Few beams at underside of Lecture Hall are deficient in shear strength along member length.

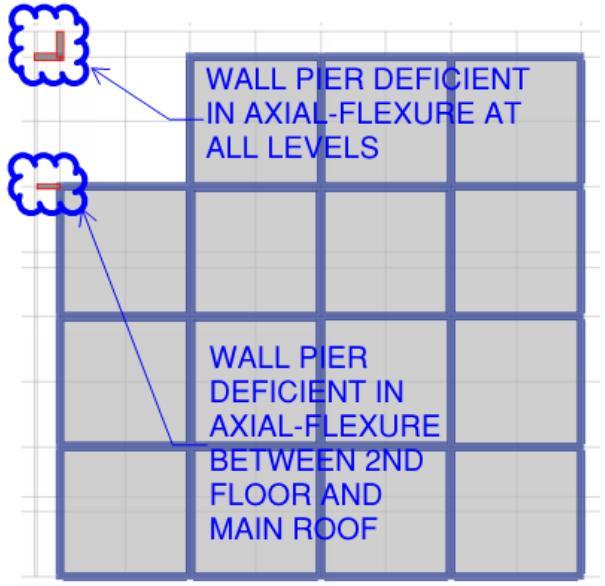
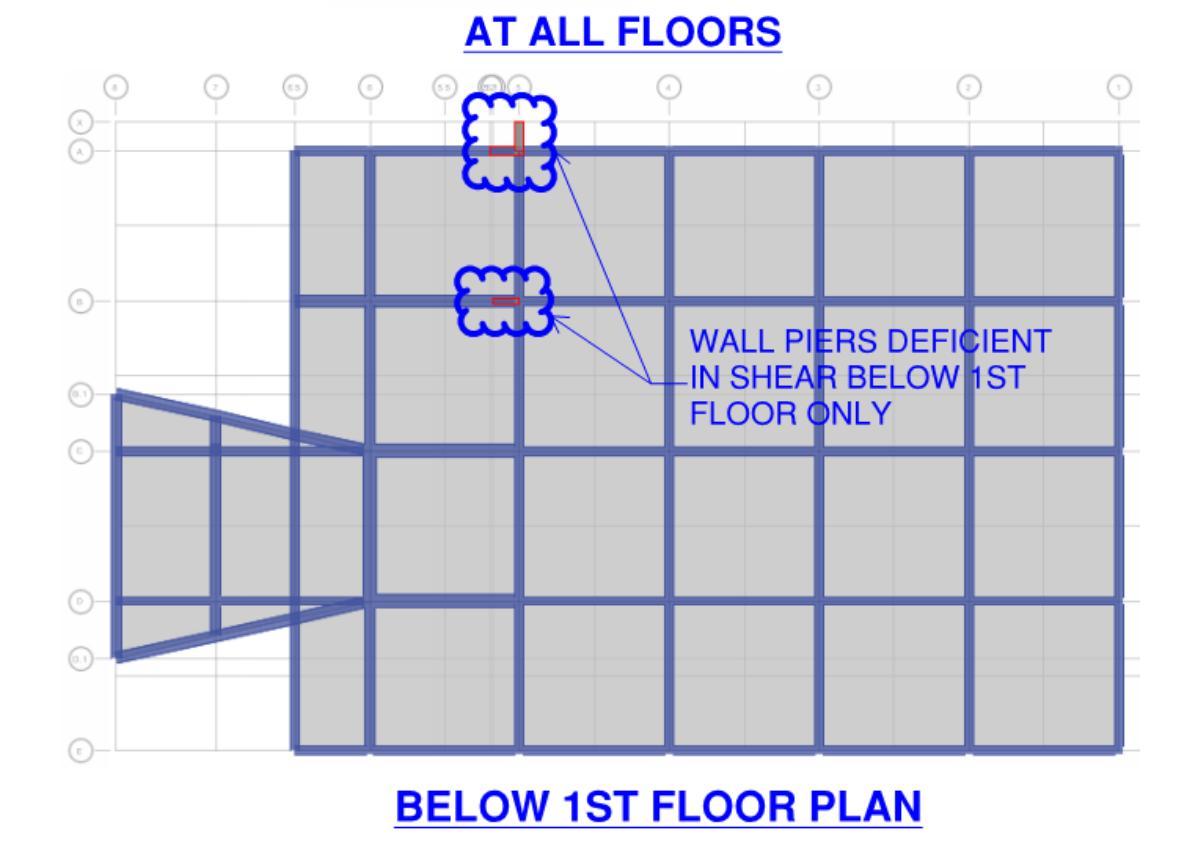
• Narrow wall piers near main entrance of the building are deficient in flexure and shear.
