ASCE 41-13 SEISMIC EVALUATION Of

City of Inglewood Civic Center -Library

101 W. Manchester Blvd Inglewood, CA 90301

Nabih Youssef Associates

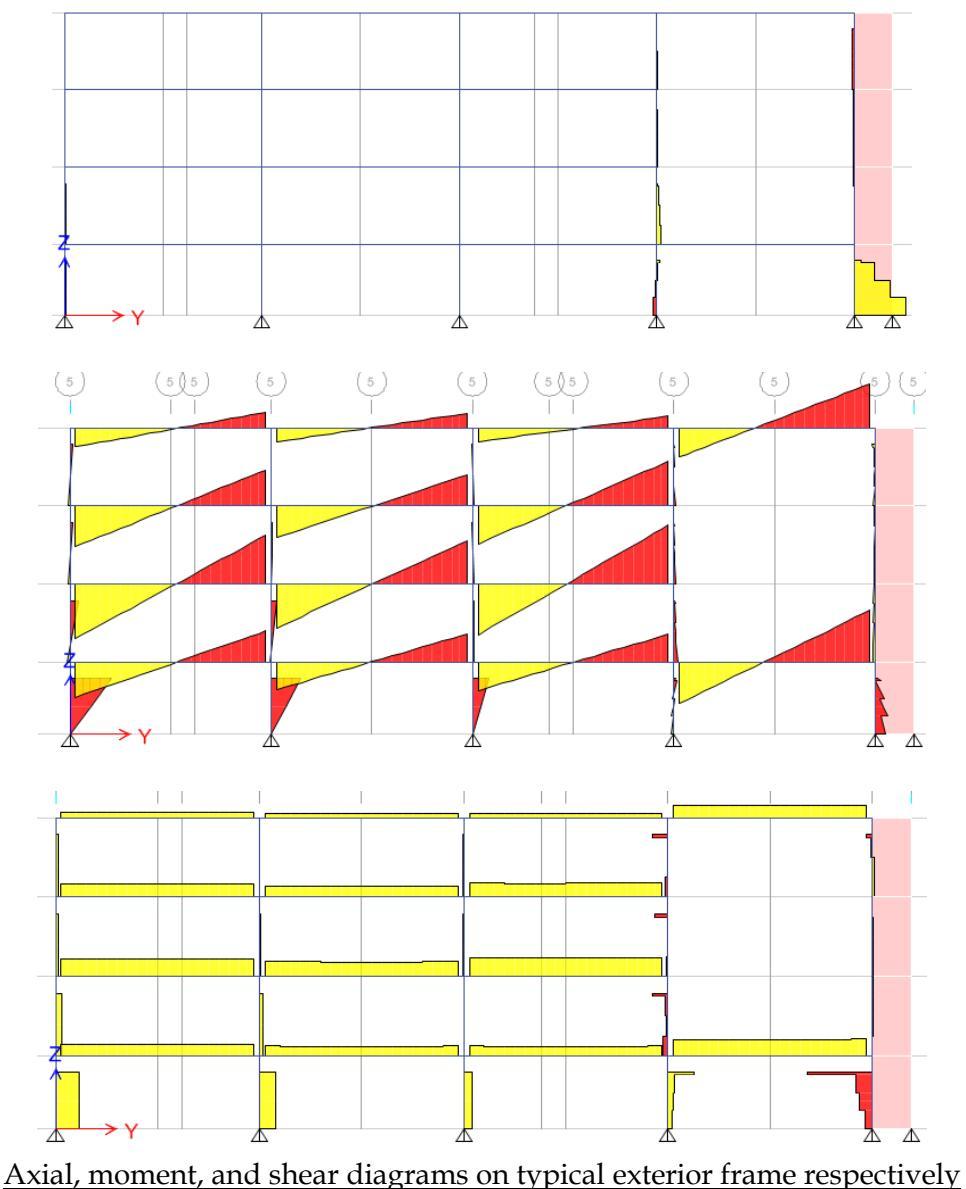
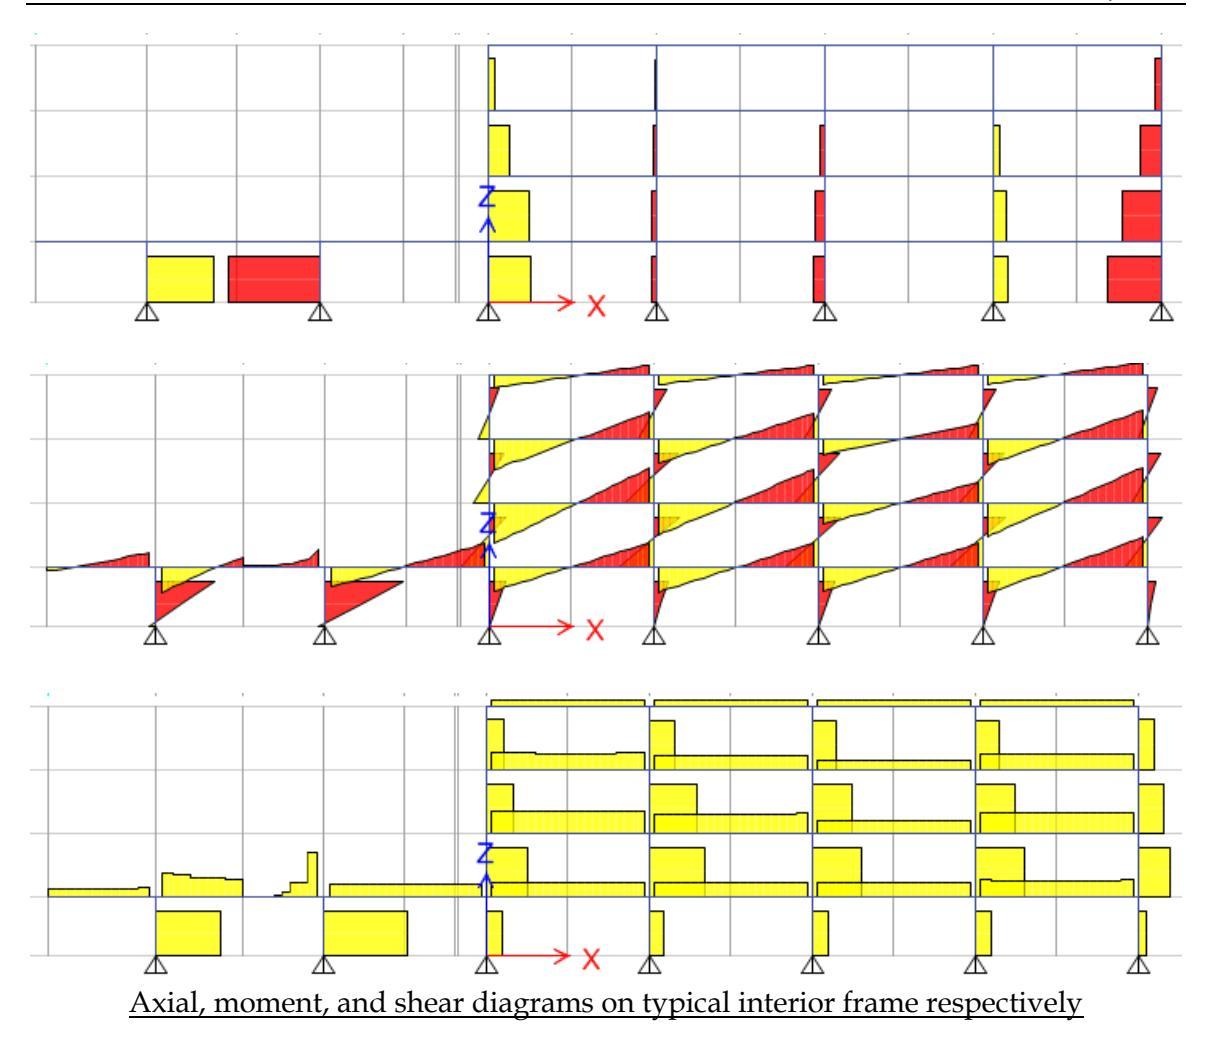
The following elevation diagrams indicate demands on the frame members under a static seismic load case as an example for various dynamic load cases used in the complete analysis process.

Columns:

- All columns are sufficient in flexural strength under all load combinations.
- Few columns at first two levels are deficient in shear strength at column ends. More columns at all levels are deficient in shear strength at mid-height.
