**Re: Asbestos and Lead Limited Survey
Tranquility High School
Aquatic Center
6052 Juanche Ave.
Tranquility, CA
Job No. C121-24**

Asbestos and Lead Limited Survey: Tranquility High School
6052 Juanche St, Tranquility, CA
C121-24

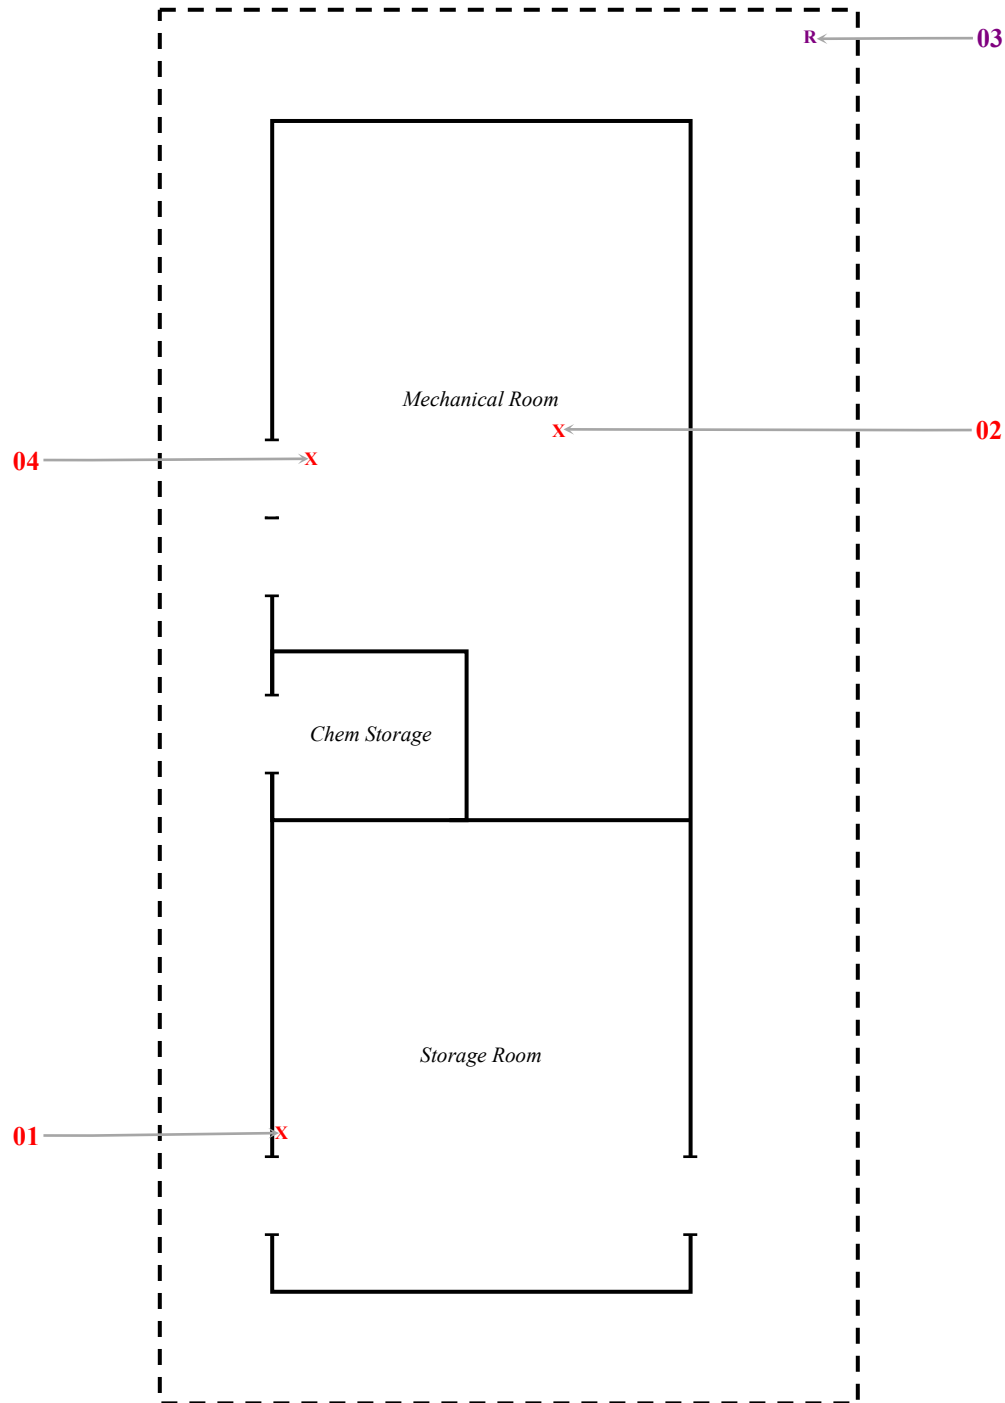
Drawing Not to Scale

X = Interior Samples
Y = Exterior Samples
R = Roof Samples

Attached is the asbestos and lead limited survey report for the above referenced site. The report includes inspection observations; a list of all samples taken, bulk sample analysis results, a sample location drawing, and recommendations concerning asbestos and lead identified at this site.

Sample	Location	Material	% Of ACM	Friable
Pool House				
01	Storage Room Wall	Base Cove Mastic	ND	
02	Mechanical Room Pipe Joint	Gasket Material	ND	
03	Roof	Underlayment	ND	
04	Foundation	Concrete	ND

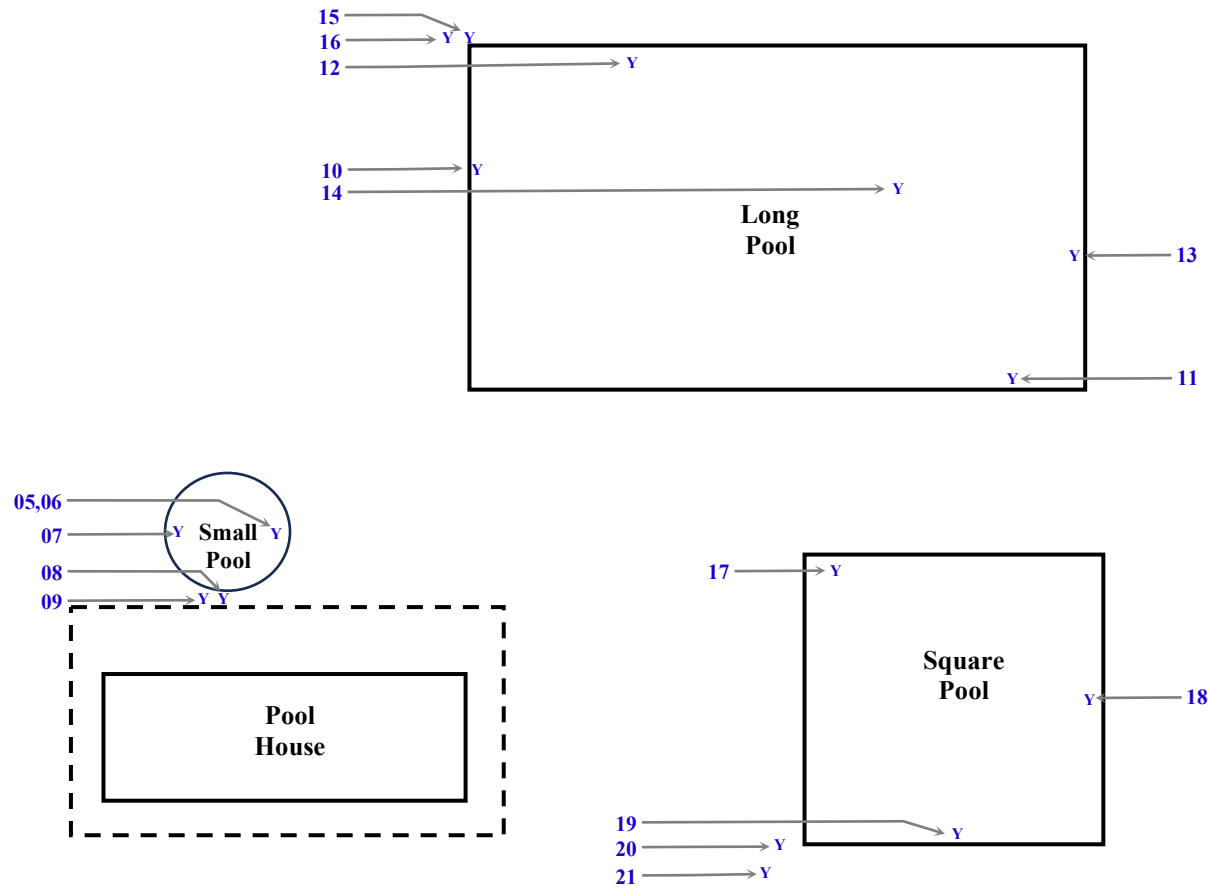
Drawing not to Scale

Y = Exterior Samples
X = Interior Samples
R = Roof Samples
