Subject: Site Grading Report
Soboba Band of Luiseno Indians
Horseshoe Property Commercial/Retail Development

Soboba Horseshoe Service Center, Phase 1

Lake Park Drive, San Jacinto Area, Riverside County, CA

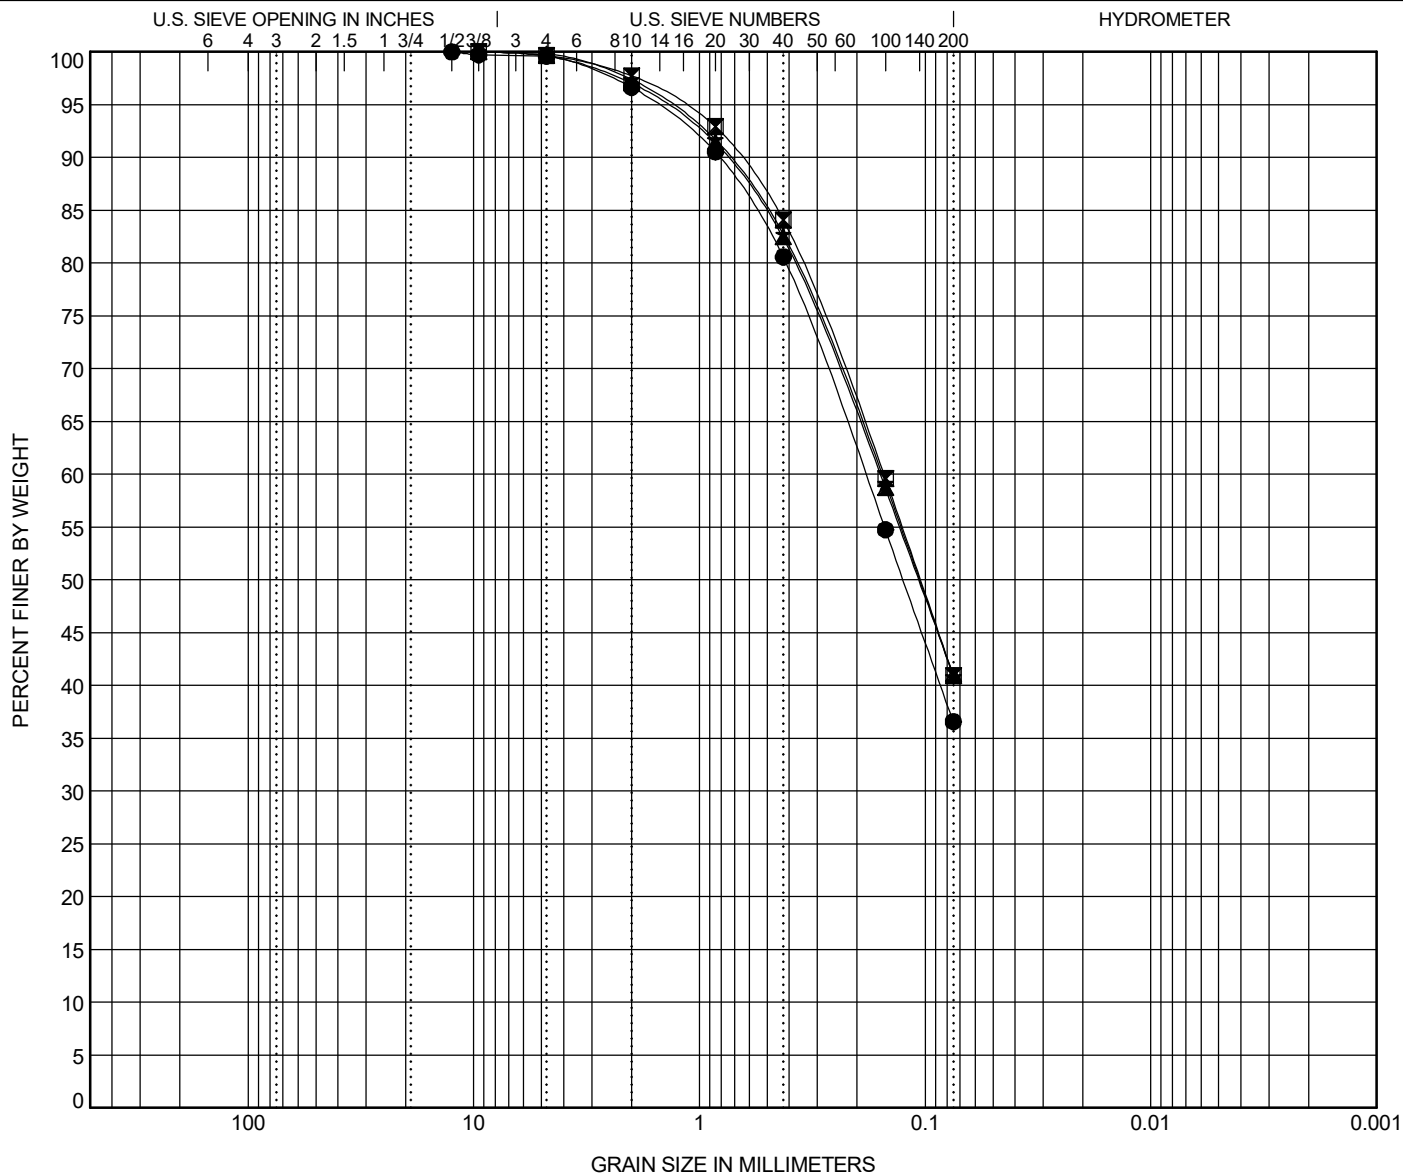
IFE SIEVE ANALYSIS - GINT STD US LAB.GDT - 7/21/20 17:10 - P:\E080\IE080-056 GRADING HORSESHOE\GINT.GPJ

COBBLES	GRAVEL		SAND			SILT OR CLAY
	coarse	fine	coarse	medium	fine

BOREHOLE	DEPTH	Classification					LL	PL	PI	Cc	Cu
● 1	1.0	SILTY, CLAYEY SAND(SC-SM)					25	19	6		
▣ 2	1.0	SILTY, CLAYEY SAND(SC-SM)					27	20	7		
▲ 3	1.0	SILTY SAND(SM)					26	22	4		
★ 4	1.0	SILTY, CLAYEY SAND(SC-SM)					25	20	5		
BOREHOLE	DEPTH	D100	D60	D30	D10	%Gravel	%Sand	%Silt		%Clay	
● 1	1.0	12.5	0.185			0.4	63.0	36.6			
▣ 2	1.0	9.5	0.152			0.3	58.7	41.0			
▲ 3	1.0	9.5	0.159			0.4	58.6	41.0			
★ 4	1.0	9.5	0.156			0.1	59.0	40.9
