July 7, 2021  
Kleinfelder Project No. 20210301.001A

**SUBJECT: Summary Report for Construction Observation and  
Special Inspection Services  
Anthony Munoz Community Center (Rehability and Park Project)  
City of Ontario Project No. PS 1314-2  
Ontario, California**

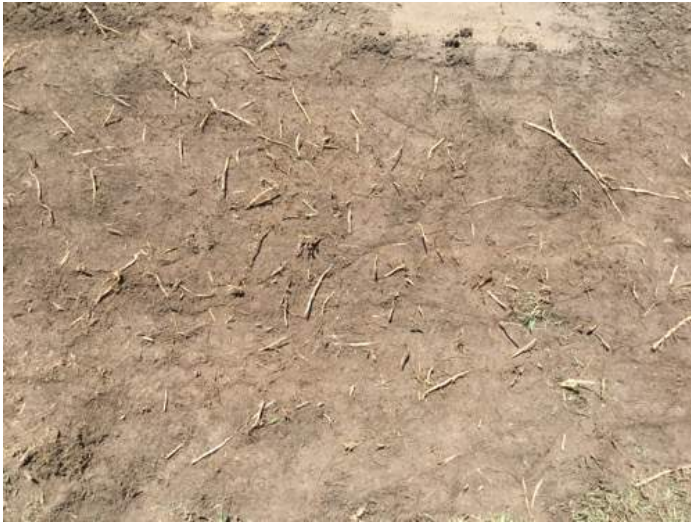
Fig. 1: NW side of site, organic soil sample picture #1.

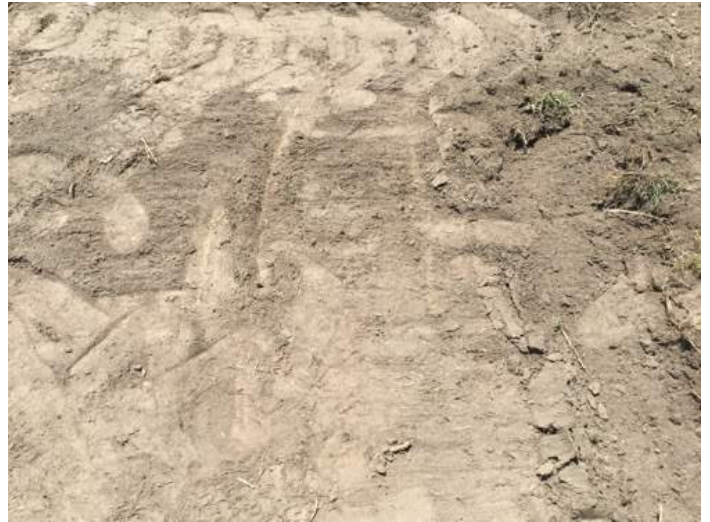
Fig. 2: NW side of site, organic soil sample #2.

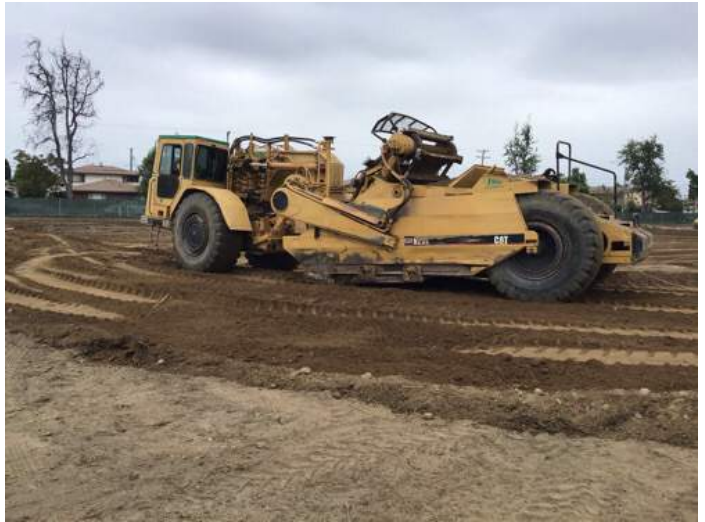
**Fig. 2:** CAT 623 scraper

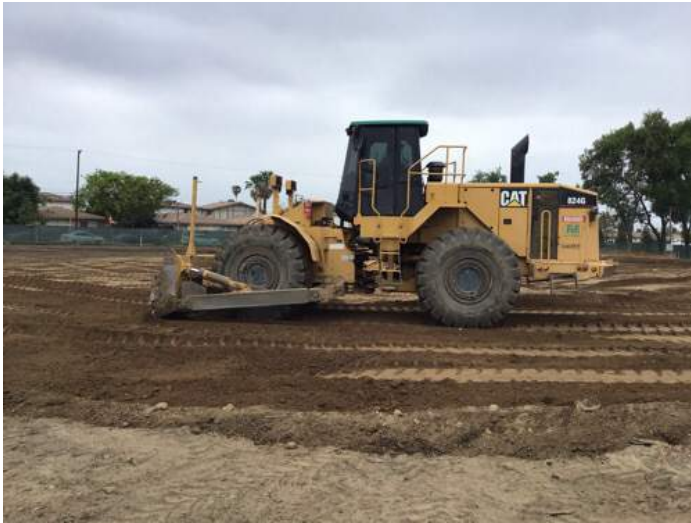
**Fig. 3:** CAT 824 compaction loader

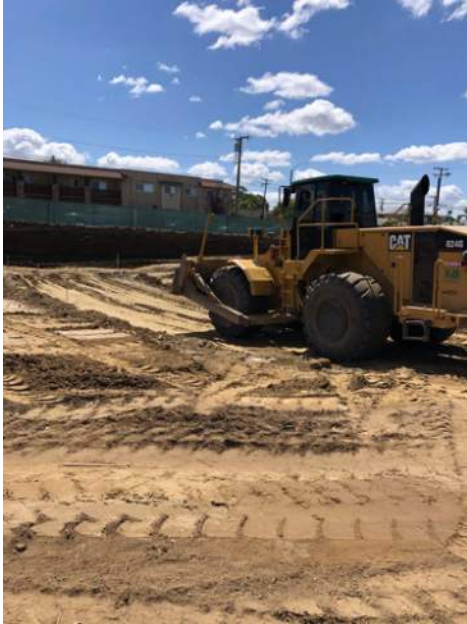
Ironclad was on site excavating soil for the over-ex at the pool location. The over-ex area was measured to verify the contractor was extending 3 ft beyond the building/pool envelope. Once the contractor reached the bottom of the pool over-ex the foreman and I verified elevation. The bottom was scarified 6" and compacted via (2) 623 scrapers. After bottom was compacted contractor placed soil in 8"-10" loose lifts and compacted via 623 scrapers and 824 compaction loader. I used a calibrated nuclear density gauge to check compaction and moisture content. 7 tests were taken, 7 tests met minimum specified compaction per plans and specifications.

Fig. 1: Pool section bottom compaction

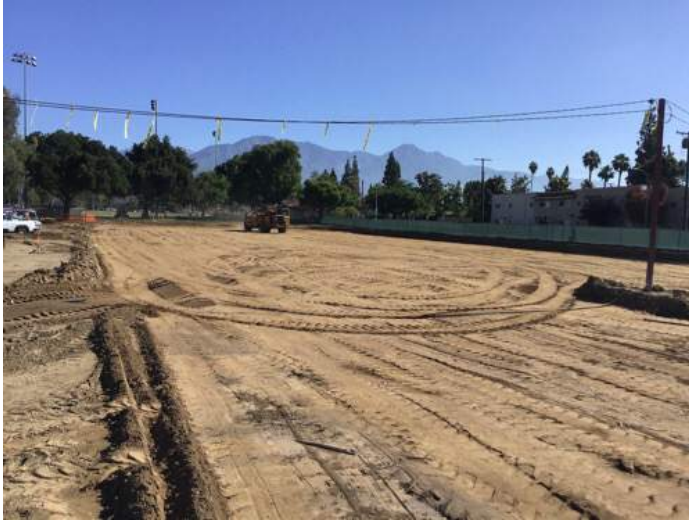
Ironclad was on site excavating soil for the parking lot over-ex. Once the contractor reached bottom elevation was verified and compaction efforts were made. Contractor used a CAT 623 scraper was used to achieve compaction. I used a calibrated nuclear density gauge to check compaction and moisture content. 6 tests were taken, 6 tests met minimum specified compaction per plans and specifications.

Fig. 1: Parking lot (bottom over-ex) compaction

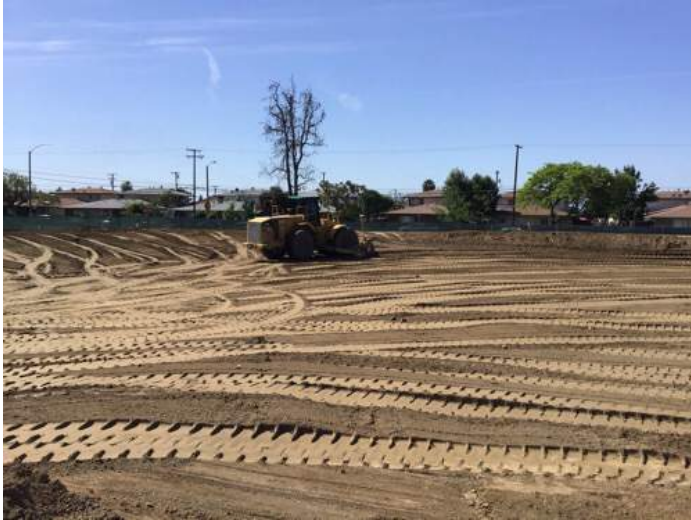
Ironclad was on site over-excavating the community center building and pool section. Ironclad had approved imported fill delivered from ontario airport. The delivery trucks placed soil from bottom dumps and the CAT 824G was used to spread soil in 8"-10" loose lifts and made 6-8 passes for compaction. I used a calibrated nuclear density gauge to check compaction and moisture content. 8 tests were taken, 8 tests met minimum specified compaction per plans and specifications.

Fig. 1: Over-ex building pad compaction

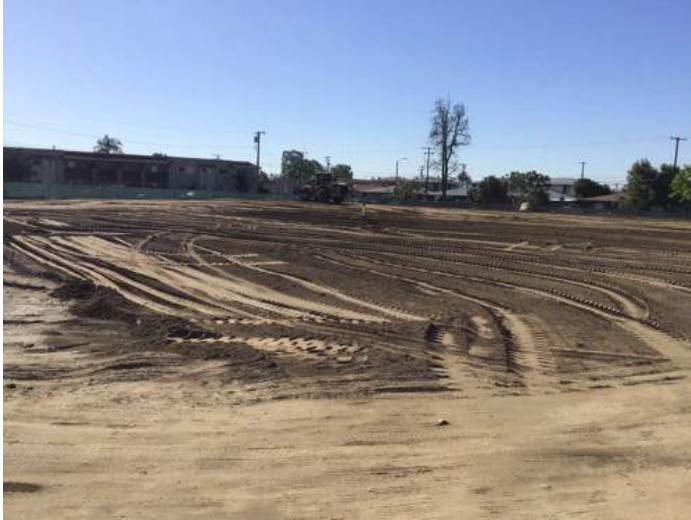
Ironclad continued work with over-excavating the community center building and pool area for the Anthony Munoz project. Contractor has approved soil imported from the ontario airport project. Once the soil was delivered the 824 compactor spread the soil out in 8"-10" loose lifts. During placement and compaction the soil was moisture conditioned via water truck. I used a calibrated nuclear density gauge to check compaction and moisture. 9 tests were taken, 9 tests met minimum specified compaction per plans and specifications.

Fig. 1: Compaction efforts

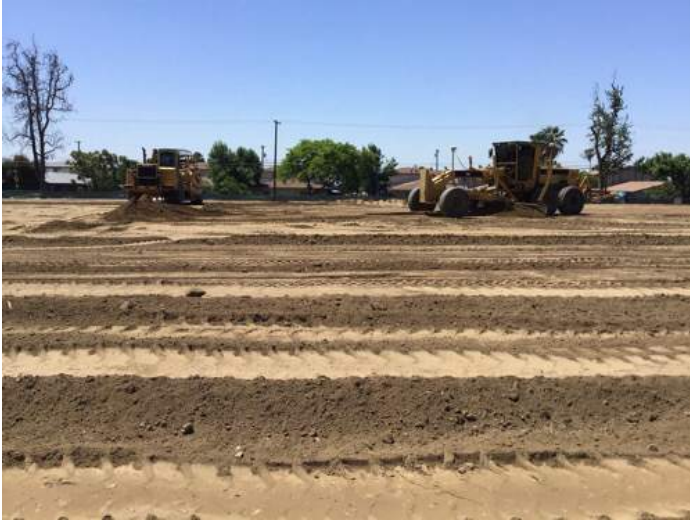
Ironclad was on site final grading the building and pool foundations. Contractor used a CAT 14H blade and CAT 623 scraper to final grade the foundations. The contractor had a laborer pay extra attention to the top 12" of fill for small boulders and debris. The water truck made passes throughout the day to moisture condition the soil. The CAT 623 scraper was used to achieve compaction. I used a calibrated nuclear density gauge to check compaction and moisture content. 9 tests were taken, 9 tests met minimum specified compaction per plans and specifications.

Fig. 1: Final grading

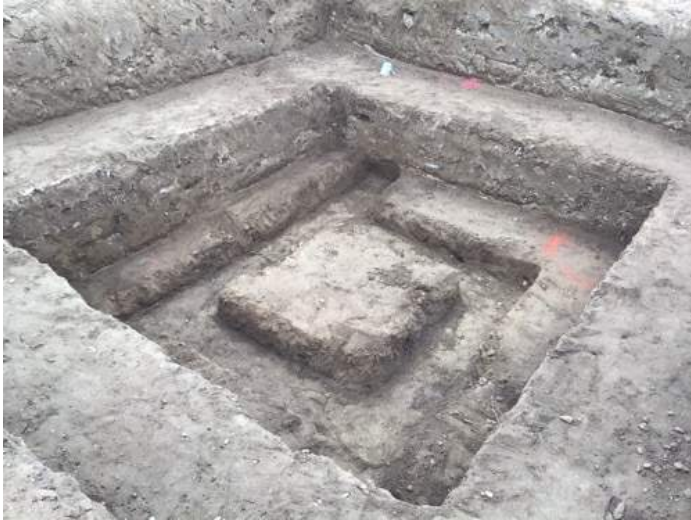
**Fig. 1:** Surge tank bottom

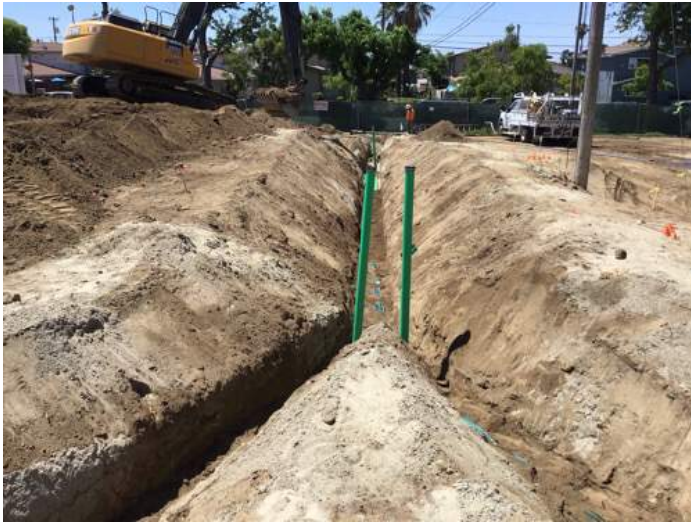
**Fig. 1:** Sewer line before backfill

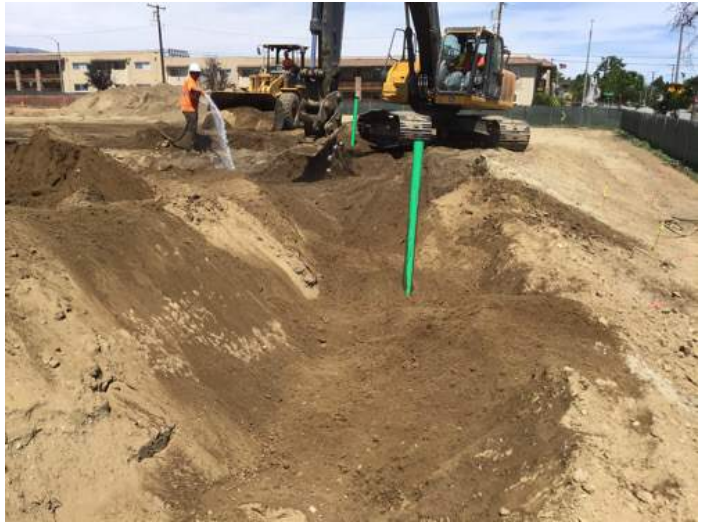
JPI was on site shading and backfilling the main sewer line. Contractor used sand for bedding (6" below pipe) and used native soil for shading and backfill. Contractor used a loader to place soil and the excavator spread the soil in 8"-12" loose lifts. The soil was moisture conditioned in stockpile and during placement. (2) Deere 250G excavators with sheep's foot were used to achieve compaction. I used a calibrated nuclear density gauge to check compaction and moisture. 4 tests were taken, 4 tests met minimum specified compaction per plans and specifications.

**Fig. 2:** Backfill compaction

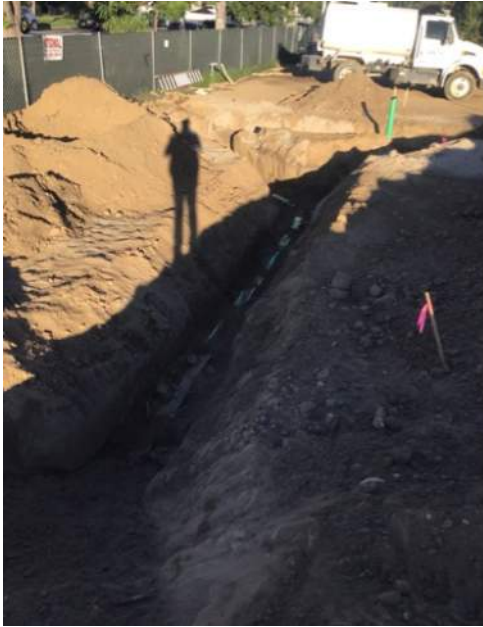
JPI was onsite with a crew of (4) to continue sewer line back fill from where they had left off the previous day. JPI had roughly 30' of sewer trench back fill remaining located at the South West side of the site located at the tie in from 4th Street. The crew used their loader to place material and excavator spread in loose 8-10" lifts. The material was moisture conditioned in stockpile and during placement. (2) Deere 250G excavators with sheep's foot were used to achieve compaction. At 10:30am the crew notified they would be stopping on sewer line back fill that they had been notified of city inspection needed due to changes made for line crossing storm drain. They notified they would have a 1:00pm inspection and then pending inspection would continue back fill.

**Fig. 1:** Sewere line back fill south west corner at 4th st. Tie in

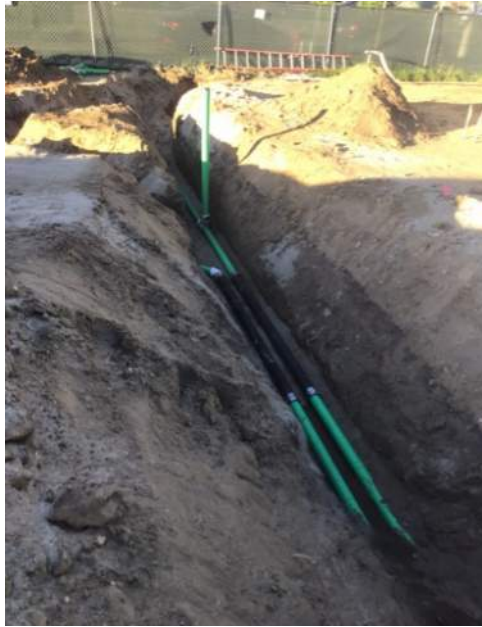
**Fig. 2:** Sewer line back fill continued

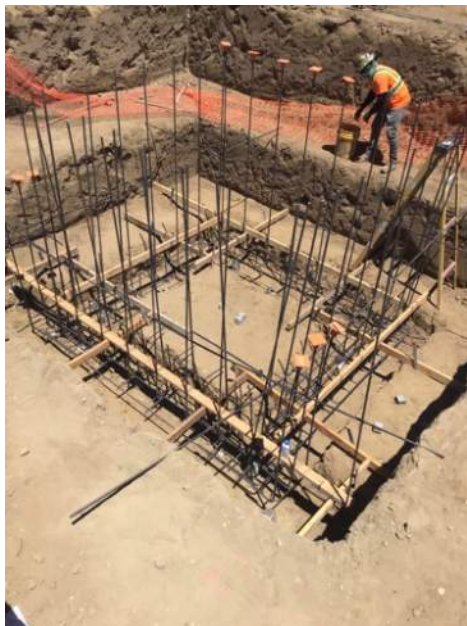
KAR Construction was onsite and received delivery of rebar for the pool surge pit footings, foundation, and slab. I verified reinforcing steel was per detail 16 on S4.11 as well as met standards per provided mill certs and S0.1 reinforcing steel note 1. All steel delivered was of correct size, grade, and shape and was bent where needed prior to delivery. Upon verification of materials the crew began to offload steel and install reinforcement steel in the pool surge pit footing area. The crew installed all reinforcing steel per S4.11 Detail 16. All steel was checked for correct size, spacing, and shape and was per approved plans mentioned above.

**Fig. 13:** Pool surge pit footing rebar placement per S4.11 Detail 16

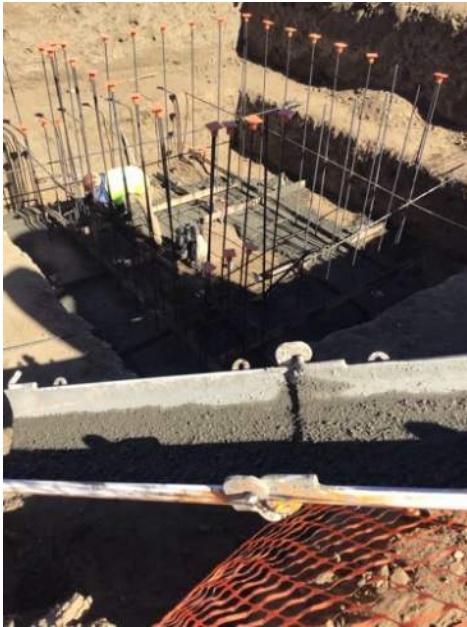
**Fig. 3:** Concrete placement pool surge pit footing

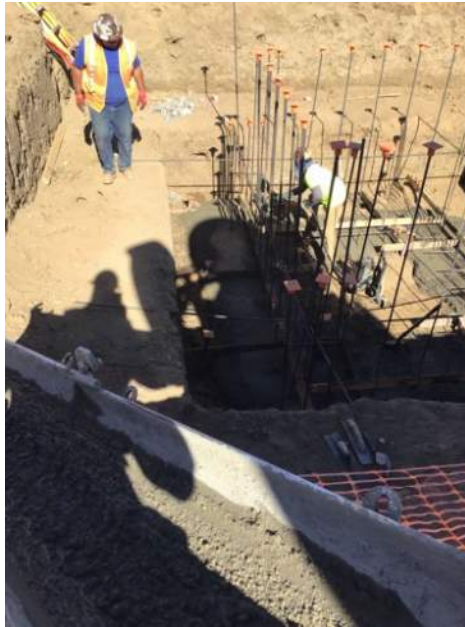
**Fig. 4:** Consolidatin with vibrator of pool surge pit footing

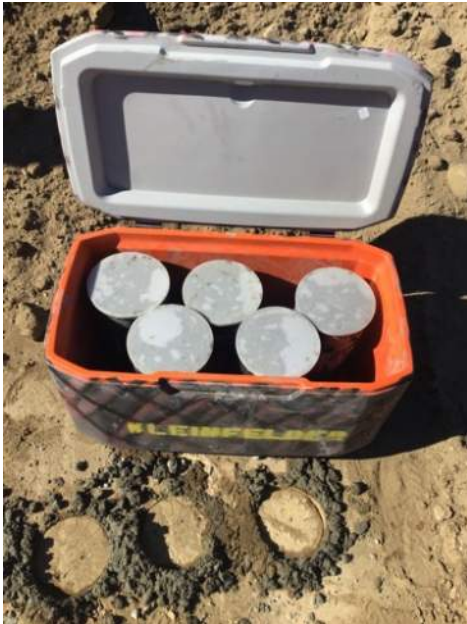
**Fig. 5:** 1 set of 5 6x12 cylinders taken at time of placement

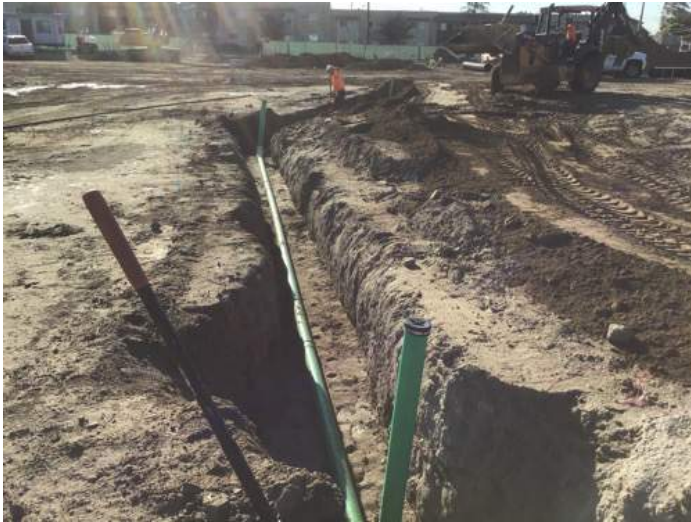
JPI was on site back filling/compacting the storm drain. Sand was used for bedding (6" below pipe). Native soil was used for shading. JPI used a loader and backhoe to place soil in 8"-10" loose lifts. Soil was moisture conditioned during placement and compaction. A backhoe and excavator w/sheep's foot was used to achieve compaction. I used a calibrated nuclear density gauge to check compaction and moisture content. 2 tests were taken, 2 tests met minimum specified compaction per plans and specifications. Work is on-going.

Fig. 1: Storm drain before backfill

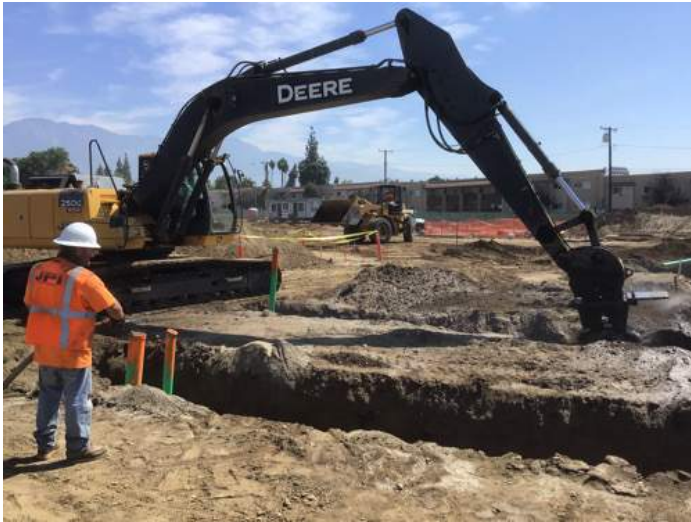
**Fig. 1:** Storm drain compaction efforts

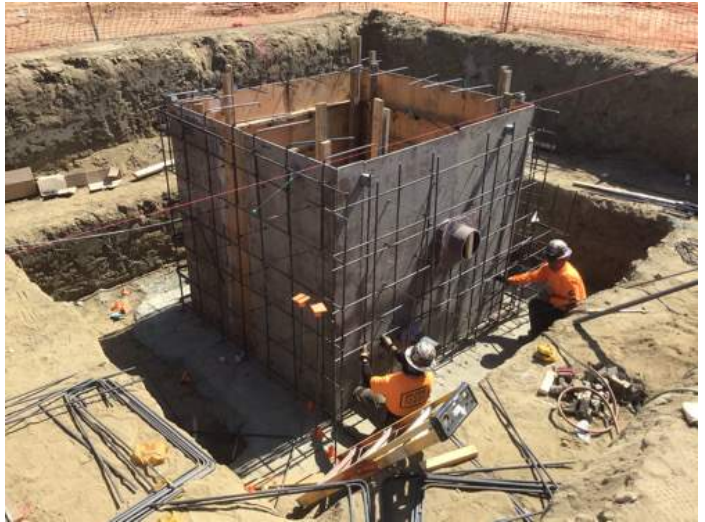
**Fig. 2:** Rebar placement for surge tanks walls

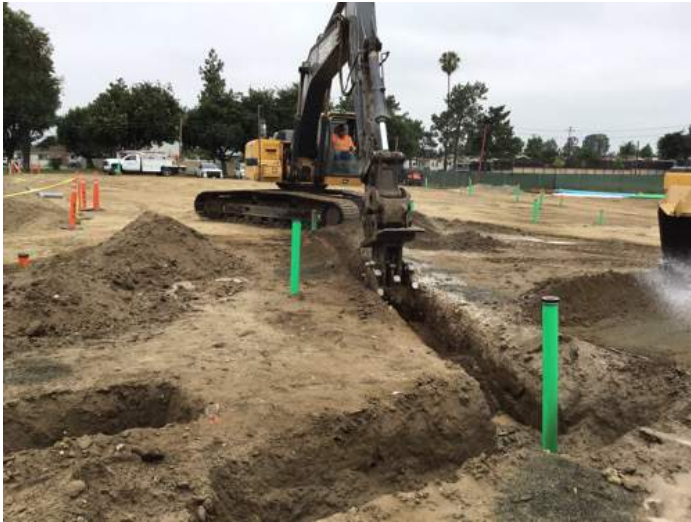
Fig. 1: Storm drain backfill/compaction

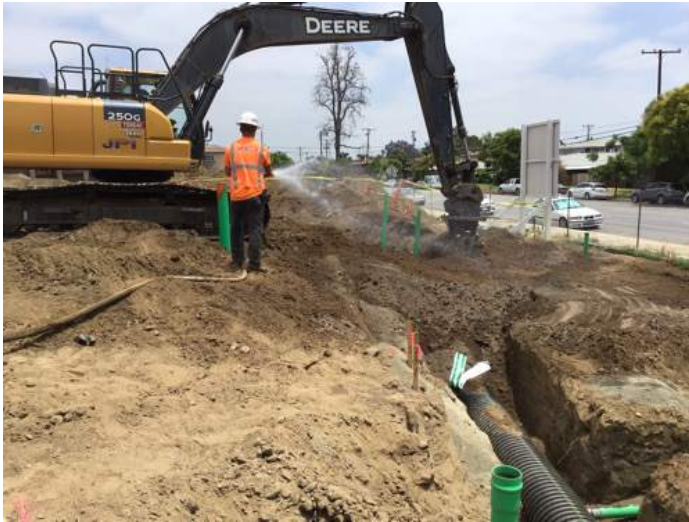
JPI was on site back filling/compacting storm drain. Sand was used for pipe bedding (6" below pipe) and native soil was used to shade the pipe. Contractor used a CAT loader to place soil in 8"-12" lifts. Soil was moisture conditioned in stockpile and during placement. A John Deere 250G excavator with sheep's foot was used to achieve compaction. I used a calibrated nuclear density gauge to check compaction and moisture content. 2 tests were taken, 2 tests met minimum specified compaction per plans and specifications.

Fig. 1: Storm drain compaction

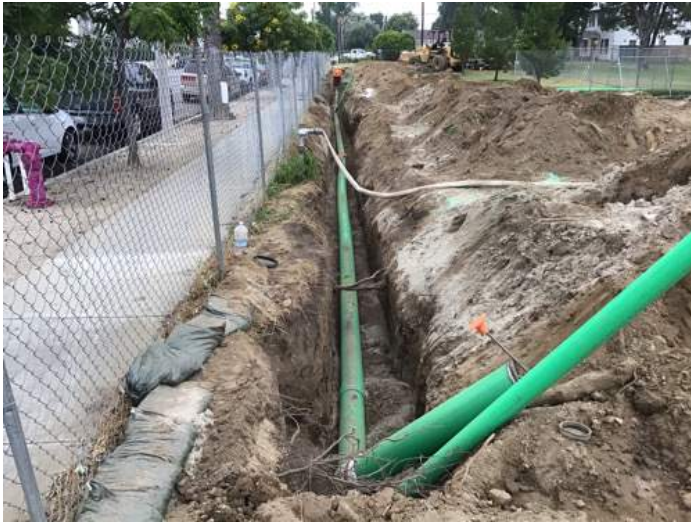
JPI was on site backfilling the sewer line at the southwest corner of the project leading to the park area. Sand was used for bedding (6" below pipe). Native soil was used for shading of pipe and backfill. Soil was moisture conditioned during placement and compaction. The first lift of soil was compacted via jumping jack and the rest was compacted via backhoe with sheep's foot. I used a calibrated nuclear density gauge to check compaction and moisture content. 3 tests were taken, 3 tests met minimum specified compaction per plans and specifications.

Fig. 1: Sewer line placement

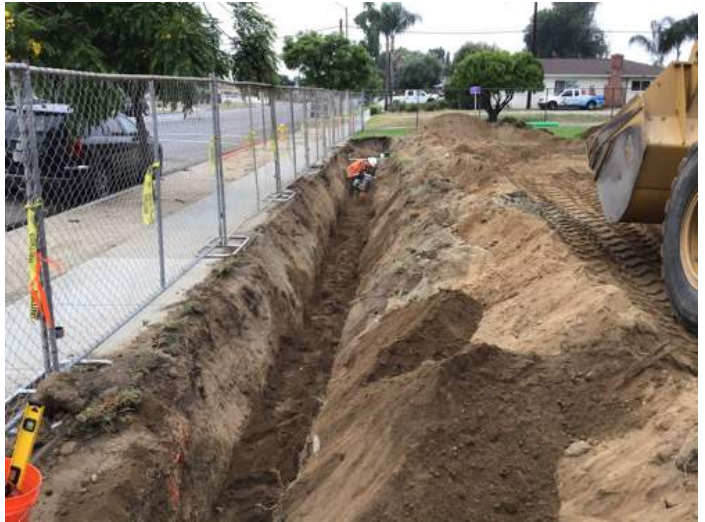
Fig. 2: Sewer line compaction efforts

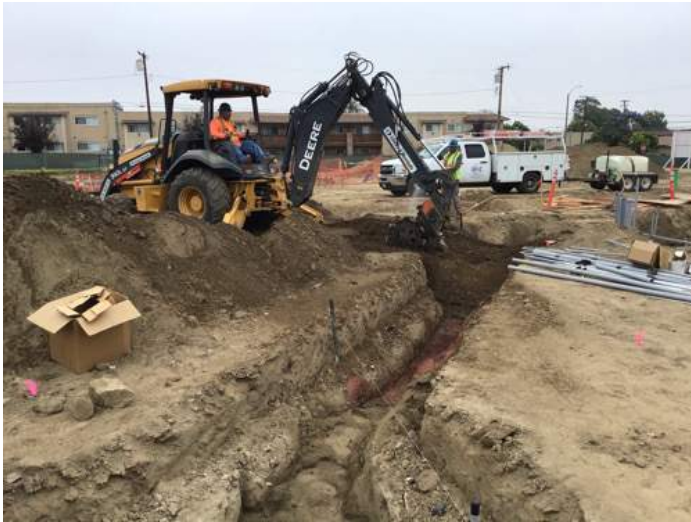
Barkley Andross corp was on site back filling the Edison electrical trench and (2) electrical rooms. Prior to my arrival the conduits were encased with red slurry. Contractor moisture conditioned soil in stockpile before placement. Soil was placed in 8" loose lifts and compacted via backhoe with sheep's foot. A jumping jack was used around all vertical conduit stub outs. I used a calibrated nuclear density gauge to check compaction and moisture content. 3 tests were taken, 3 tests met minimum specified compaction per plans and specifications.

**Fig. 1:** Compaction efforts with backhoe

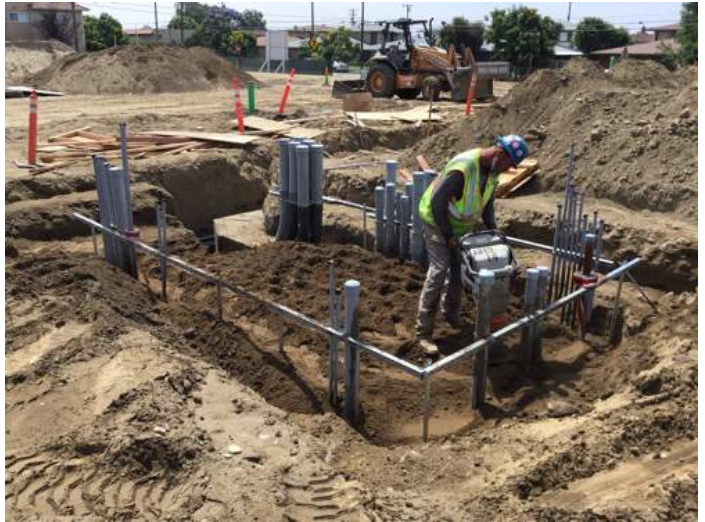
**Fig. 2:** Compaction around conduit

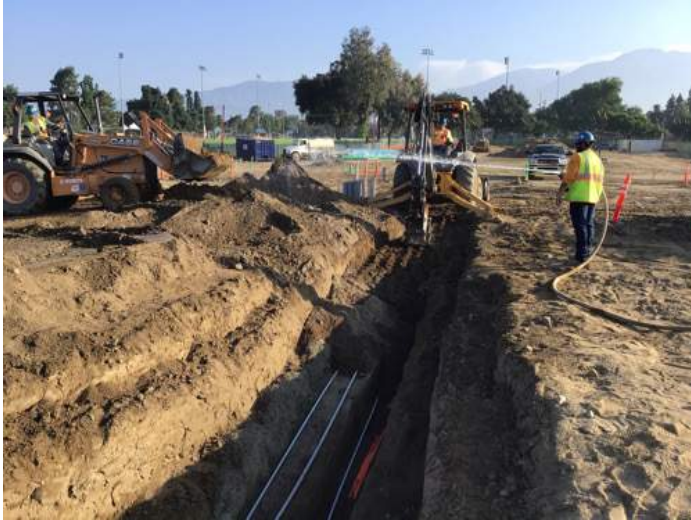
Barkley Andross corp was on site back filling the Edison electrical trench. Prior to my arrival the conduits were encased with slurry. Contractor moisture conditioned soil in stockpile before placement. Soil was placed in 8" loose lifts and compacted via backhoe with sheep's foot. I used a calibrated nuclear density gauge to check compaction and moisture content. 3 tests were taken, 3 tests met minimum specified compaction per plans and specifications.

Fig. 1: Edison/electrical backfill compaction

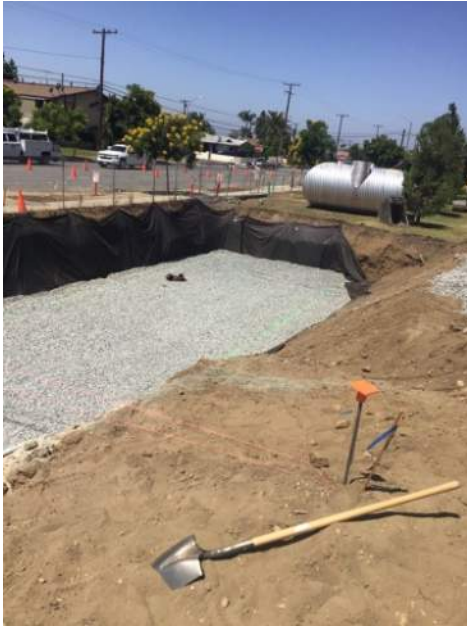
**Fig. 1:** Retention basin excavation with 1.5" rock bedding placed

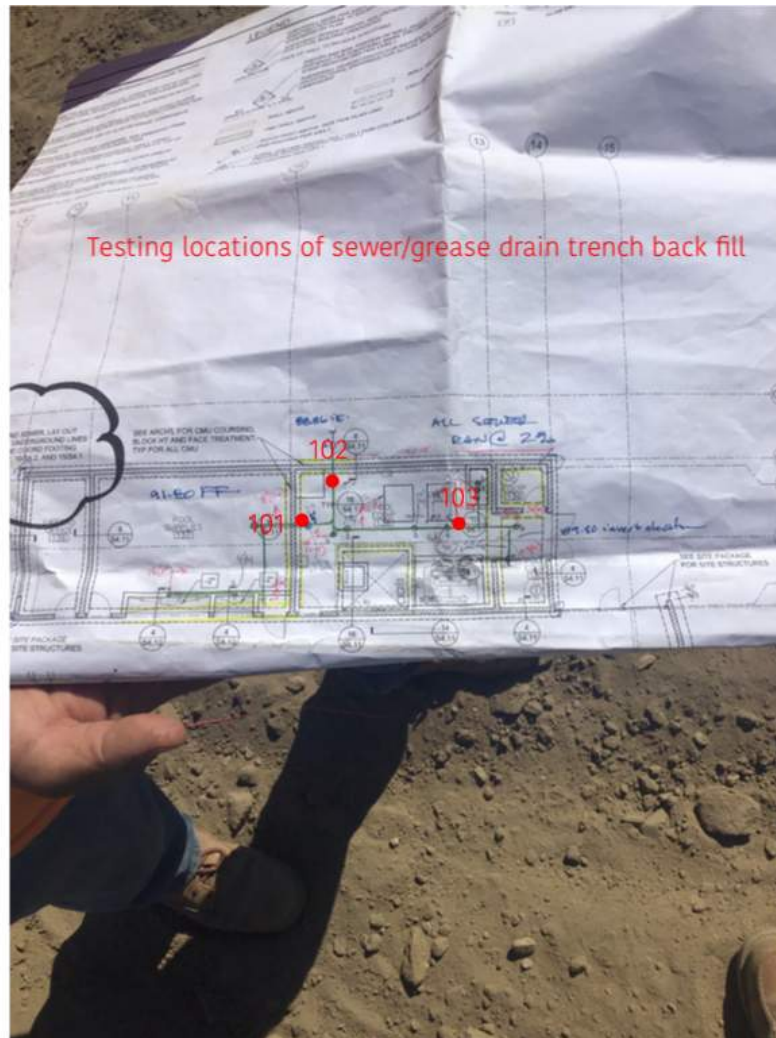
**Fig. 2:** Testing locations of sewer/grease drain trench back fill

JPI was onsite to begin back fill of sewer/grease line trench in various locations through out the building pad and pool area. I was notified the crew would not begin back fill until after scheduled city inspection that was scheduled for 8:00am. City inspector arrived onsite at 10:15am to perform inspection of lines, notified contractor that only trenches around pool equipment area for outdoor showers was approved for back fill due to leaks in various fittings throughout the remaining areas of the building area. Upon approval the crew with JPI began back fill of trench located throughout the pool equipment area. The crew shaded trenches with roughly 8 -10" of sand before placing native materials above. Placement was done with backhoe in loose 8" lifts. Material was moisture conditioned via water truck during placement. Compaction efforts were made via jumping jack, upon compaction efforts density testing was performed via calibrated nuclear density gauge. A total of (3) tests were performed, all tests met or exceeded required 90% compaction. (See attached plot plan and SDT sheet for detailed results and locations.)

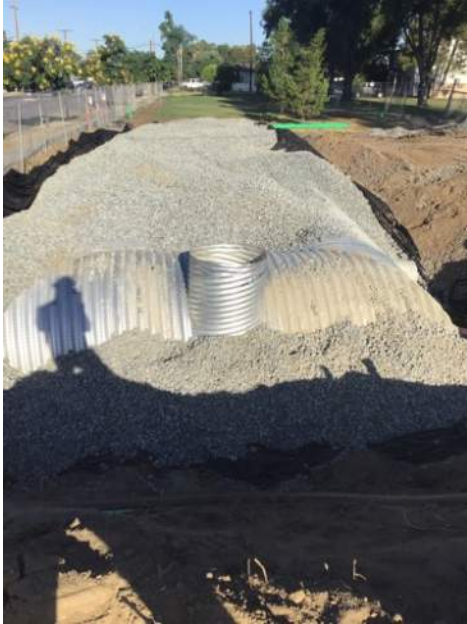
**Fig. 1:** CMP retention system back fill area incomplete

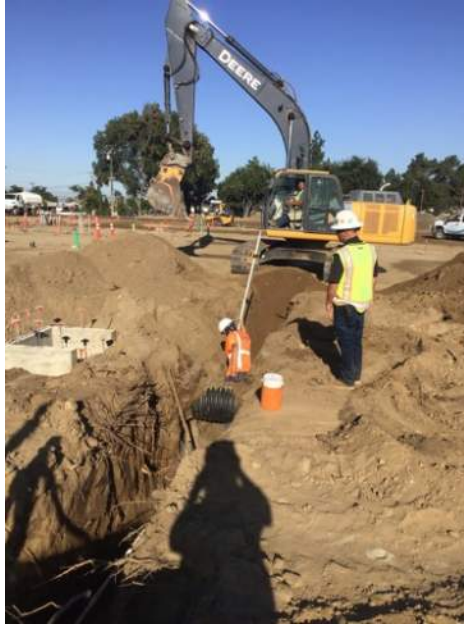
**Fig. 2:** 8" fire line trench excavation

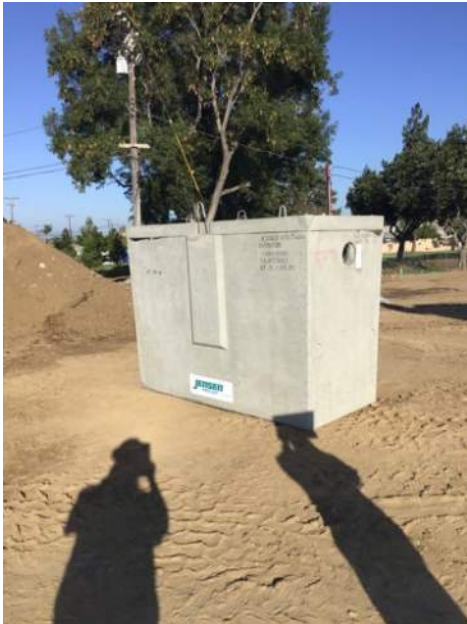
**Fig. 1:** Grease interceptor to be placed

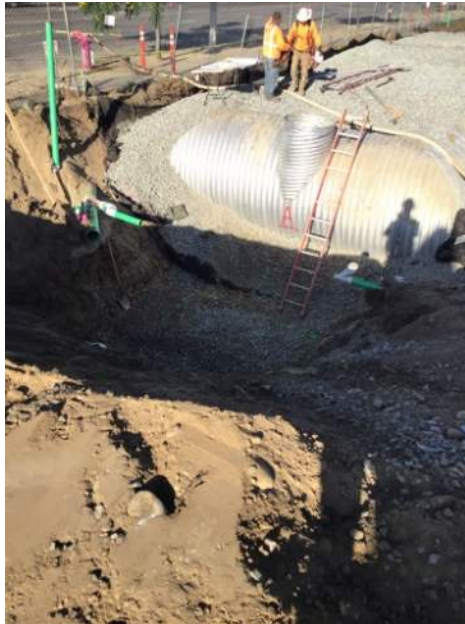
**Fig. 2:** 12" rock bedding placed below grease interceptor area

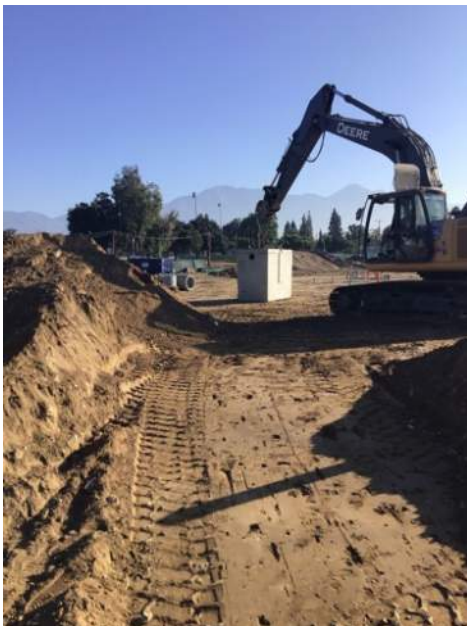
**Fig. 3:** Grease interceptor placement

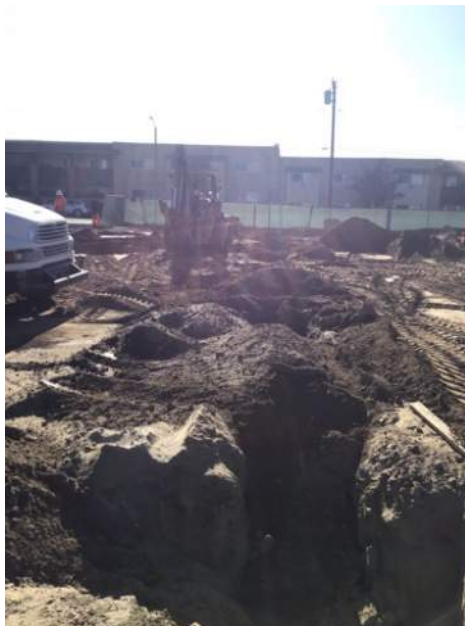
**Fig. 4:** Fire line center loading to be removed and recompactd after hydro testing complete

During removal of gravel from BMP system JPI also had a crew of (2) that began center loading fire line to prepare for inspection by fire marshal and hydro testing. The crew placed roughly 2.5' of material loosely between all bells and connections along the 8" fire line to center load for hydro testing. Material was placed via backhoe and no compaction efforts were made. Material will need to be removed and replaced upon completion of hydro testing when back fill is approved by fire inspector.

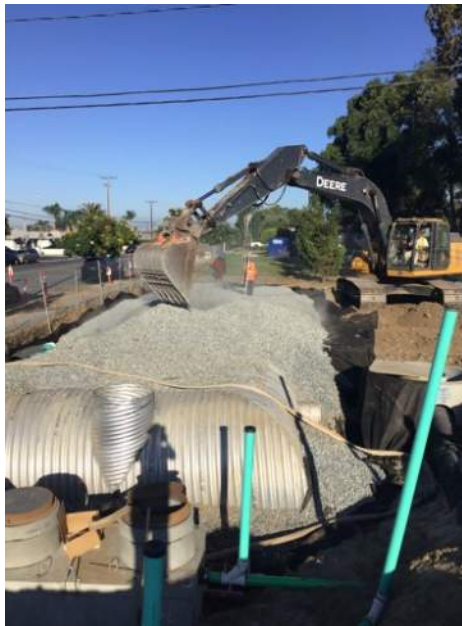
**Fig. 2:** Removal of roughly 6" of gravel from top of CMP retention system pipes

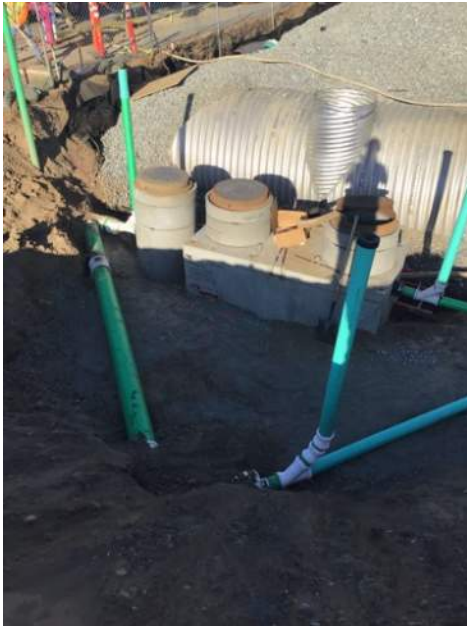
**Fig. 3:** Grease interceptor placed and to be back filled

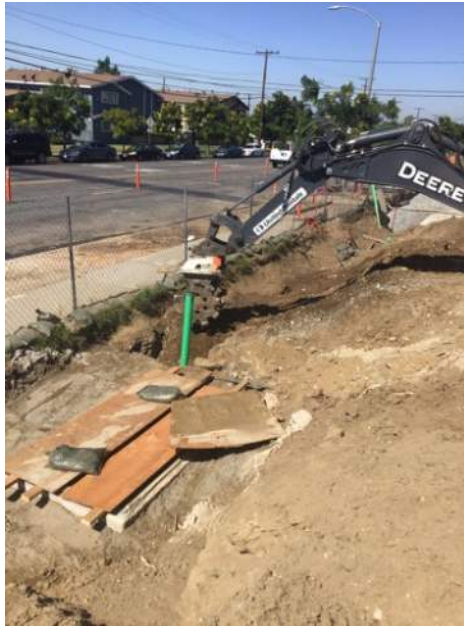
Upon completion of sidewalk area being complete while awaiting concrete delivery the crew with BAC moved over to complete back fill of electrical conduit trench just inside the perimeter fence to Edison box from street. Trench was roughly 20' long and 1' deep. Crew previous began back fill and continued from where they had previously left off. The crew moisture conditioned native materials with water buffalo and placed as well as compacted material with backhoe and sheep's foot roller attachment. A total of (1) density test was taken in the area of back fill via calibrated nuclear density gauge, test taken met or exceeded required 90% compaction. (See attached plot plan and SDT sheet for detailed results and location of testing.)

**Fig. 4:** Edison line trench back fill and compaction

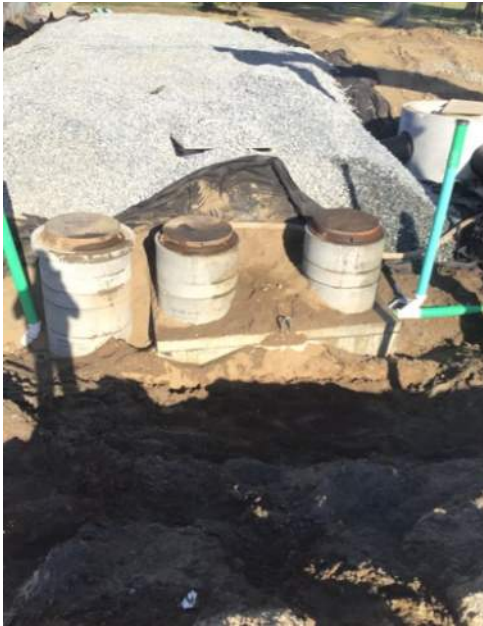
JPI had a crew of (5) onsite to begin back fill in various locations onsite. The crew began back fill of the previously placed grease interceptor on the south west end of the building pad near the BMP retention system. They broke a 4" sewer line running near the interceptor and were forced to repair before moving forward. During repairs being made they moved over to begin back fill of 8" fire line.

**Fig. 1:** Grease interceptor area of back fill

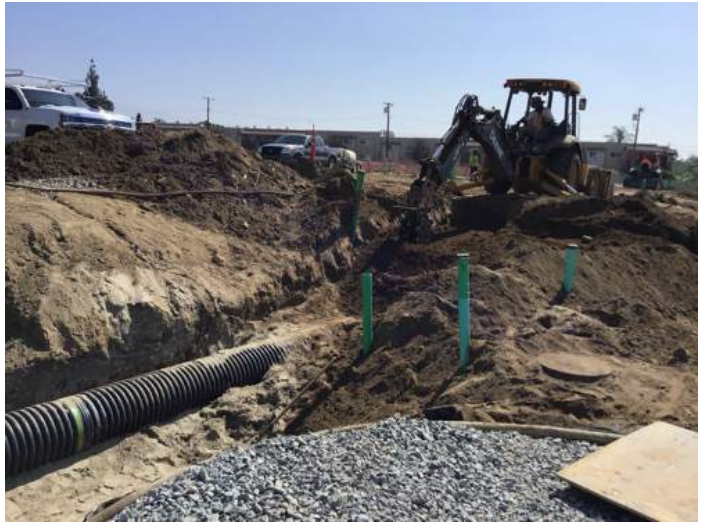
JPI was on site backfilling the storm drain leading to the retention system. JPI moisture conditioned soil in stockpile prior to placement. The contractor used a backhoe with sheeps foot achieve compaction. I used a calibrated nuclear density gauge to check compaction and moisture content. 2 tests were taken, 2 tests met minimum specified compaction per plans and specifications.

**Fig. 2:** Storm drain backfill/compaction

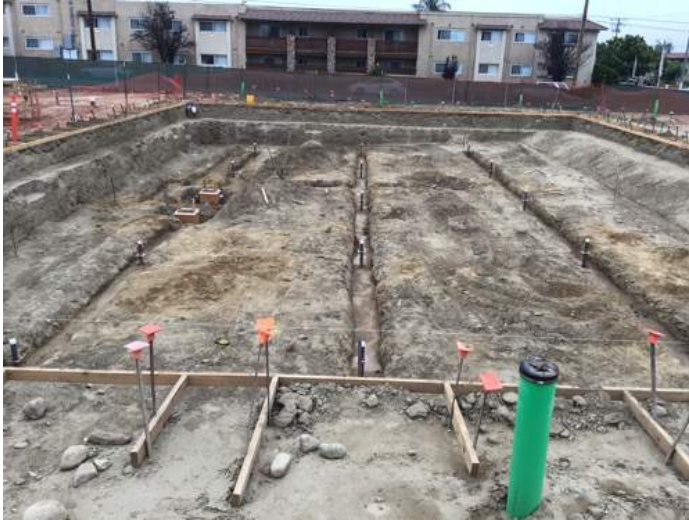
California Waters was on site back filling the pool return/drain lines. Sand was used to shade pipe. I used a probe to check relative compaction. Probing confirmed sand was firm and unyielding. Contractor moisture conditioned soil prior to placement. Contractor used a jumping jack to achieve compaction. I used a calibrated nuclear density gauge to check compaction and moisture content. 3 tests were taken, 3 tests met minimum specified compaction per plans and specifications. I also used a probe to check relative compaction. Probing confirmed soil was firm and unyielding.

**Fig. 1:** Pool drain plumbing (sand shading)

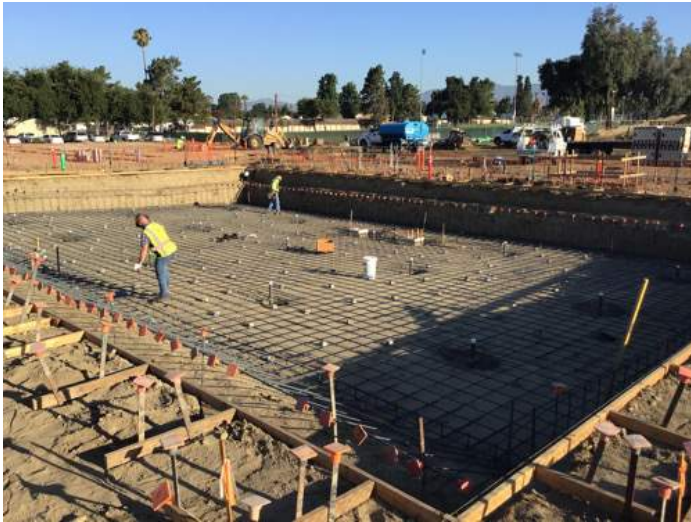
California Waters was on site placing reinforcement for the pool bottom. All reinforcement was free from rust and mill certs were verified. All reinforcement placed met all plans and specifications (size, spacing, clearances, ties). Below the west drain rock was placed to fill an excavation for a relief valve. The relief valve was not approved and removed. The rock was removed and will be replaced with additional concrete. Work is on going and concrete will be placed on the next working day.

**Fig. 1:** Pool reinforcement (bottom)

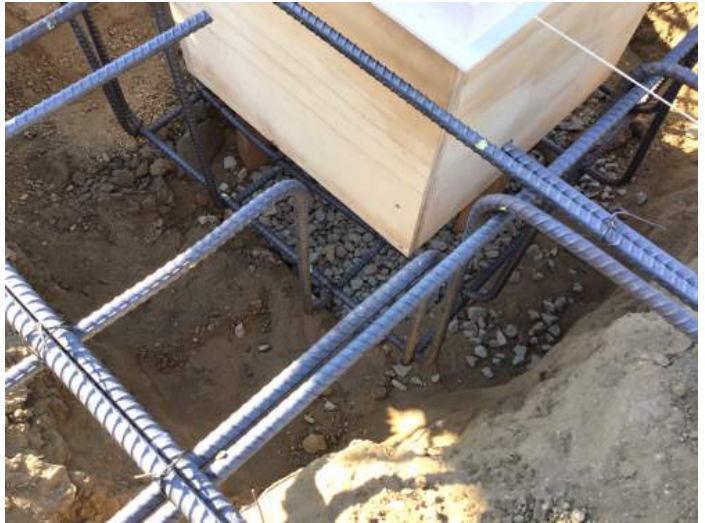
**Fig. 4:** Rock below drain needed to be removed

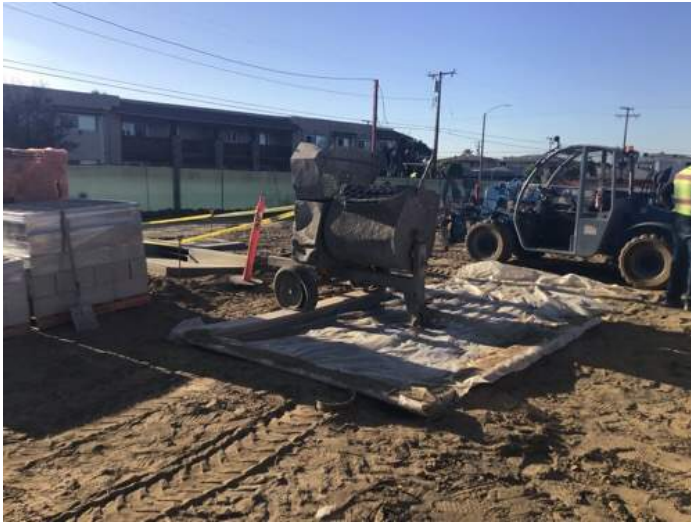
**Fig. 9:** Drum mixer used onsite

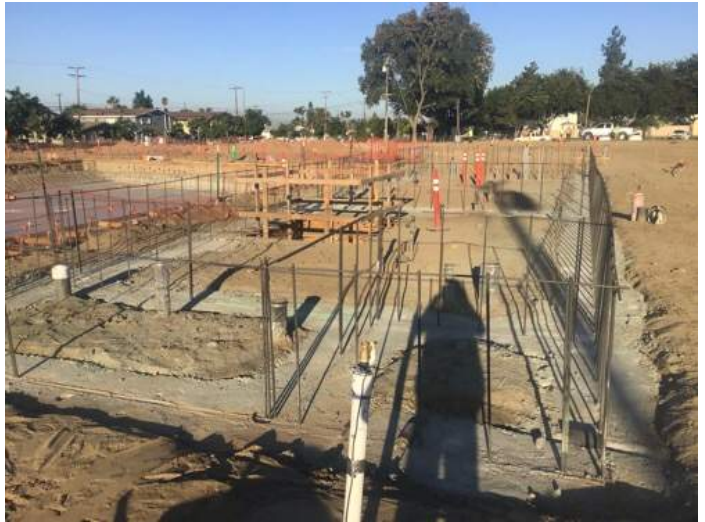
**Fig. 10:** Pool building area of CMU placement

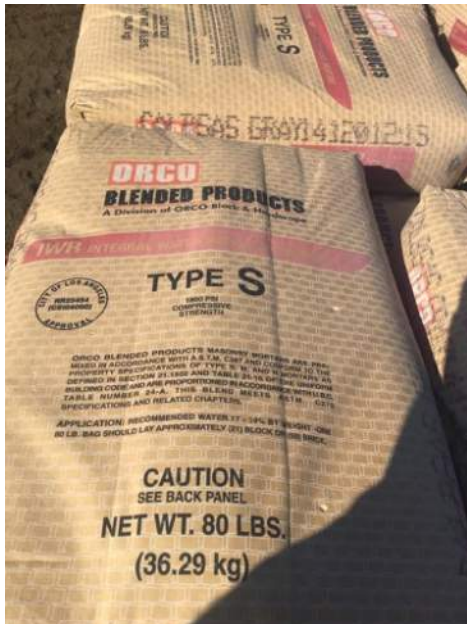
**Fig. 11:** Mortar used onsite

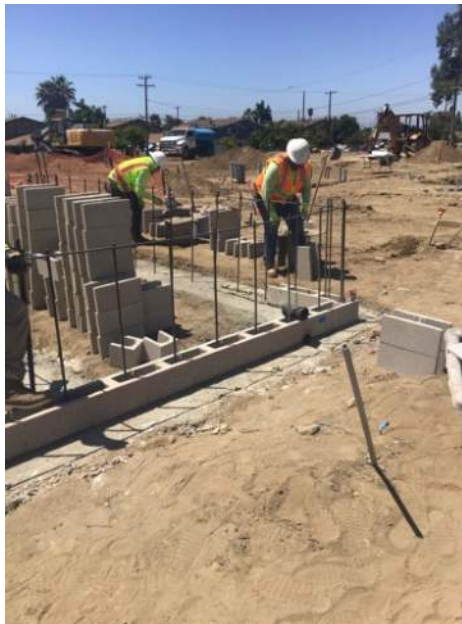
**Fig. 12:** CMU placement

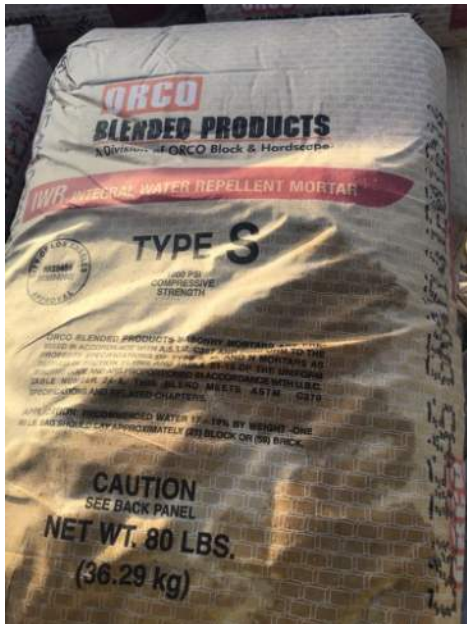
Fig. 1: Orco type s mortar used onsite

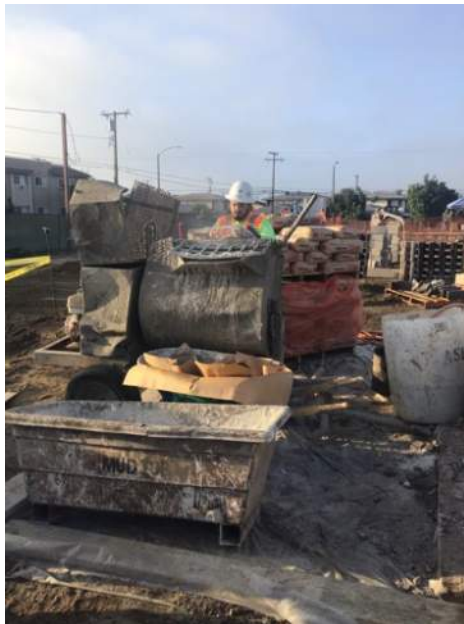
Fig. 2: Drum mixer used to mix mortar

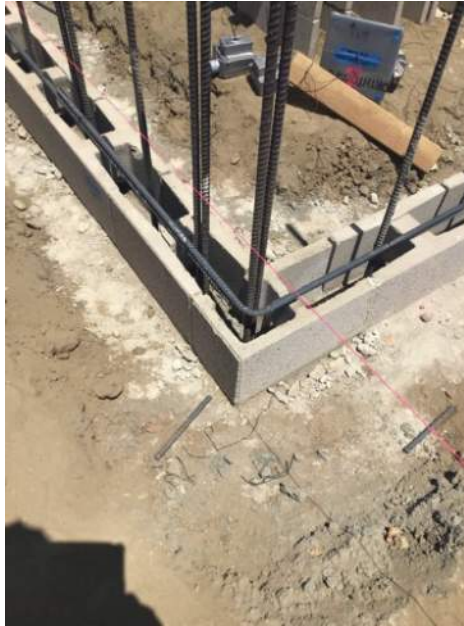
**Fig. 6:** Corner bars palced per plan

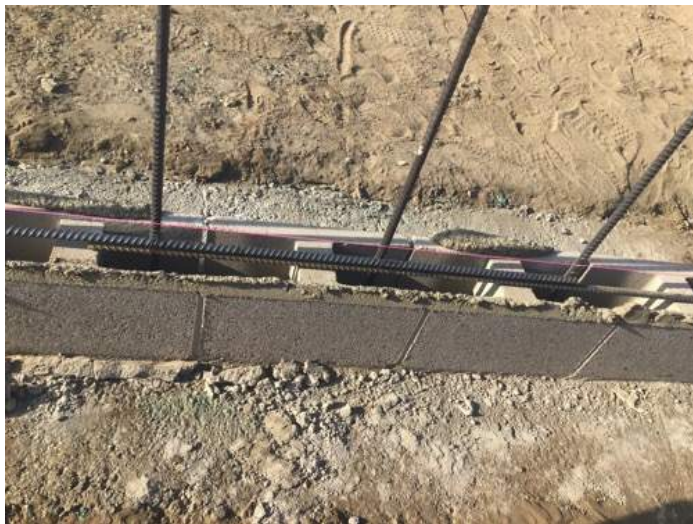
**Fig. 7:** Lap splices per lap schedule s4.11 detail 3

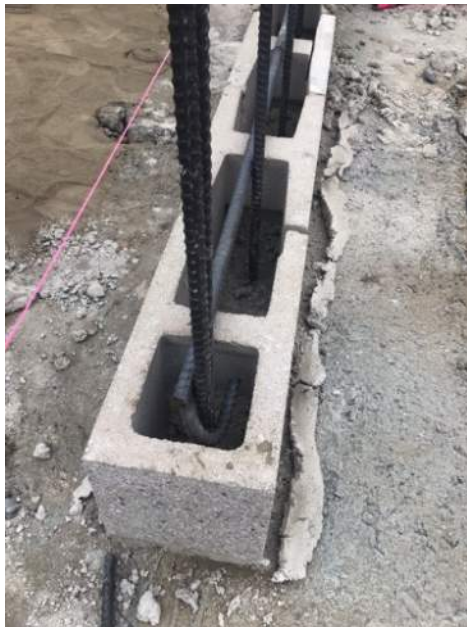
Fig. 3: 180° hook at ends per S4.11 detail 3

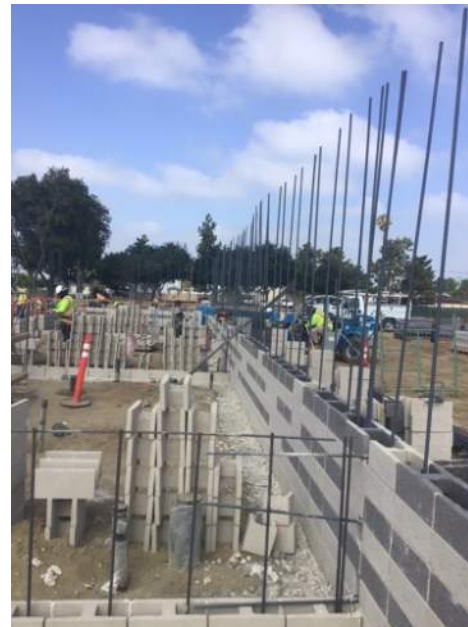
Fig. 4: Vert bars placed (#5's@16"OC)

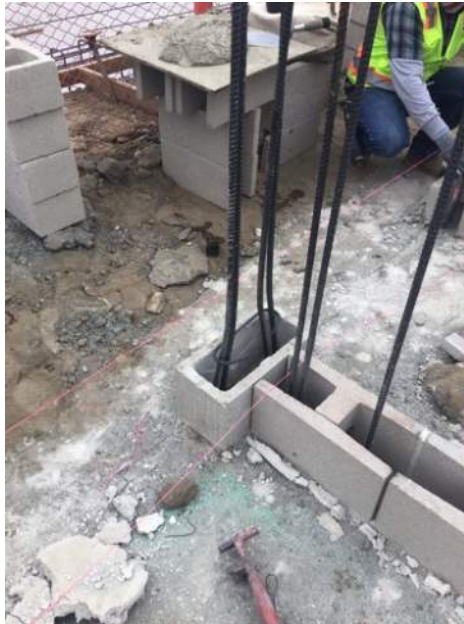
**Fig. 6:** Column ties

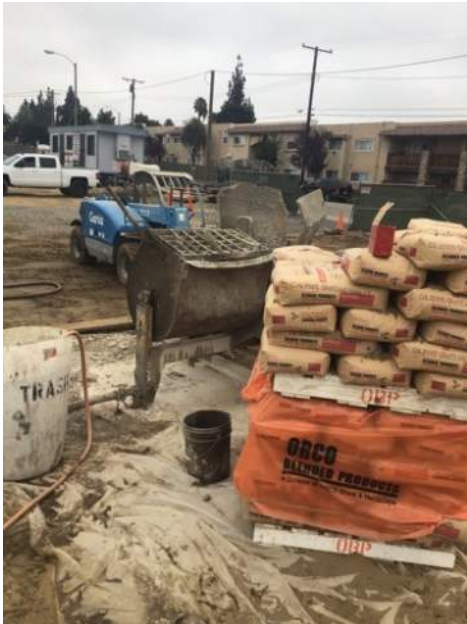
**Fig. 1:** Drum mixer used
