July 7, 2021  
Kleinfelder Project No. 20210301.001A

**SUBJECT: Summary Report for Construction Observation and  
Special Inspection Services  
Anthony Munoz Community Center (Rehability and Park Project)  
City of Ontario Project No. PS 1314-2  
Ontario, California**

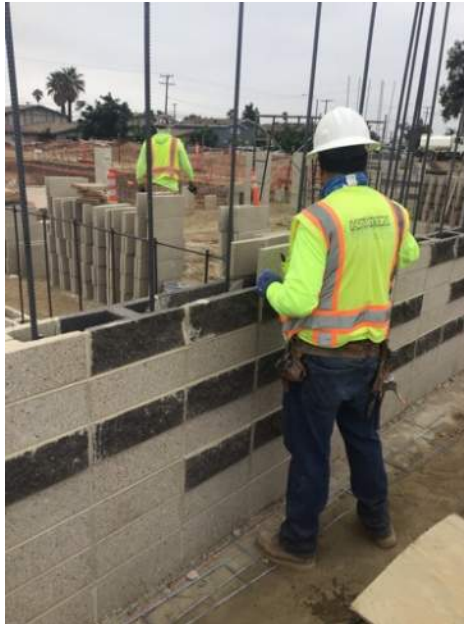
**Fig. 2:** CMU placement

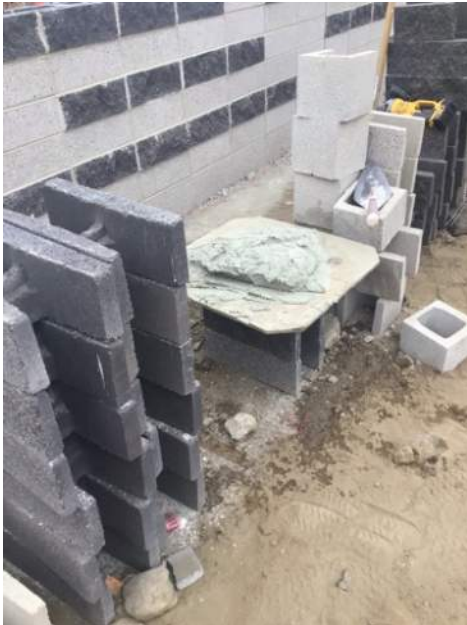
**Fig. 3:** Mortar boards used for CMU placement

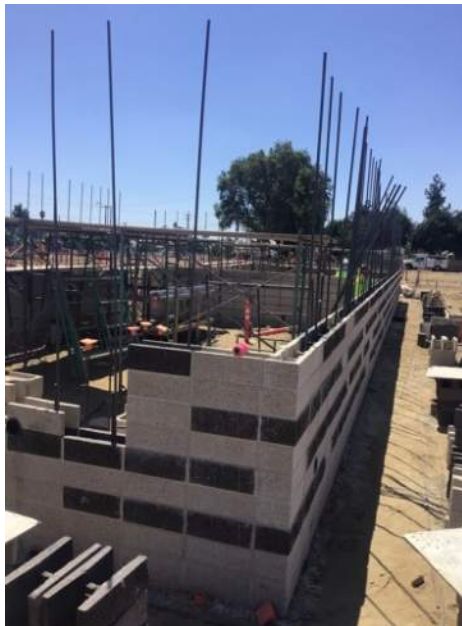
**Fig. 6:** End of day

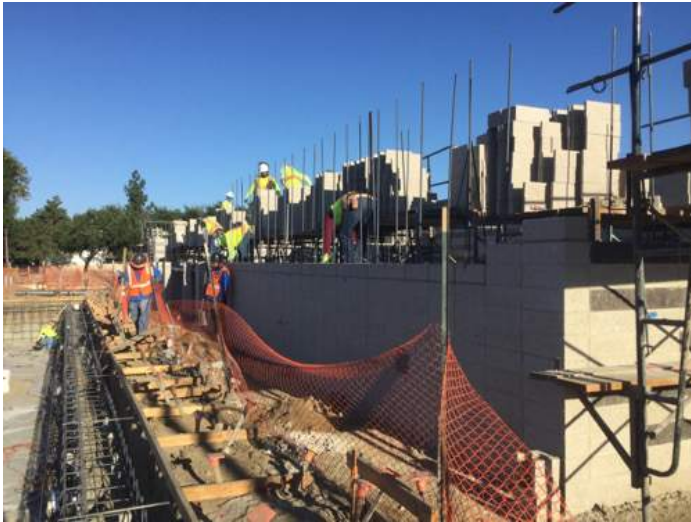
Fig. 1: CMU installation at F line

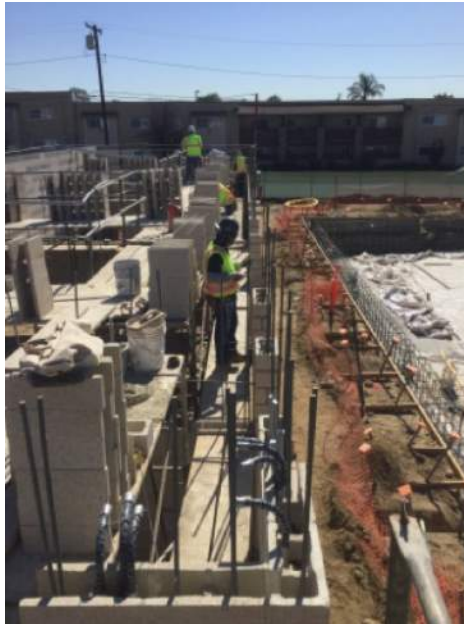
Fig. 2: CMU installation at F line

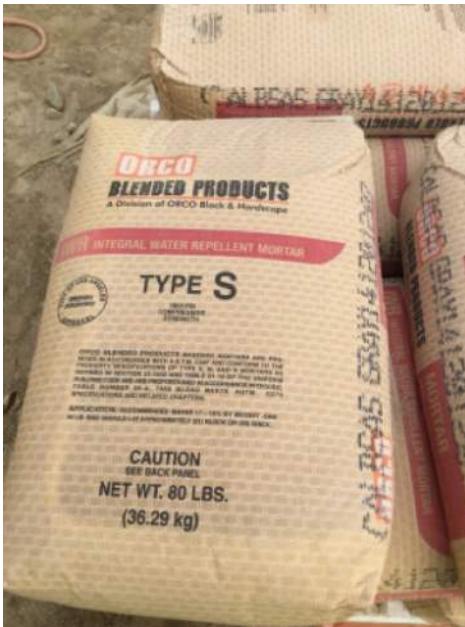
Fig. 3: Orco Type S IWR Mortar

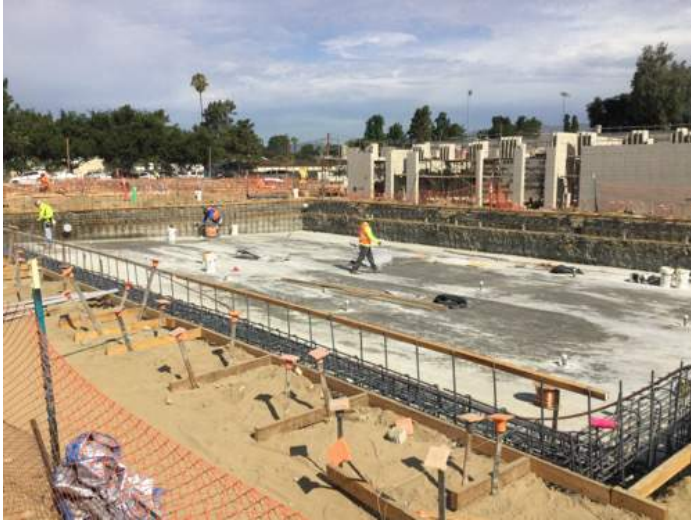
**Fig. 1:** Pool reinforcement

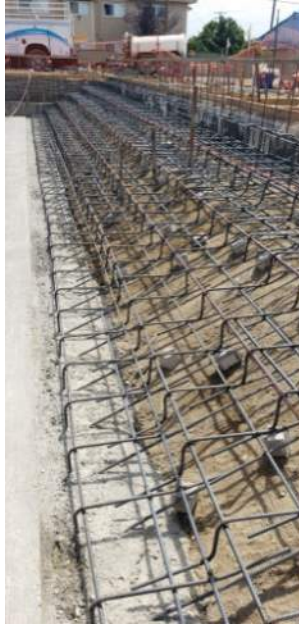
**Fig. 2:** Reinforcement at pool steps

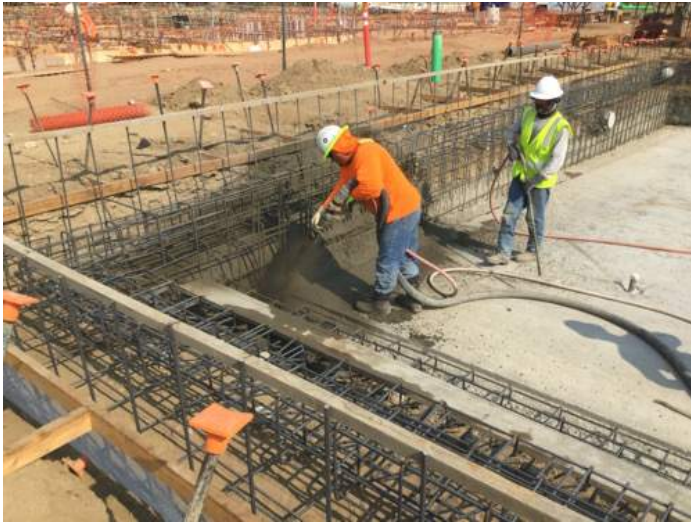
**Fig. 1:** Shotcrete placement

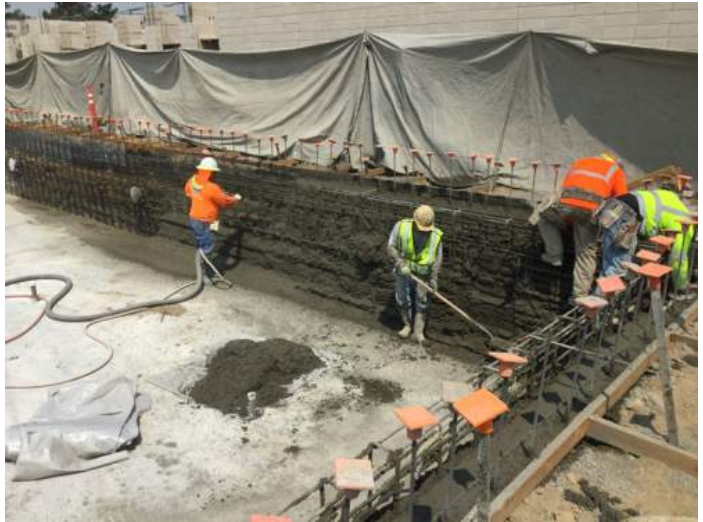
**Fig. 2:** Shotcrete placement at grid line F

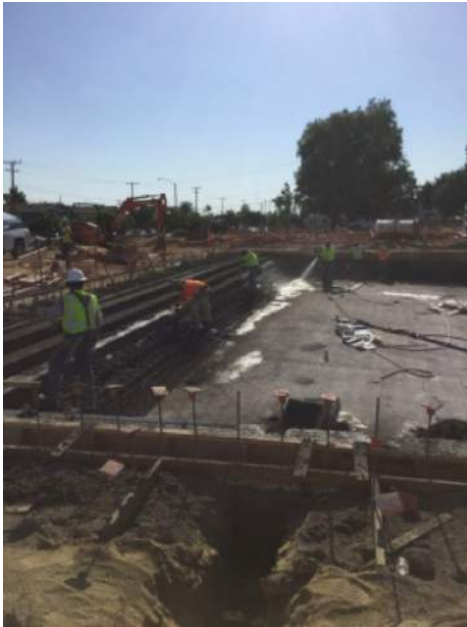
**Fig. 3:** Shotcrete placement

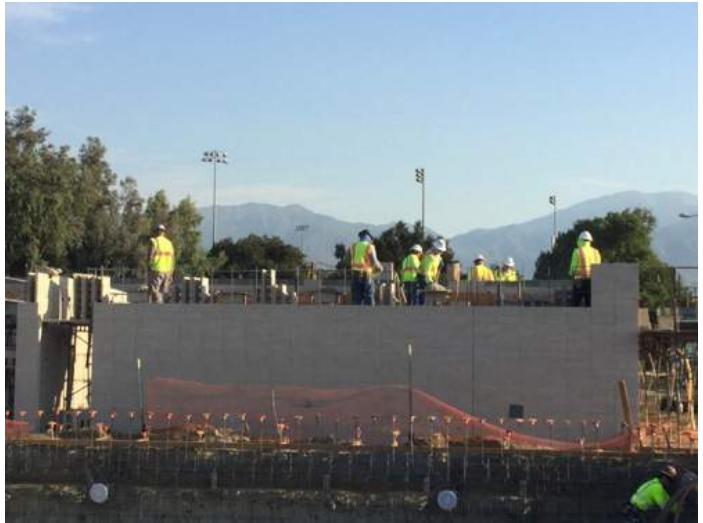
**Fig. 4:** CMU placement at grid line F

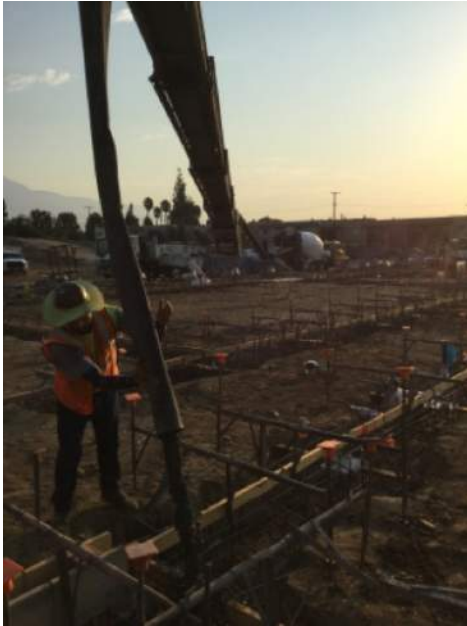
**Fig. 1:** Concrete placement utilizing the Putzmeister telebelt

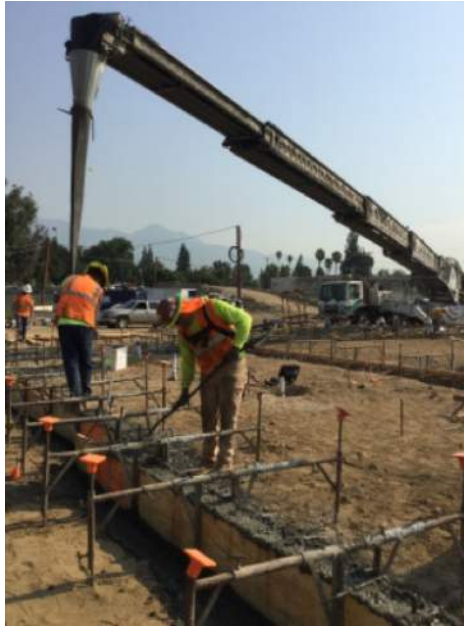
**Fig. 2:** Concrete placement with consolidation being performed in the foreground

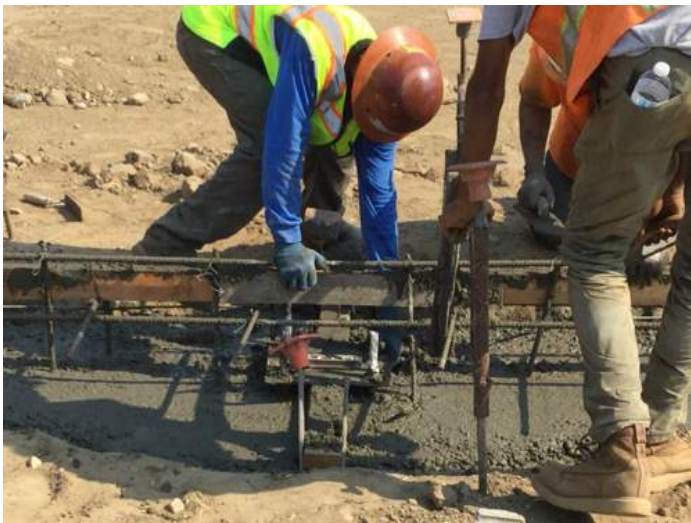
**Fig. 3:** Cloumn base plates being leveled after placement and prior to consolidation

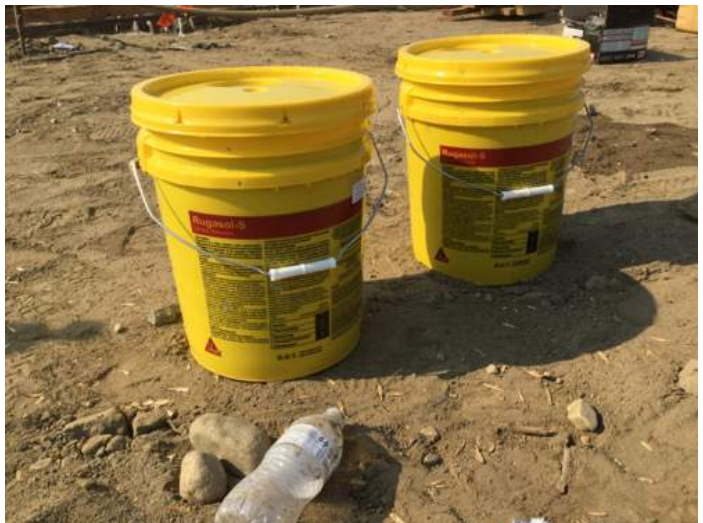
**Fig. 4:** Rugasol-S surface retarder

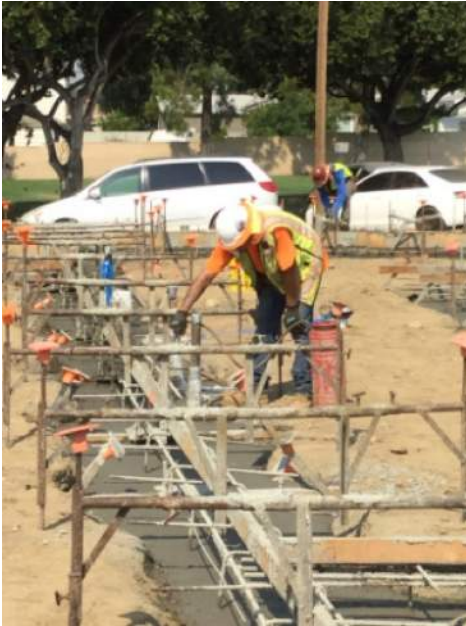
**Fig. 5:** Rugasol-S being applied to the tops of footings by pressurized tank

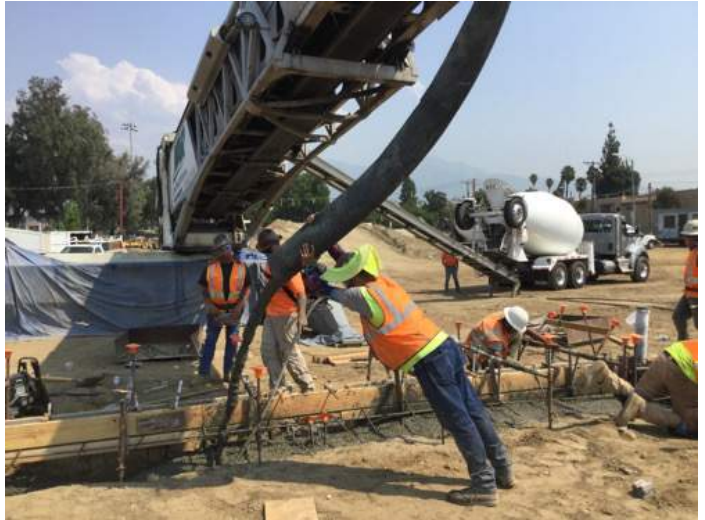
**Fig. 6:** Concrete placement

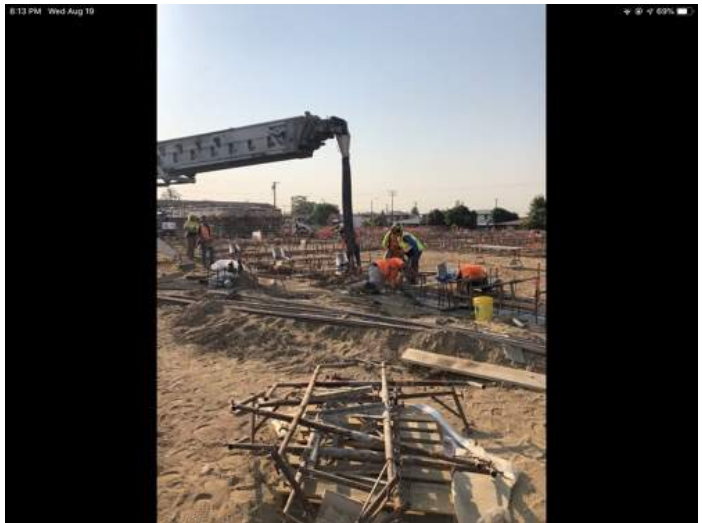
Fig. 4: Concrete pour

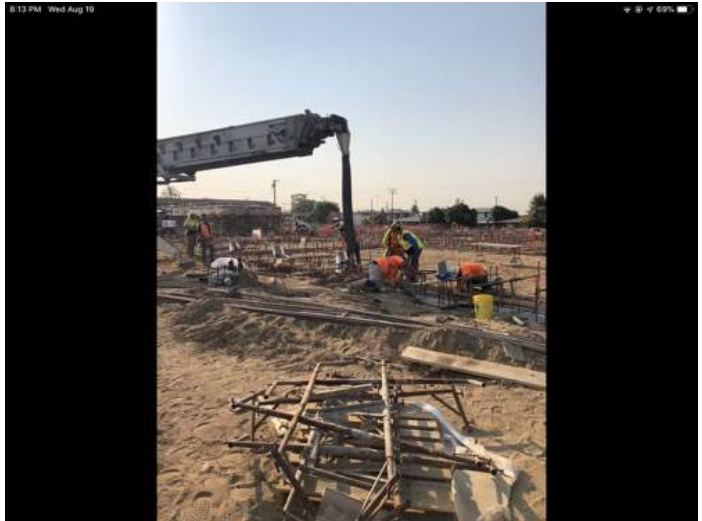
Fig. 4: Concrete pour

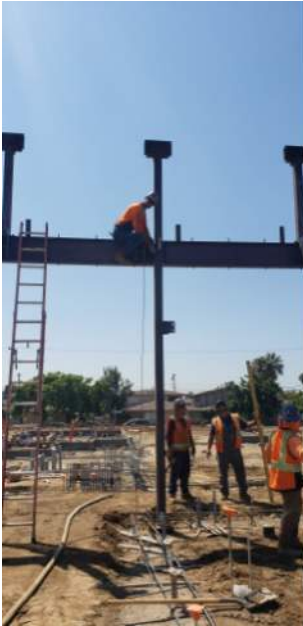
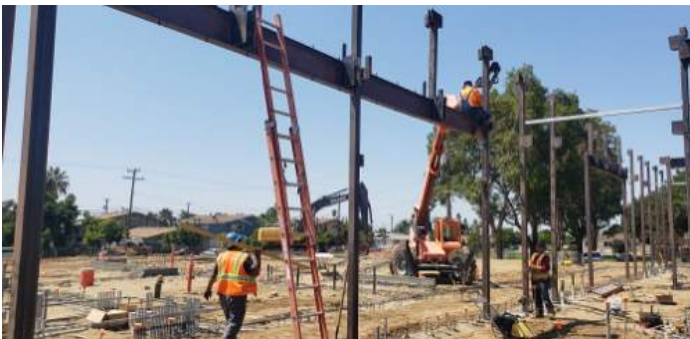
**Fig. 1:** Tensioning of the TC Bolts at the W16x25 Beam to column connections

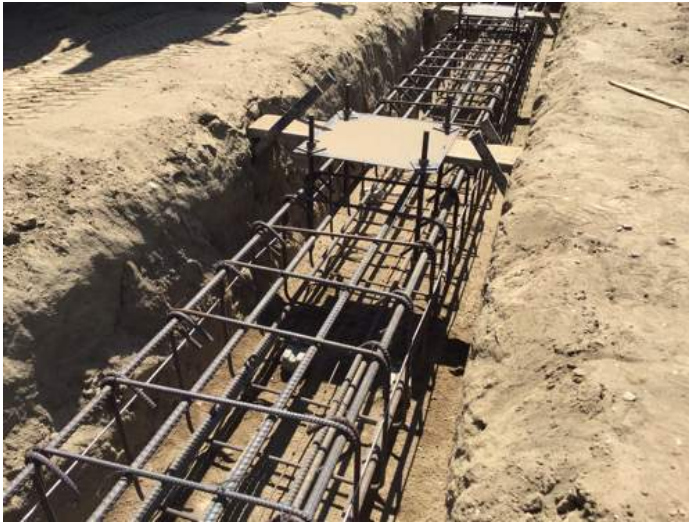
Fig. 1: Footing reinforcement

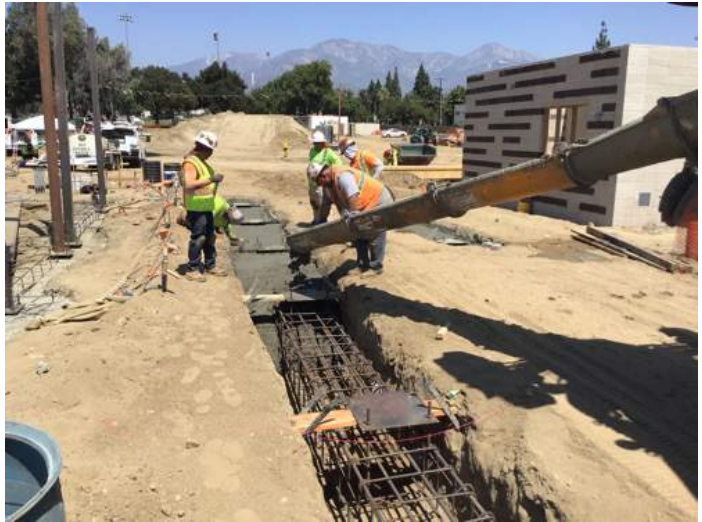
Fig. 2: Concrete placement

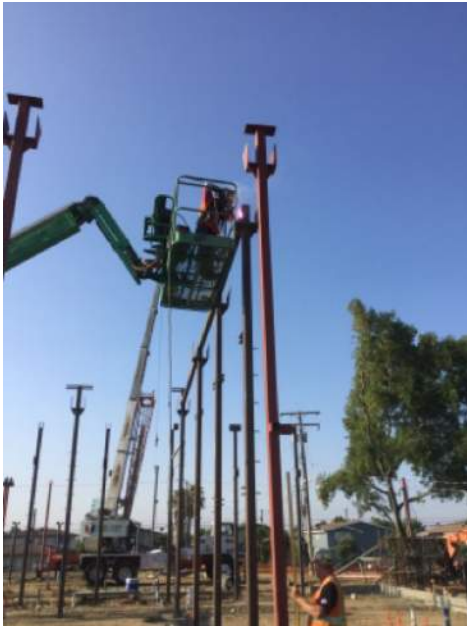
**Fig. 1:** Crown Steel performing the CJP welds at grid line 2/C.1

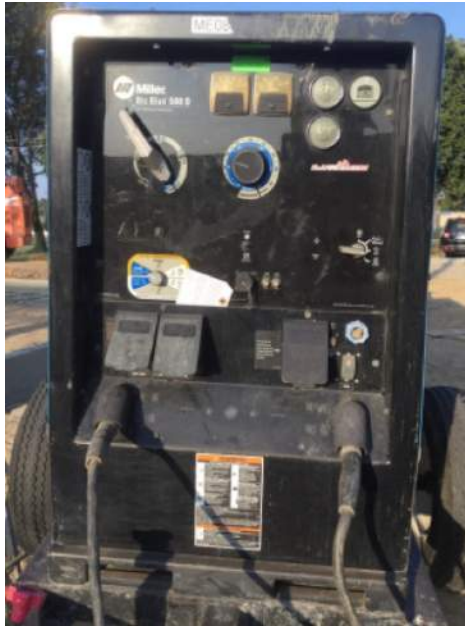
**Fig. 2:** Weld generator settings

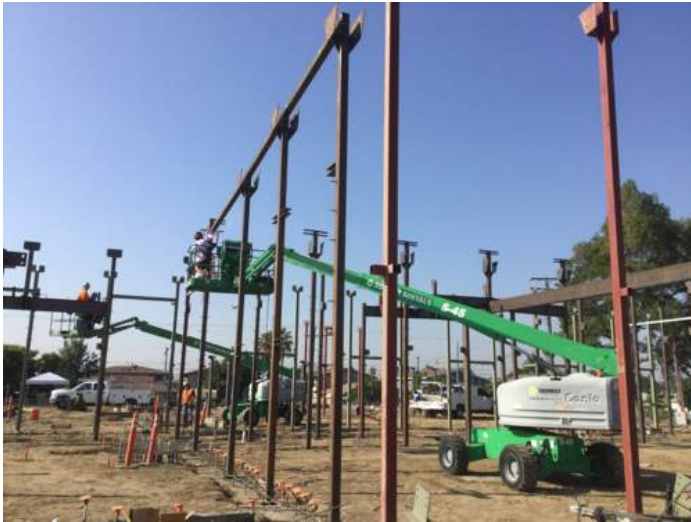
**Fig. 1:** Welding being performed at grid line 5

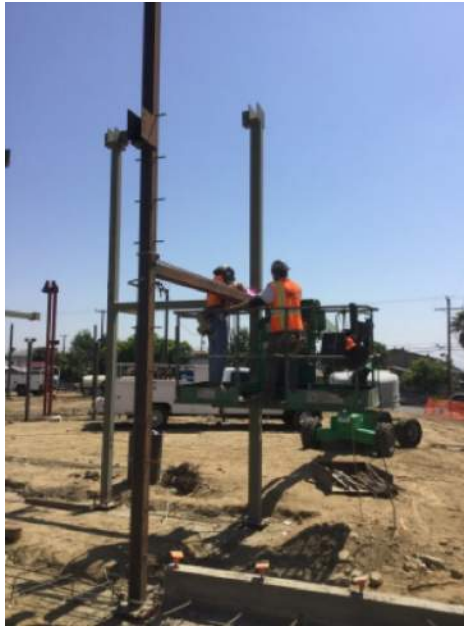
**Fig. 2:** Girts installed at grid line G

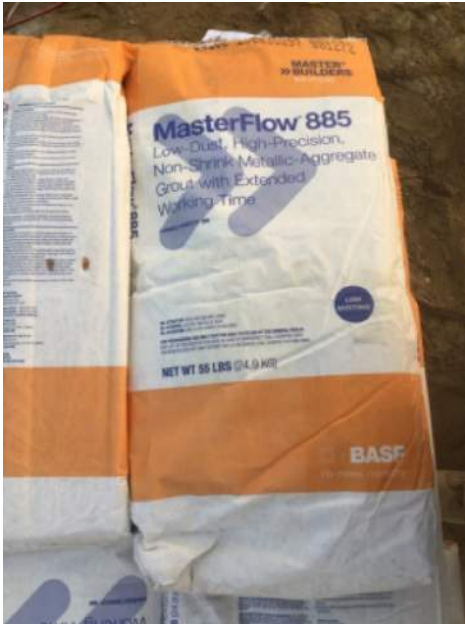
Fig. 1: MasterFlow 885

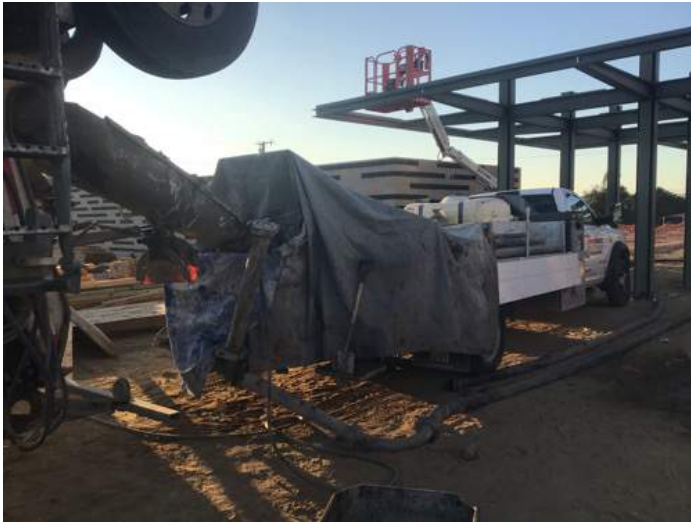
Fig. 1: Trailer Pump.

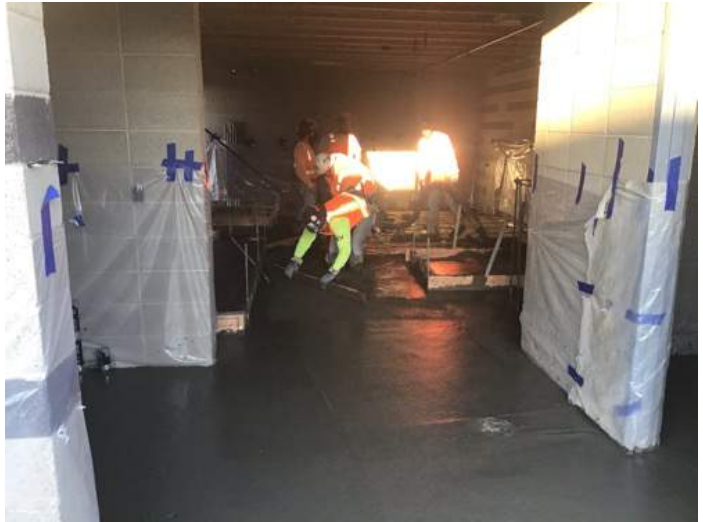
Fig. 2: Pool Building SOG. Placement.

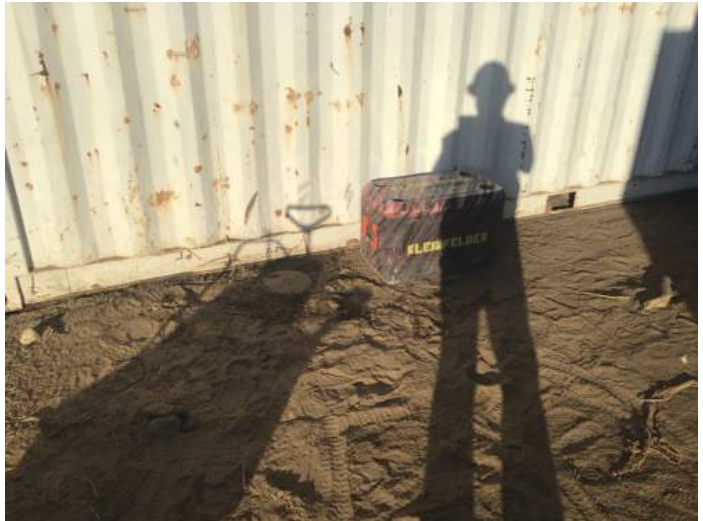
Fig. 4: Smamples Left Onsite.

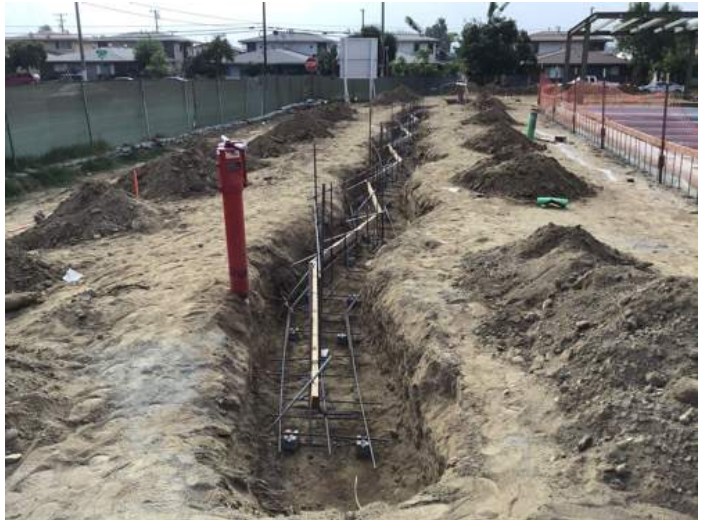
**Fig. 2: Rebar placement 1**

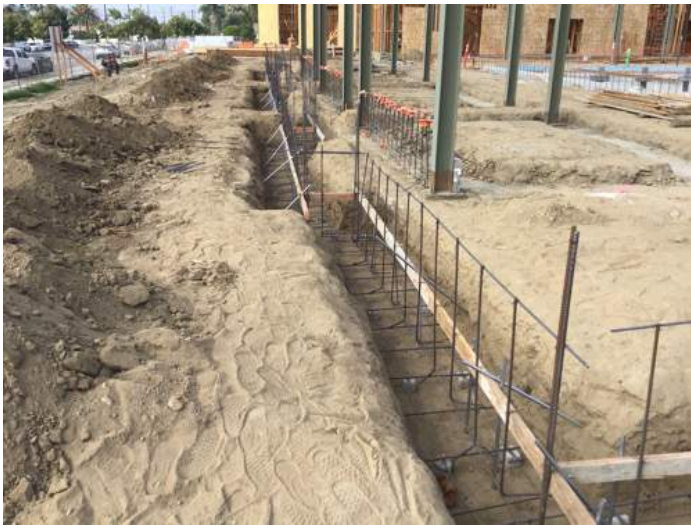
**Fig. 3: Rebar placement 2**

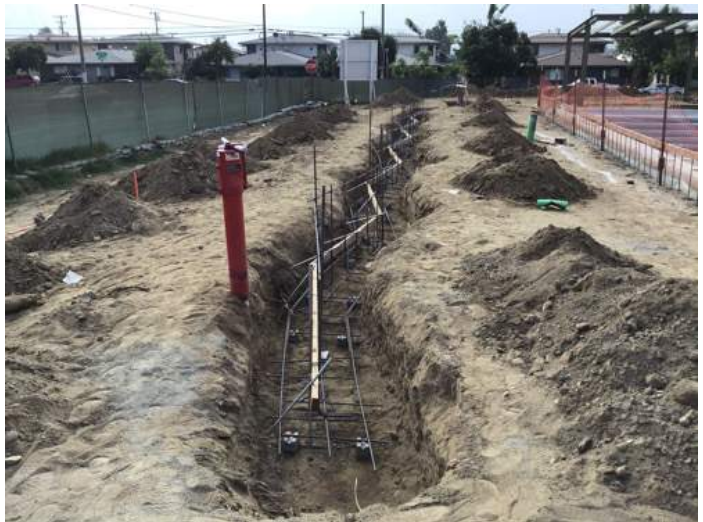
**Fig. 2: Rebar placement 1**

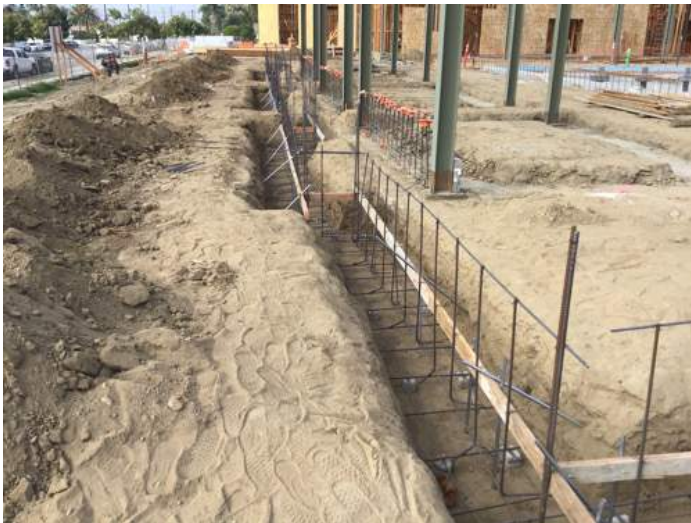
**Fig. 3: Rebar placement 2**

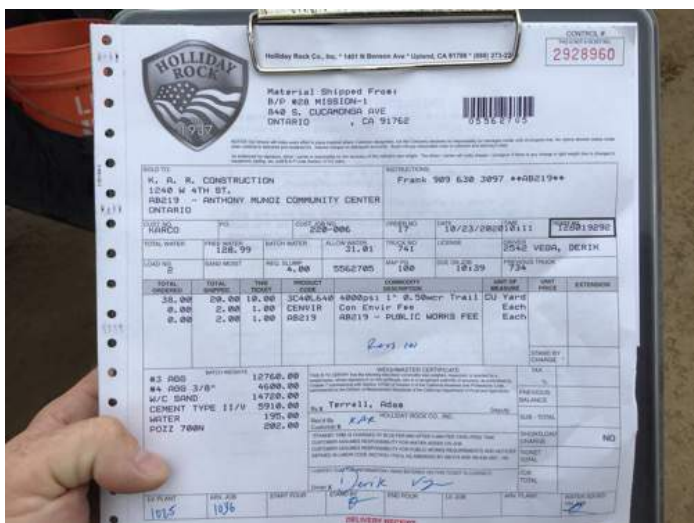
KAR was on site placing concrete for the CMU screen wall footings for the perimeter pool area. Holiday rock provided 38 yards of mix: 3C40L640. 5 gallons of water was added to each truck before placement (per foreman). The foreman did not moisture condition the footing excavation prior to placement. Contractor used a vibrator to consolidate the concrete. performed ACI slump, concrete temp, ambient temp and fabricated (4) 6x12 test specimens. I stored the test specimens on site in the cure box.

**Fig. 1: Concrete batch ticket**

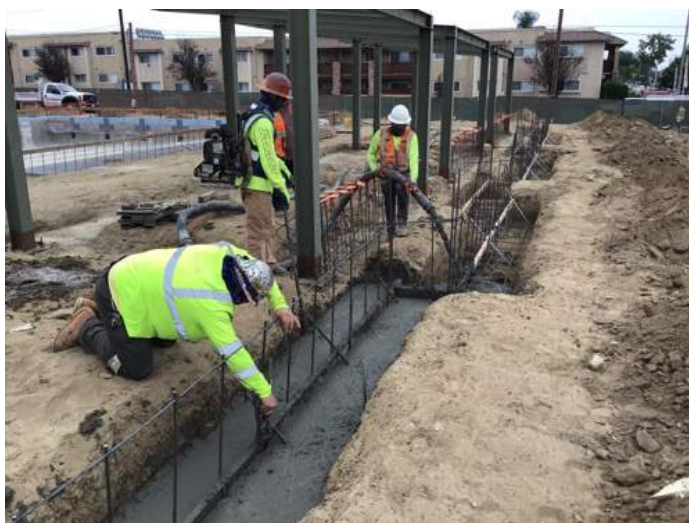
**Fig. 2: Concrete placement**

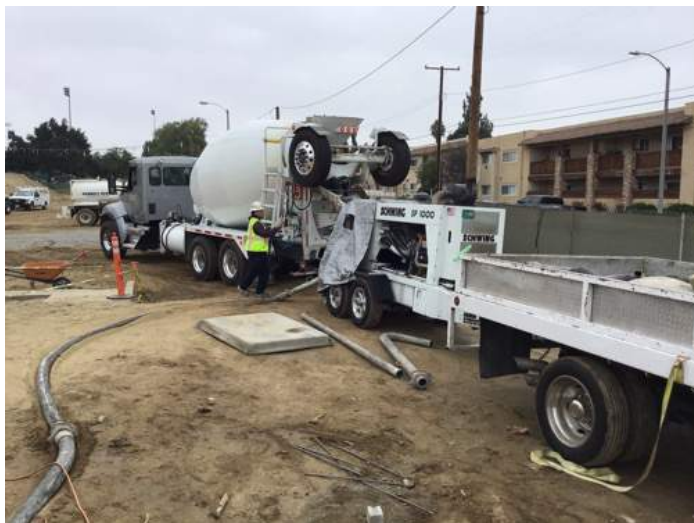
**Fig. 3: Concrete pump**

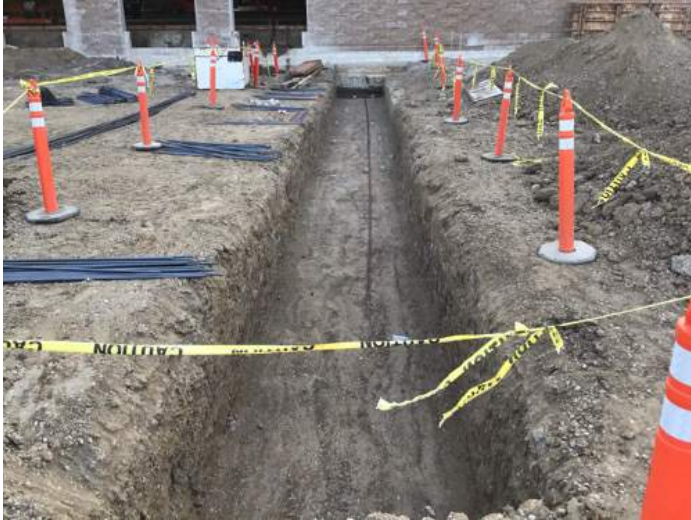
Boberg was on site excavating for a wall footing (excavation/compaction was done prior to my arrival) at GL: C. 1 from 10 line west about 30 feet. I used a calibrated nuclear density gauge to check compaction and moisture content. 2 tests were taken, 2 tests met minimum specified compaction per plans and specifications.

**Fig. 1:** Wall footing bottom

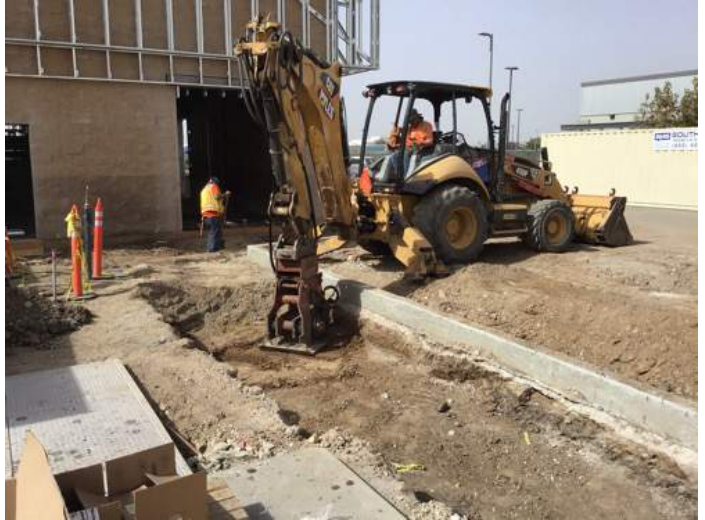
**Fig. 2:** Sidewalk over-ex bottom compaction

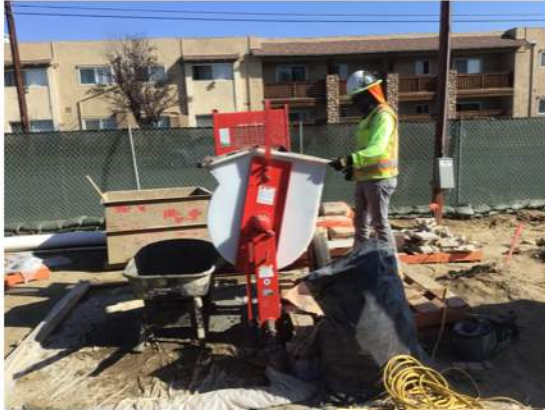
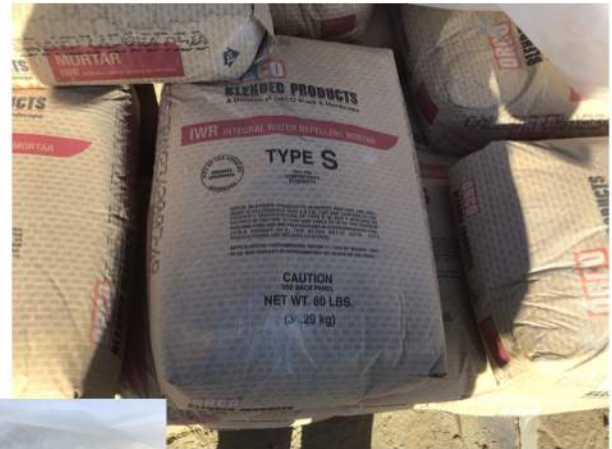
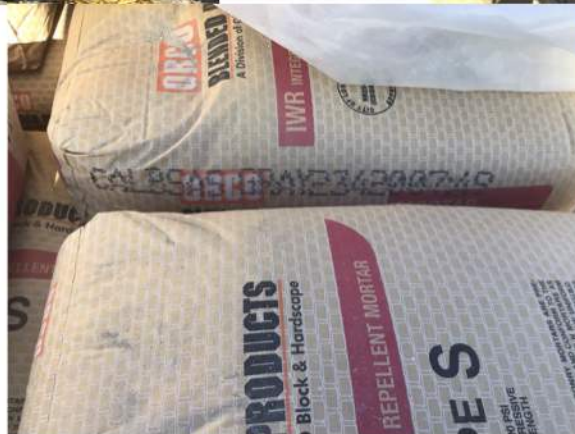
Fig. 2: Mortar mix

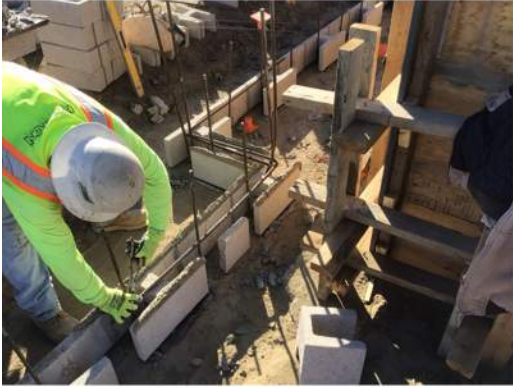
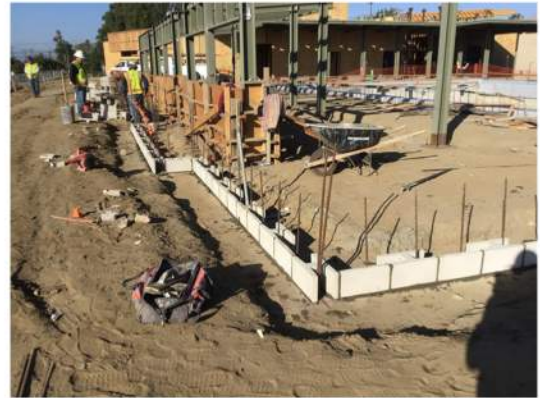
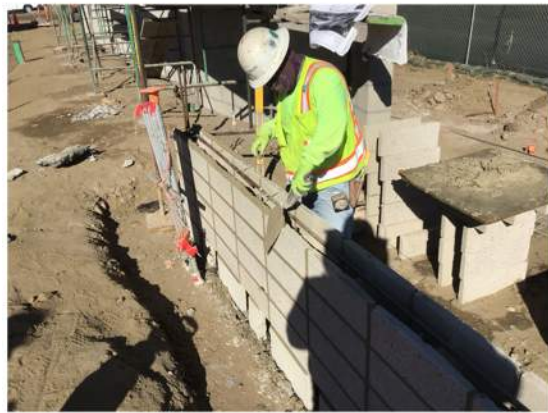
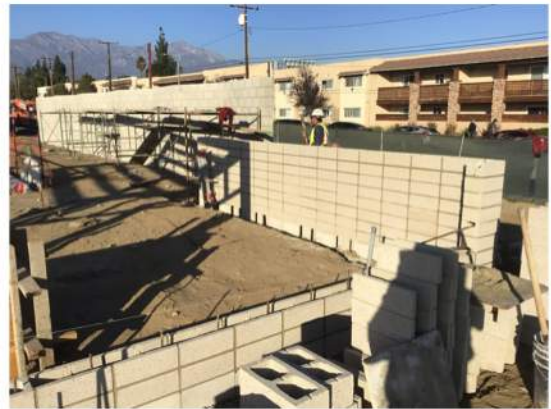
**Fig. 3:** The days work

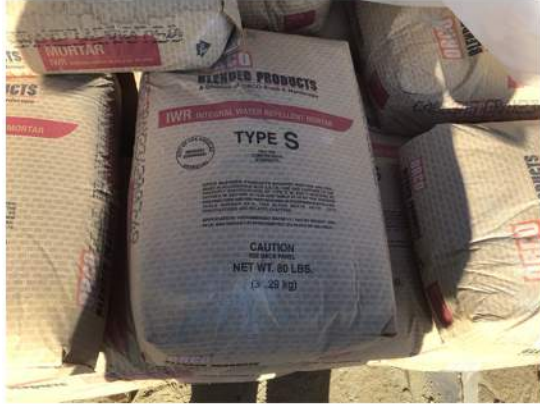
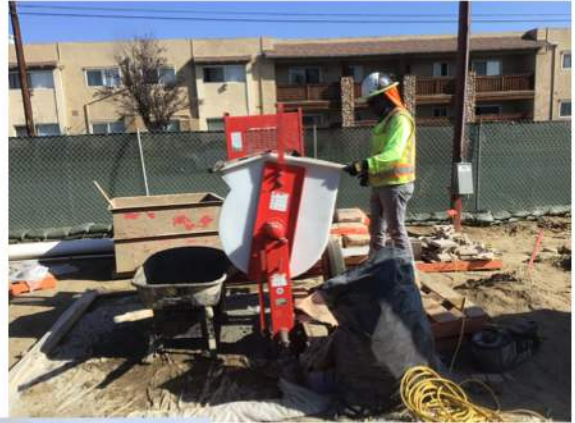
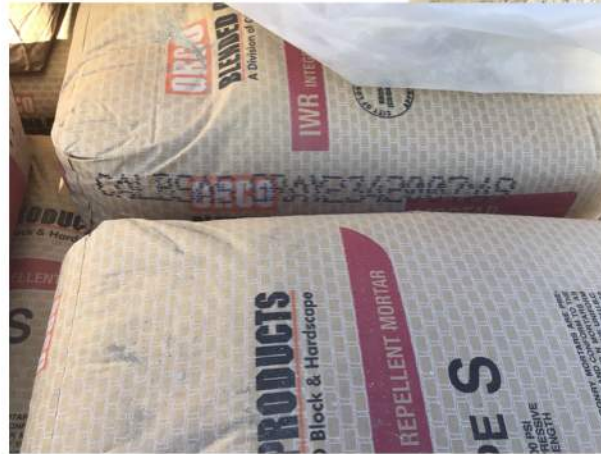
Fig. 2: Mortar mix

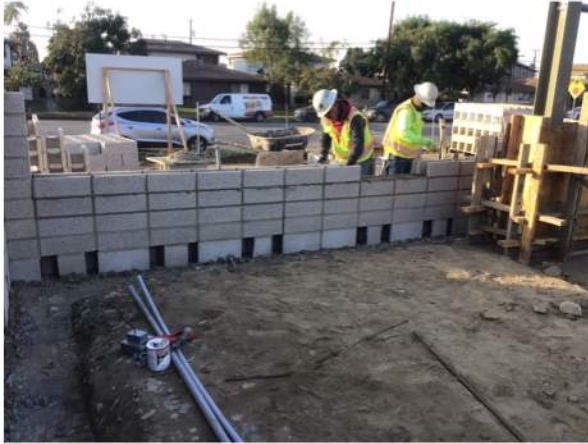
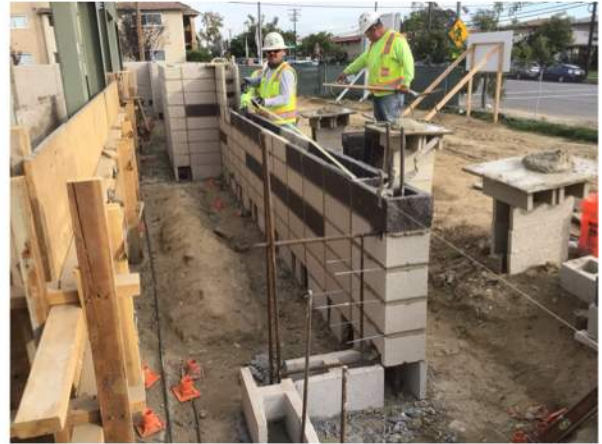
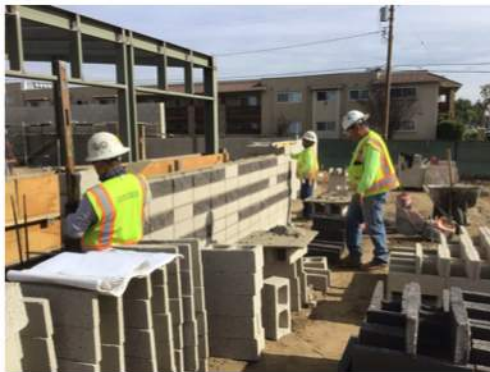
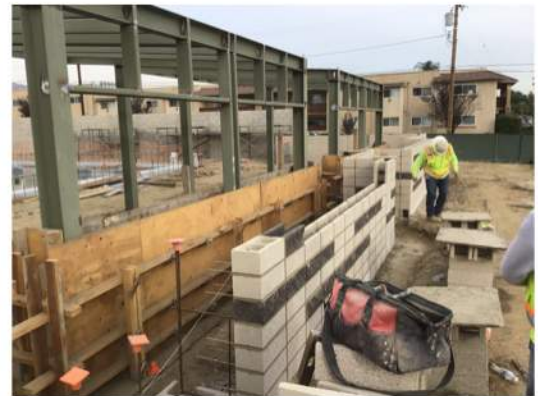
**Fig. 3:** Work for the day

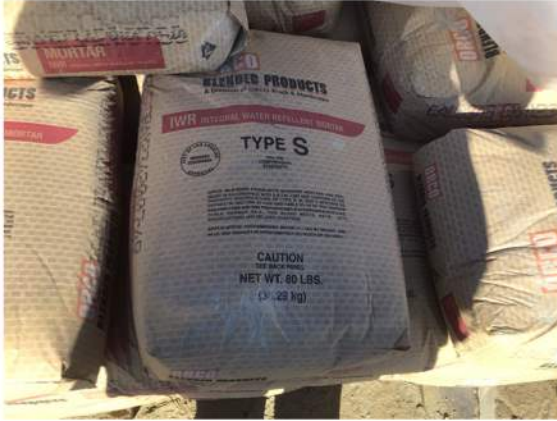
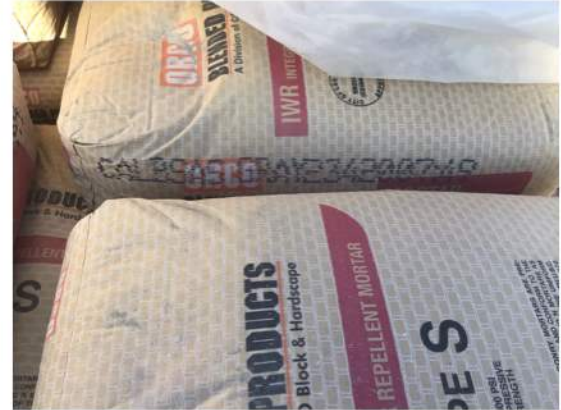
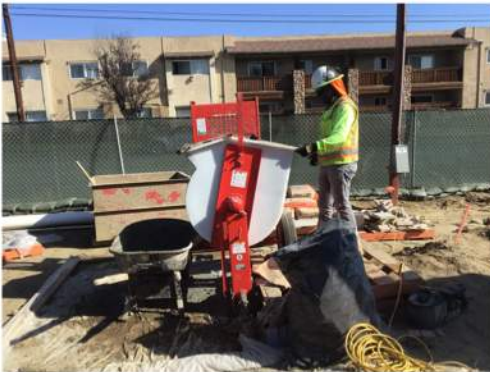
Fig. 2: Mortar mix

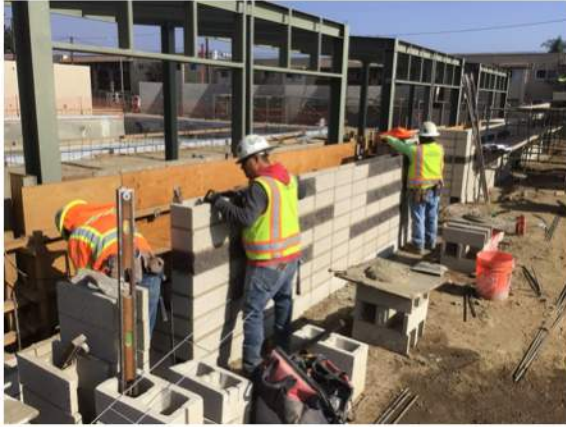
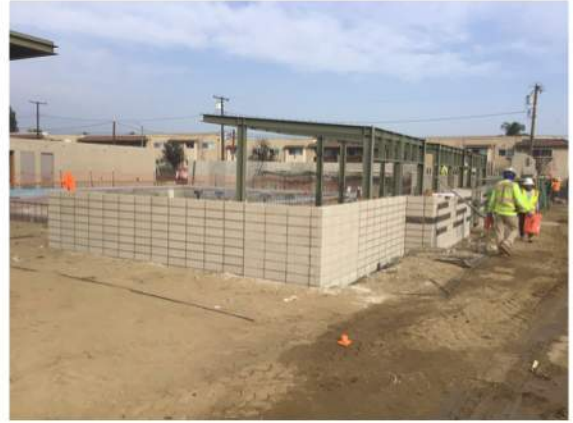
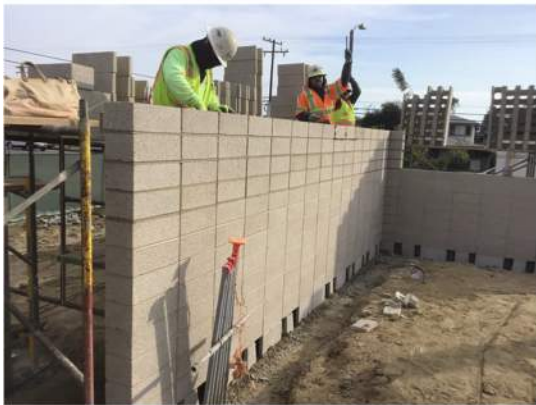
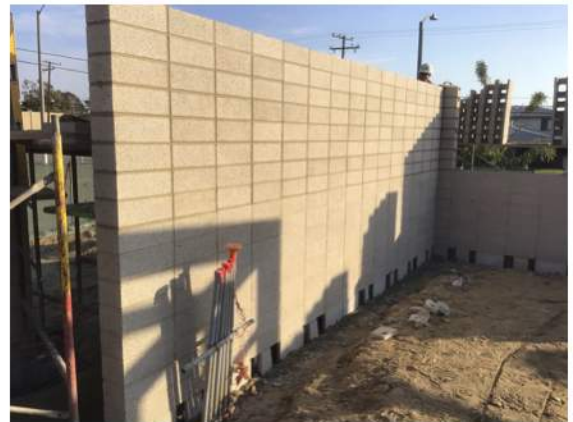
Fig. 3: Work for today

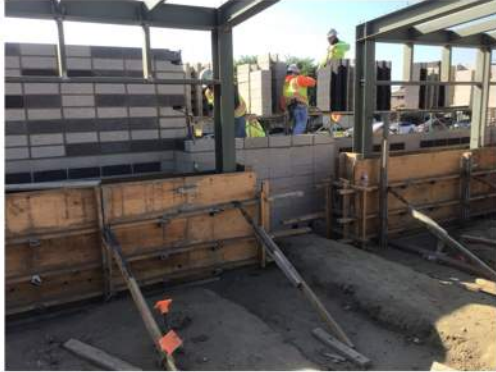
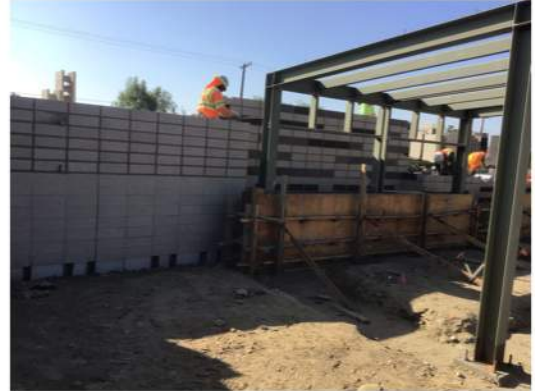
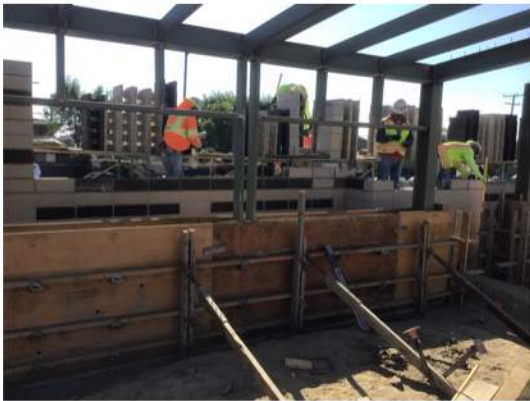
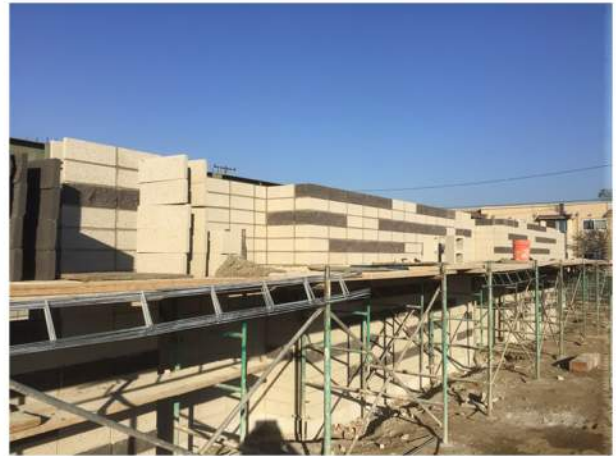
**Fig. 2:** Work for the day

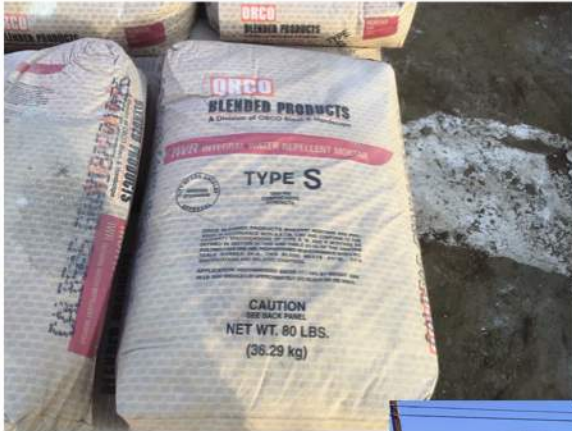
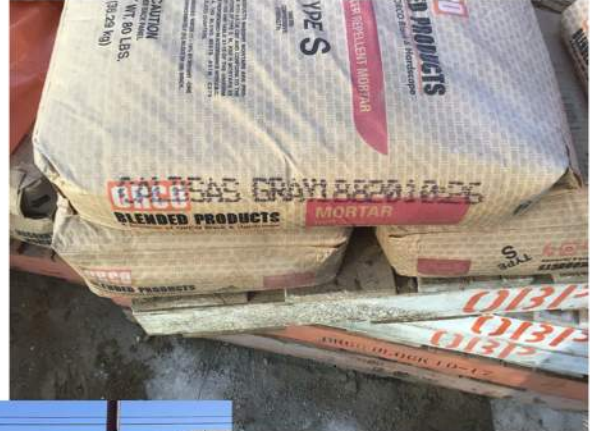
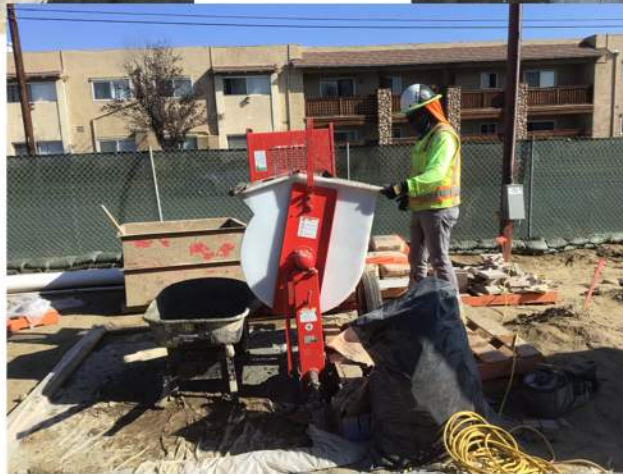
Fig. 3: Mortar mix

Prior to and during block placement, I observed a total of (17) 80lb bags of IWR Type S mortar get mixed to the manufacturers recommendations. Each batch of mortar was mixed for 5 mins by paddle mixer with a sufficient amount of water to get to a work able consistency. Haxton then transfer the mix by wheelbarrow to the work area. I monitored the time and temp of the mix after initial mixing and confirmed mortar was used in the allotted time frame during CMU placement.

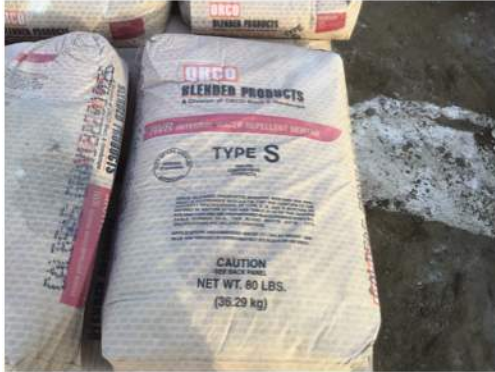
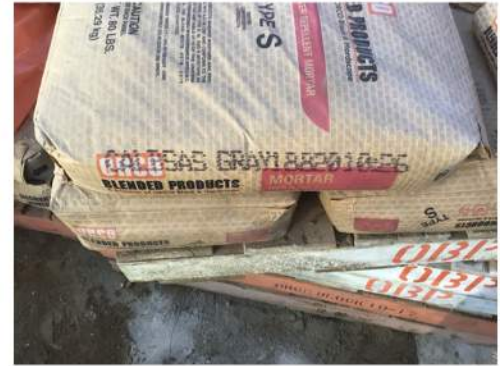
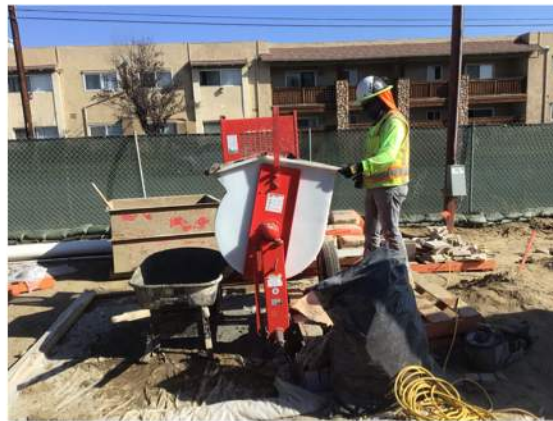
**Fig. 1: Mortar Mix**

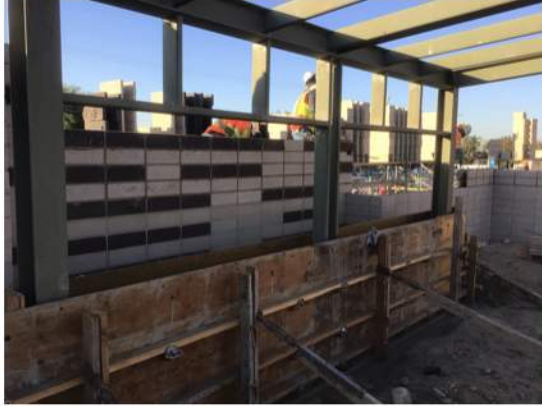
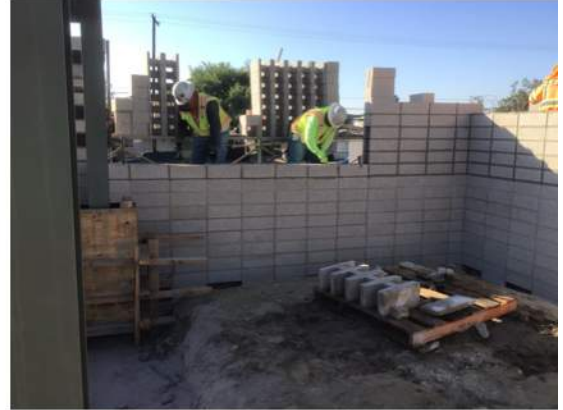
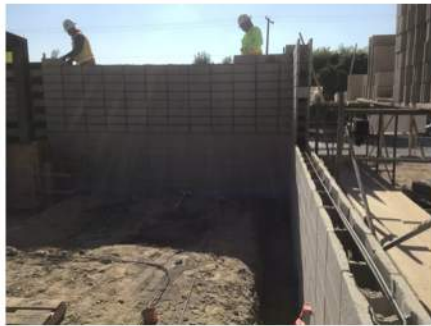
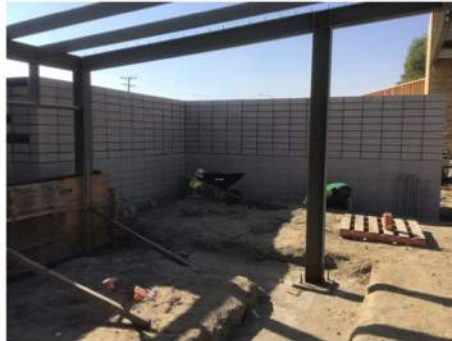
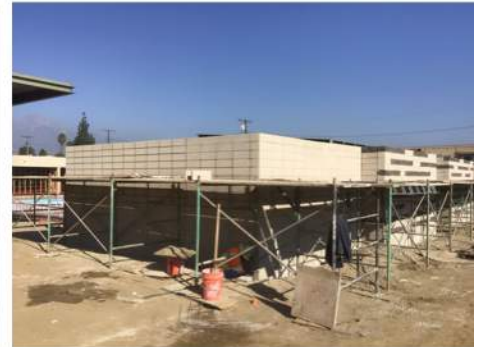
Work Observed for the day met the minimum requirements of the contract documents. The CMU walls east and south of the pool meet minimum requirements of the contract documents and are complete and ready for grouting.

Fig. 3: Work for today
