July 7, 2021  
Kleinfelder Project No. 20210301.001A

**SUBJECT: Summary Report for Construction Observation and  
Special Inspection Services  
Anthony Munoz Community Center (Rehability and Park Project)  
City of Ontario Project No. PS 1314-2  
Ontario, California**

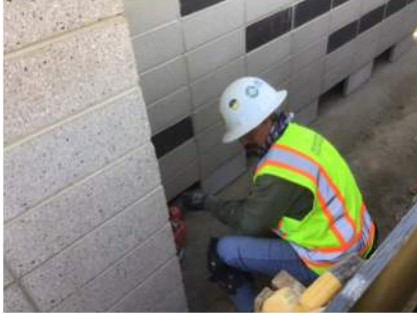
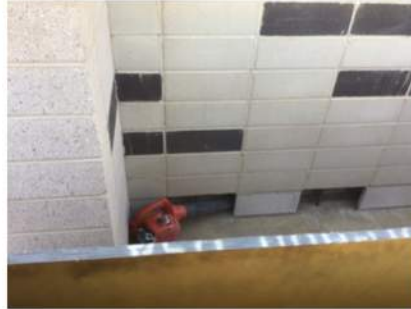
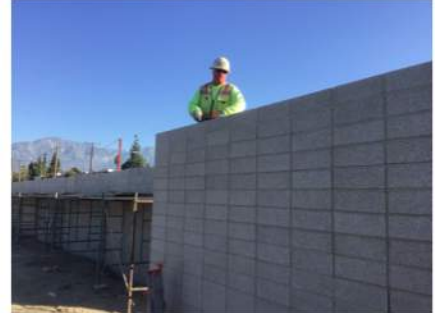
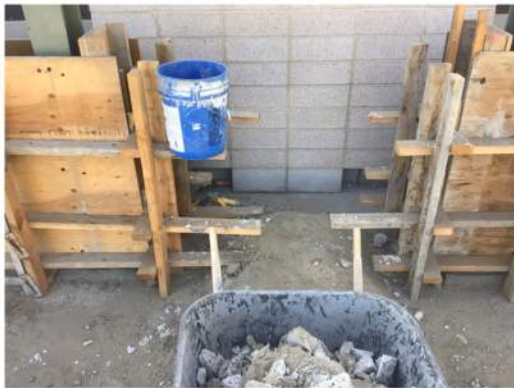
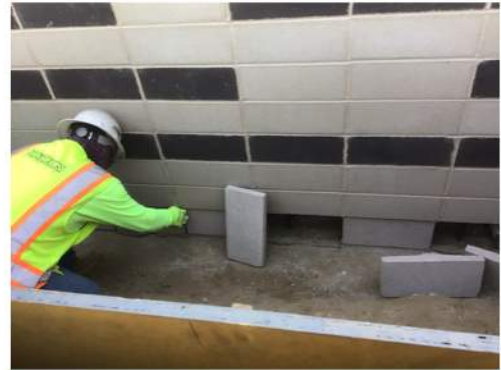
**Fig. 4:** Clean outs and vertical rebar placement

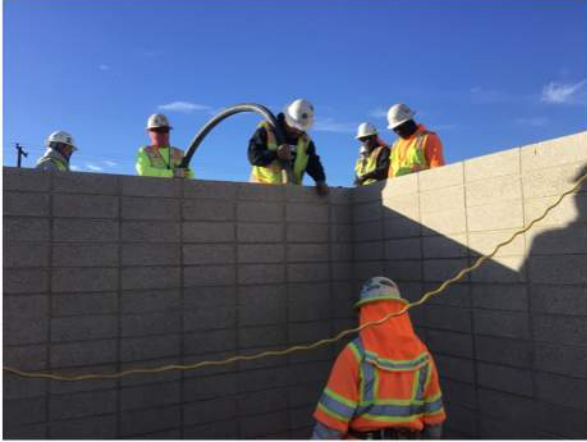
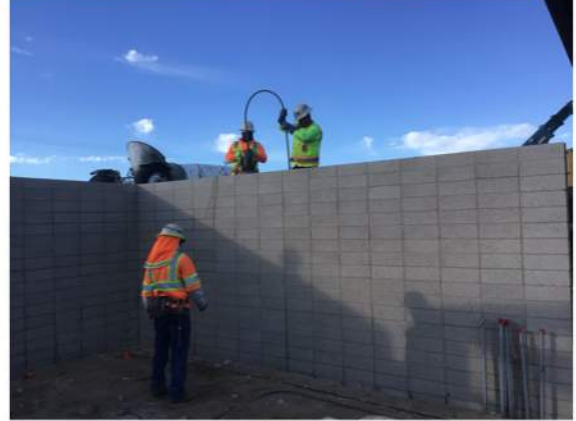
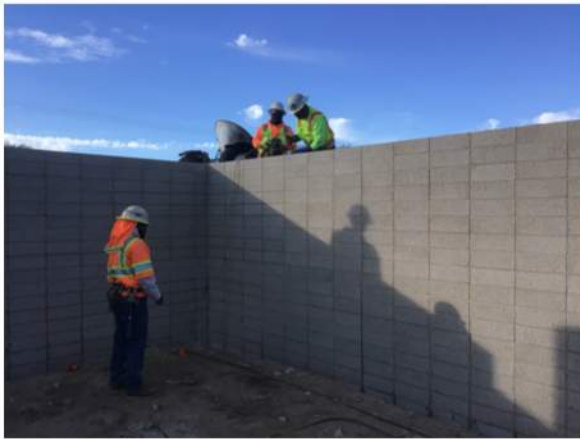
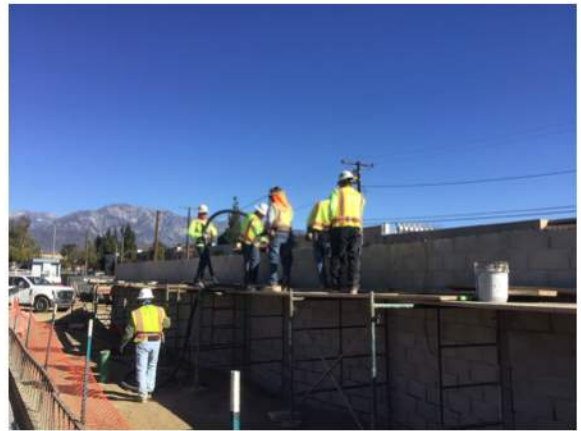
Haxton Masonry Inc (Haxton) had an 7 men crew start the day by staging equipment to began placement of grout. Haxton used Robertson's as their grout supplier front their Rialto Ca location. Haxton used a 3000psi grout mixture with a 9" + 1" slump, mix design #61833, 3/8" max aggregate. Two bags of R-Crete GA213 R-Grout AID and 20 gallons of water were added to each of the (3) trucks prior to discharge from truck. I observed grout placement in the CMU wall at grid lines N-P:8.9-15 and East of grid line 15:N-F. Grout was placed using a 2" T/A 650 concrete pump trailer and was consolidated and re-consolidated using a Minnich Stinger vibrator. I took (1) set of (4) grout samples from the 2nd truck. Samples were taken from the middle 3rd of the truck. See Compression Testing Summary for sample details.

**Fig. 5:** Grout placement, consolidation and re-consolidation

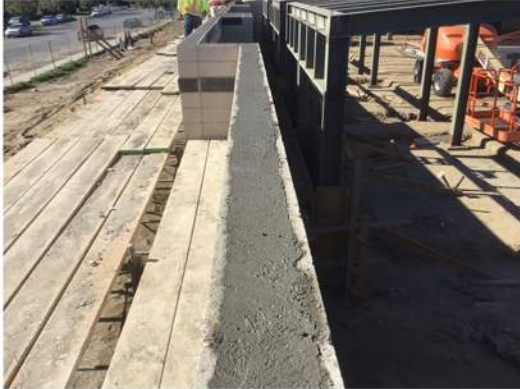
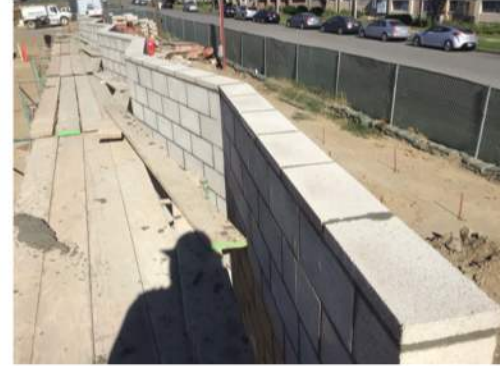
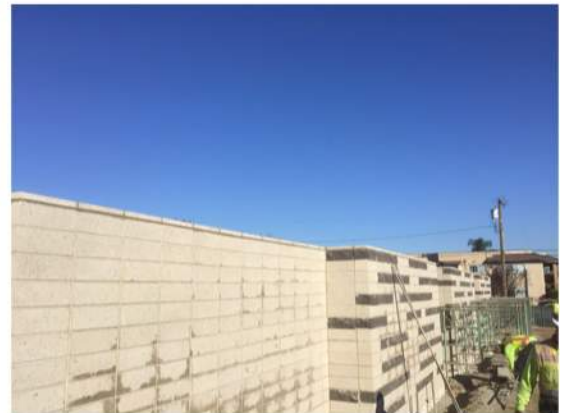
Prior to and during capping block placement, I observed a total of (6) 80lb bags of IWR Type S mortar get mixed to the manufacturers recommendations. Each batch of mortar was mixed for 5 mins by hand with a sufficient amount of water to get to a work able consistency. Haxton then transfer the mix by wheelbarrow to the work area. I monitored the time and temp of the mix after initial mixing and confirmed mortar was used in the allotted time frame during CMU placement.

Work Observed for the day met the minimum requirements of the contract documents. The grout placed in the CMU walls and placement of the capping blocks east and south of the pool meet minimum requirements of the contract documents and are complete.

**Fig. 6:** Capping placement

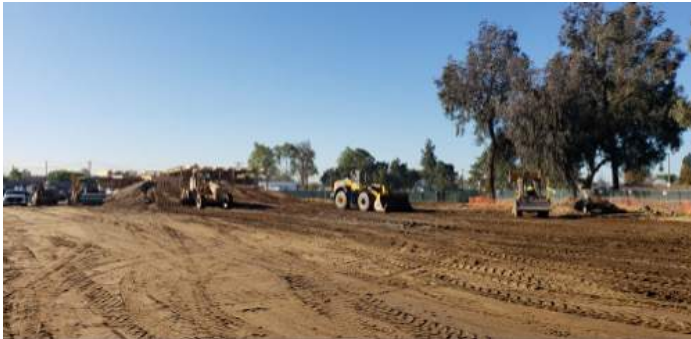
Ironclad Engineering was onsite performing fill operations at the north parking area. I observed soil from the on-site stockpile to be thoroughly mixed, moisture conditioned, and placed in 8 in. loose lifts to approximately +1'0" by a Komatsu WA380 Loader for the first part of the day, with placement after 12:00PM by a CAT 613C scraper. Compaction efforts were applied by rubber tire rolling with follow-up compaction provided by a Bomag BW211D-50 single drum roller. Soil at areas to receive asphalt were compacted to minimum 95% at the top 1'0", with planter islands compacted to 90%. Fine grading was accomplished utilizing a CAT 140H blade.

**Fig. 1:** Fill operations at the north parking area.

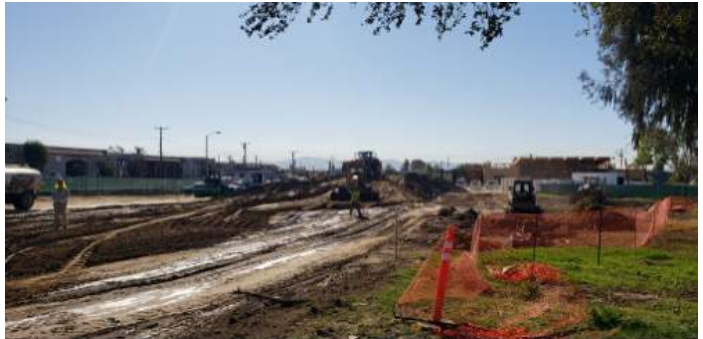
**Fig. 2:** Fill operations with stockpile in background.

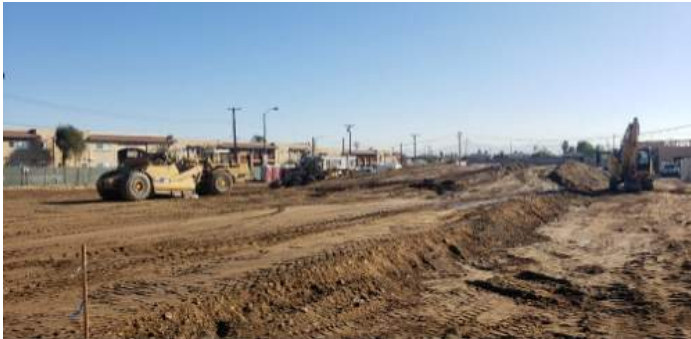
**Fig. 3:** Scraper being utilized to perform fill operations

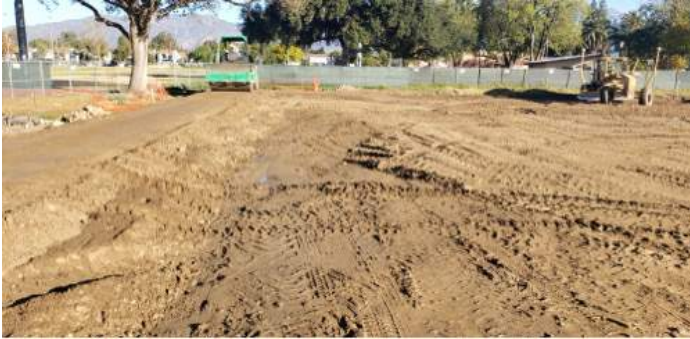
Ironclad Engineering was onsite performing fill operations at the north parking area south of previous days work. I observed soil from the on-site stockpile to be thoroughly mixed, moisture conditioned, and placed in 8 in. loose lifts to approximately +1'0" by a CAT 613C scraper. Compaction efforts were applied by rubber tire rolling with follow-up compaction provided by a Bomag BW211D-50 single drum roller. Soil at areas to receive asphalt were compacted to minimum 95% at the top 1'0", with planter islands compacted to 90%. Fine grading was accomplished utilizing a CAT 140H blade, along with cutting in curb faces.

**Fig. 1:** Compaction being applied by a Bomag single drum roller

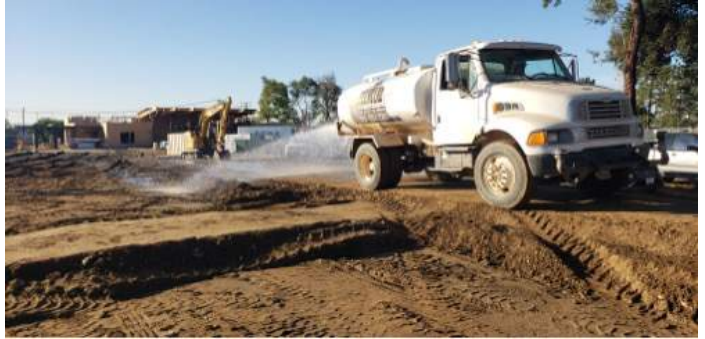
**Fig. 2:** Moisture conditioning of soil

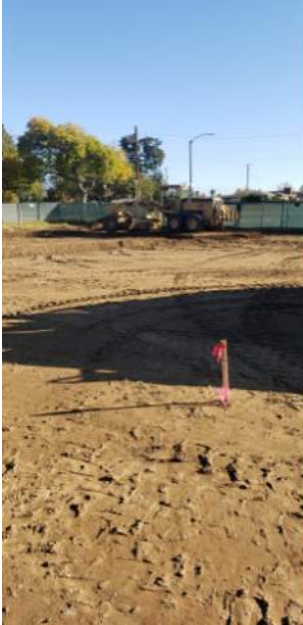
**Fig. 3:** Fine grading by CAT 140H blade

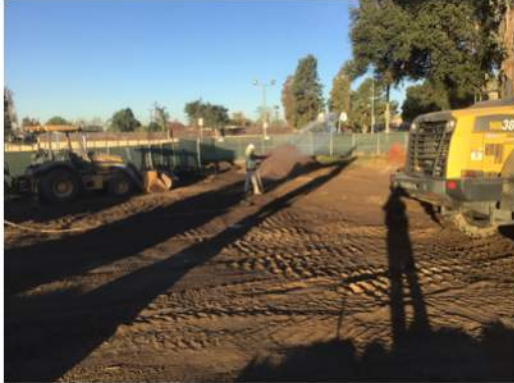
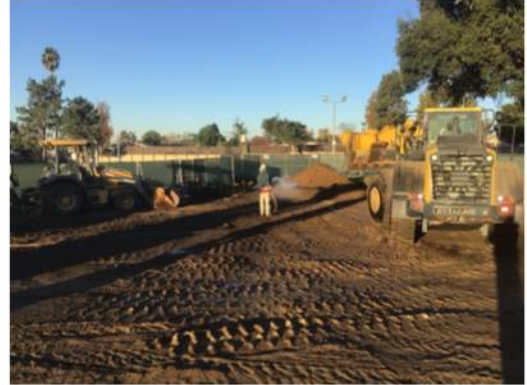
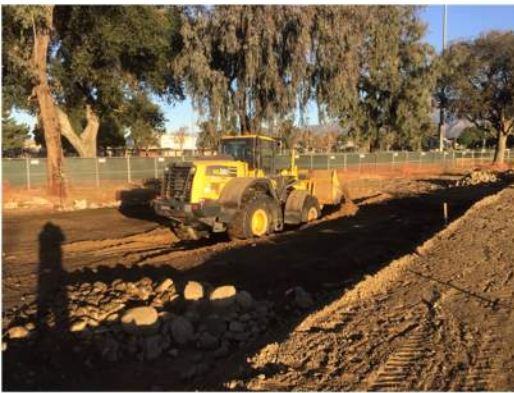
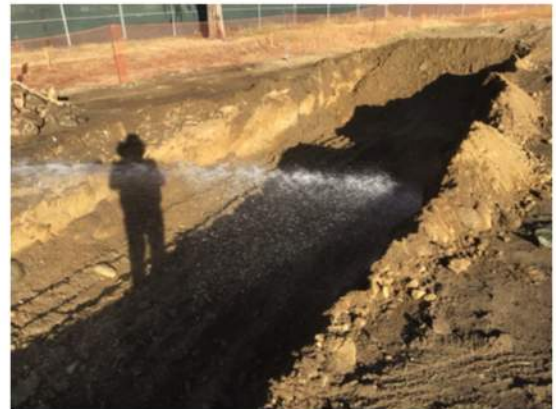
**Fig. 2:** Area A excavation and moisture conditioning

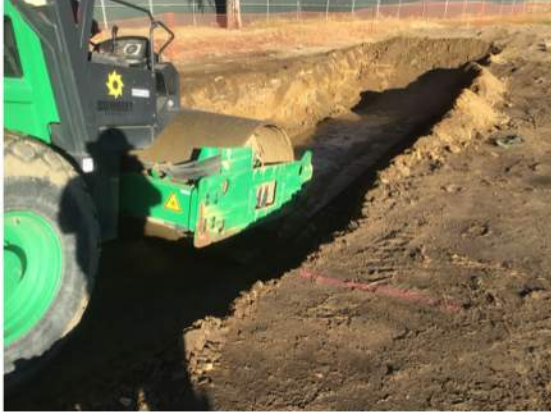
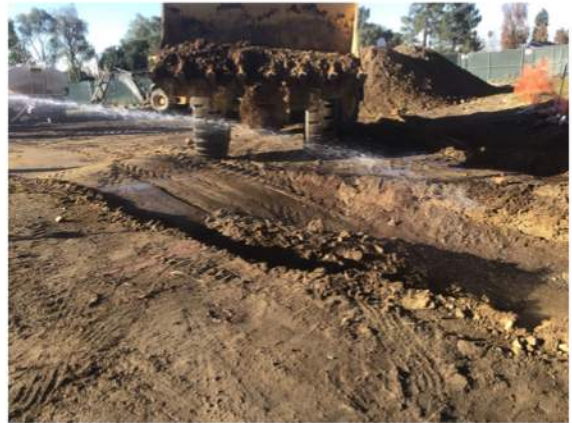
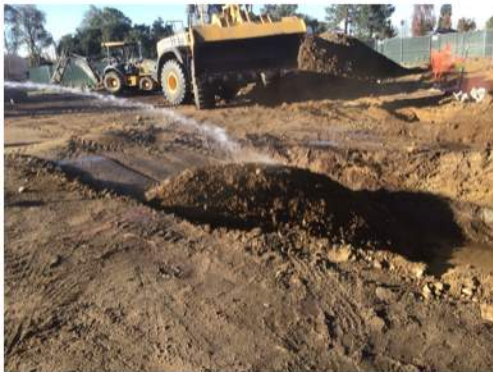
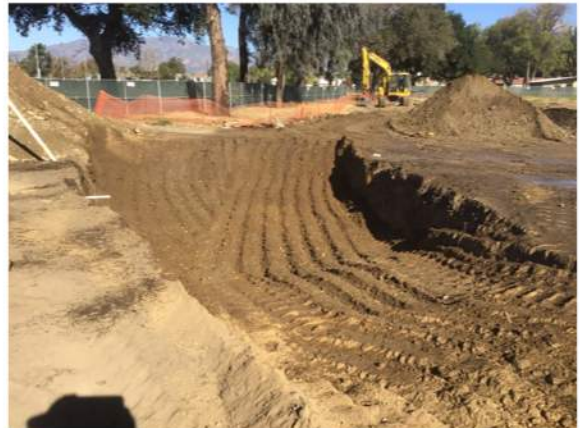
**Fig. 3:** Site excavation

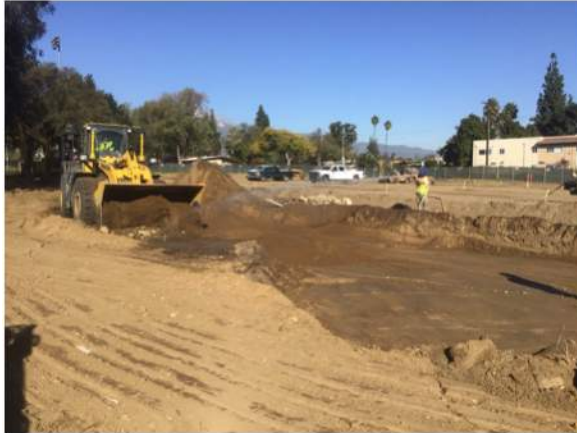
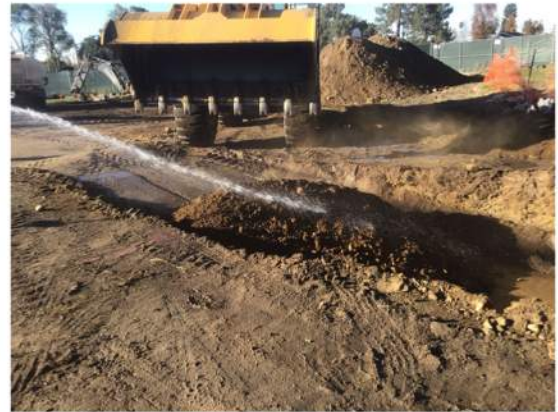
**Fig. 4:** Site excavation

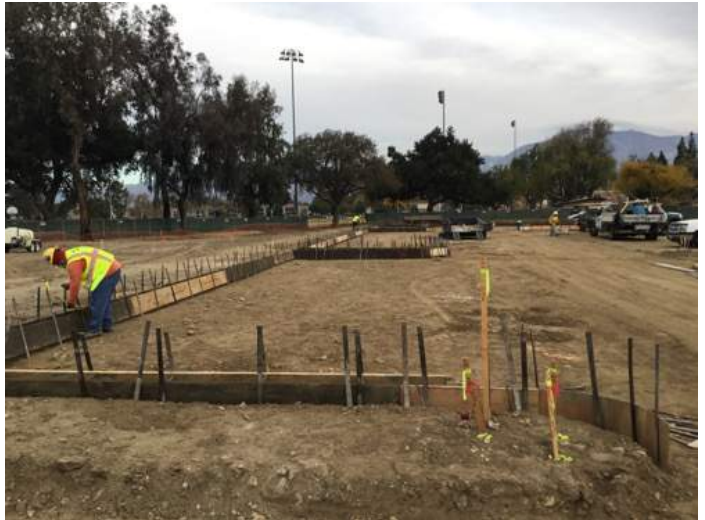
**Fig. 2: Concrete Location -North West Parking Lot A-Curb**

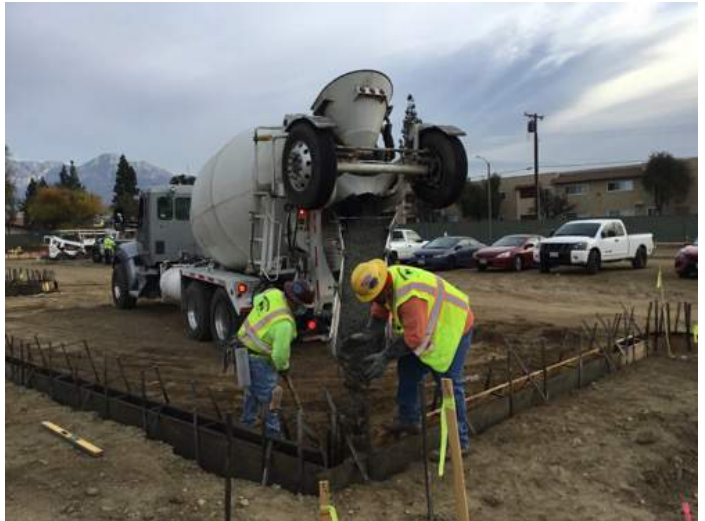
**Fig. 4: Concrete Placement - Via Tailgate/ Chute Method**

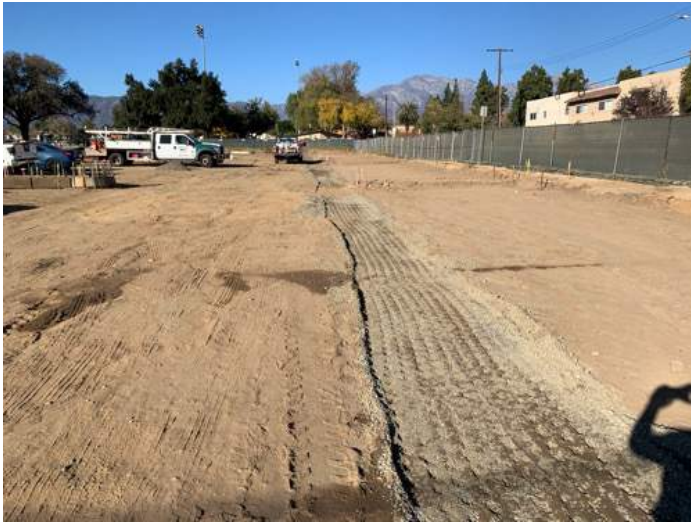
Prior to arrival contractor had already performed compaction on ribbon gutter(see plan markup for details). A Bomag-BMP 8500 was used to accomplish compaction in area tested. I used a calibrated nuclear density gauge to check compaction and moisture content. I performed a total of 5 density test to verify 95% relative compaction. All areas tested were found to meet or exceed the 95% compaction required(see data sheet for more details). All tests results were shared with Tom Hanrahan (superintendent).

**Fig. 1:** Ribbon Gutter worked on

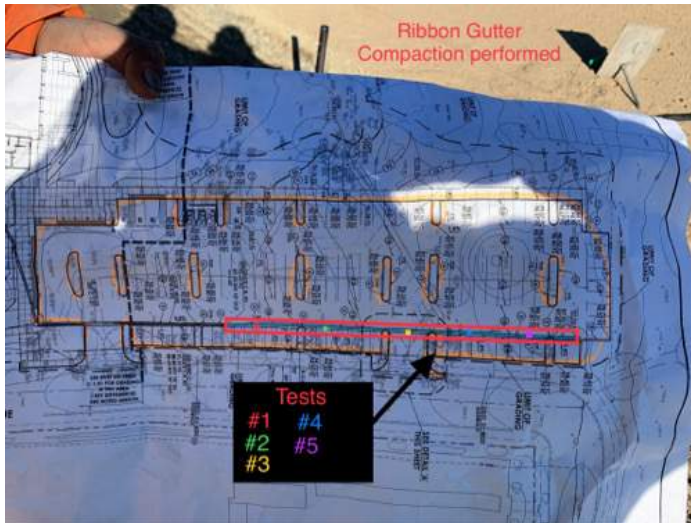
**Fig. 3:** Test performed

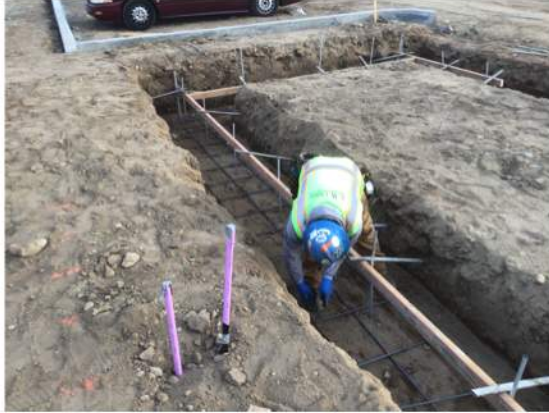
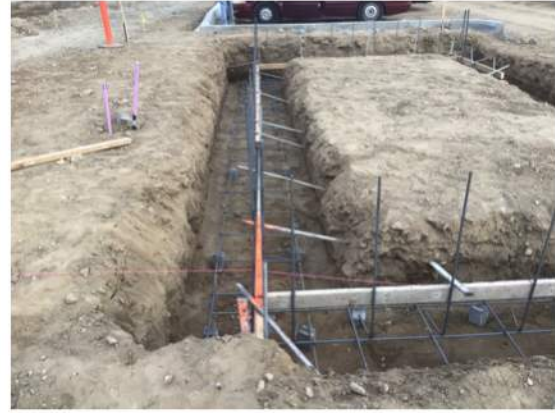
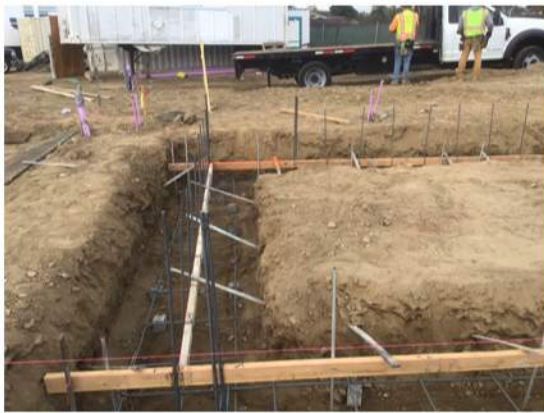
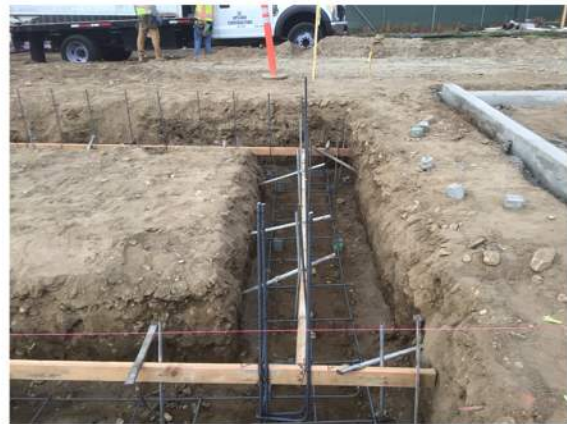
Kar Construction (KC) had a (2) man crew placing reinforcing bars (rebar) for the Trash Enclosure on the south west corner of the parking lot. Upon arrival I took one density test, with the nuclear density gauge, and confirmed the sub grade for the foundation met the 95% compaction recommendation. (See Density Test Data Sheet for results). KC began placing rebar per detail (4) on S1.3 with horizontal #4's @16"oc and vertical #4's @ 16"oc with (2) #5 vertical jam bars at the corners and end of walls per detail (3) on S4.11. Anchor bolt template for gate posts were installed per (8) on S1.3. Reinforcing steel placement has been verified for reinforcing steel size, grade, lap, locations, clearances.

**Fig. 3: Rebar Installation**

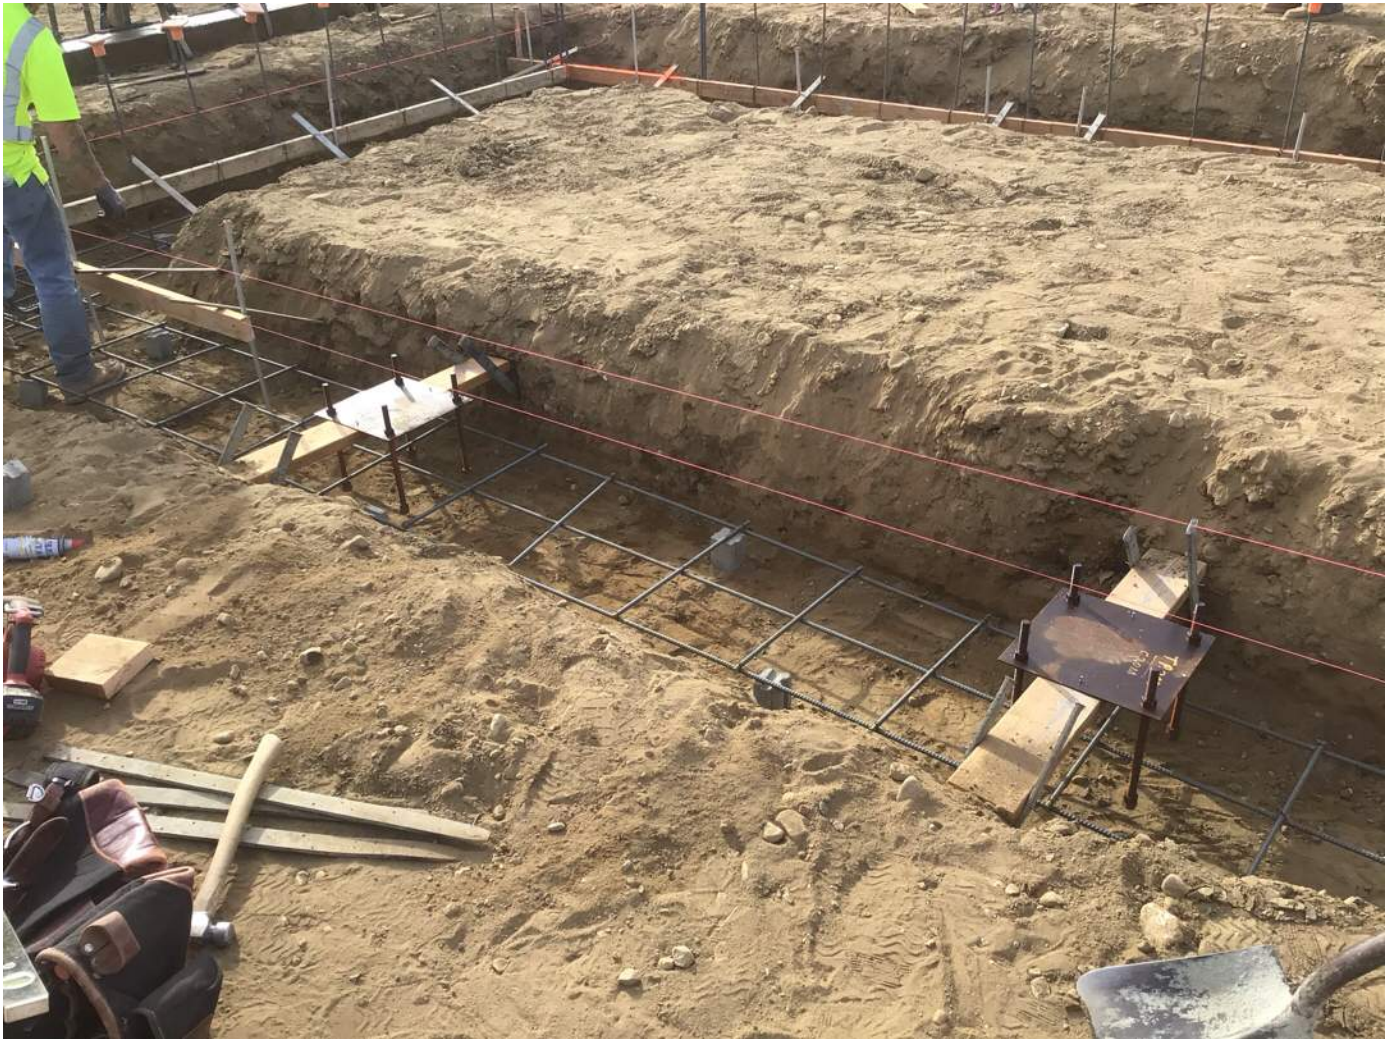
**Fig. 5:** Anchor bolt template instation

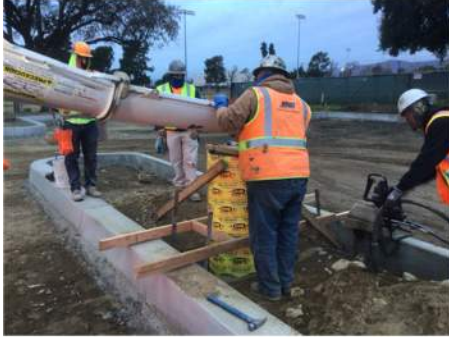
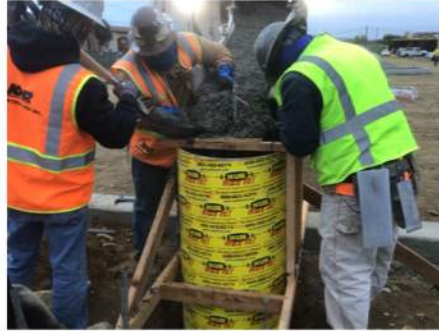
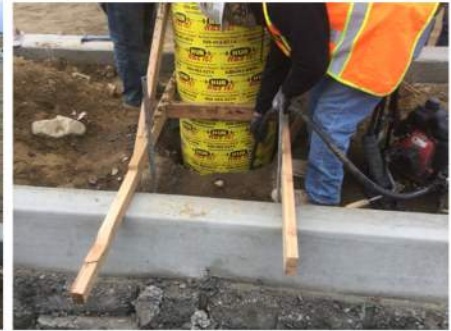
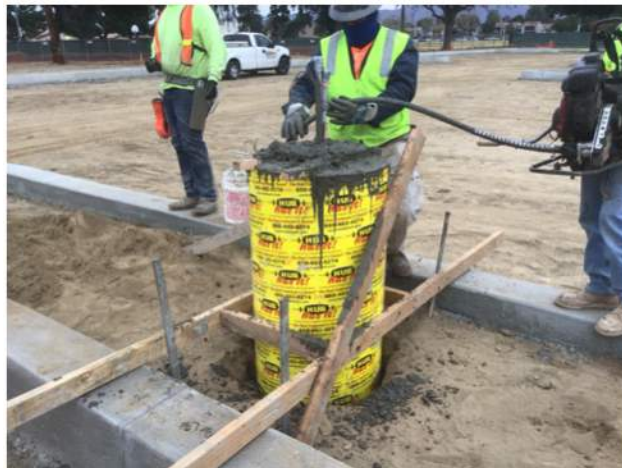
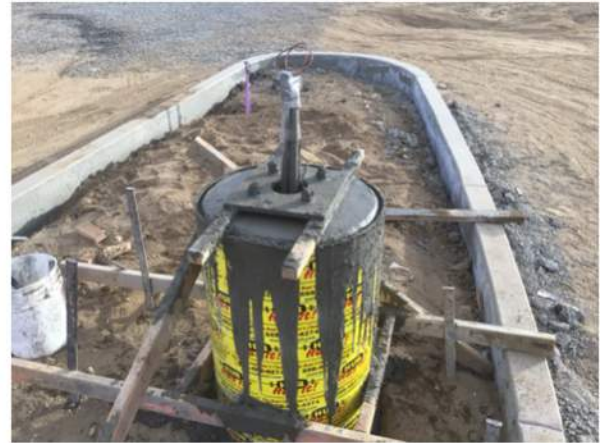
Fig. 3: Light Pole Base Concrete placement

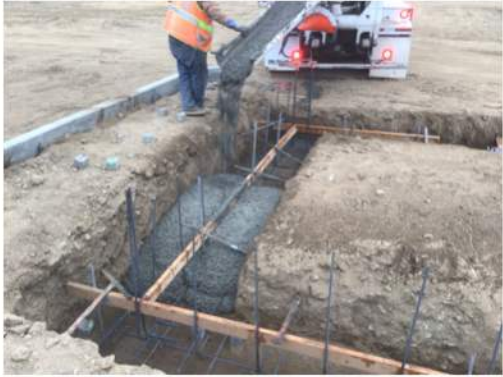
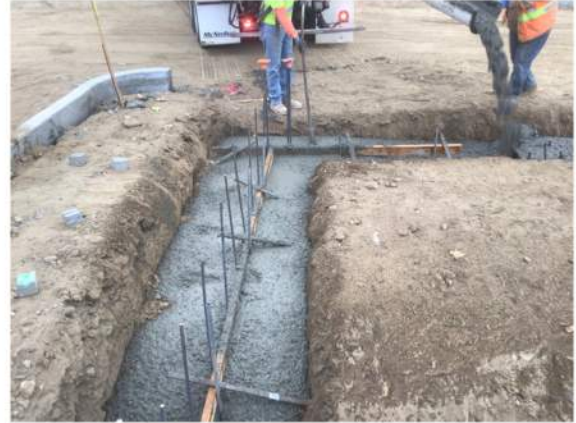
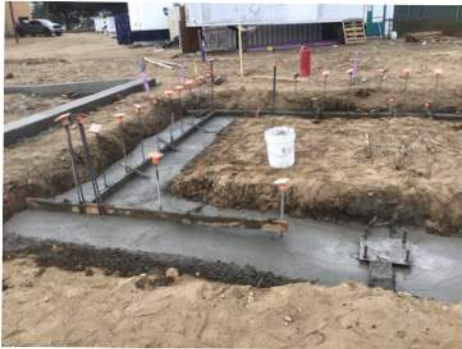
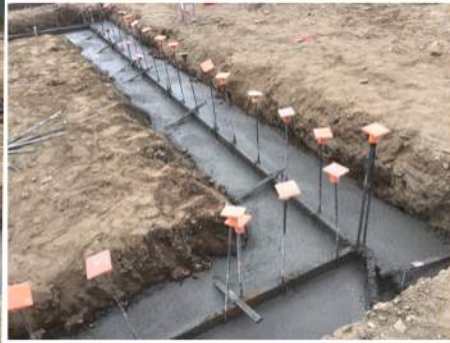
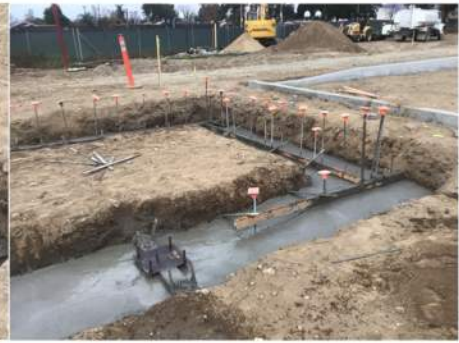
**Fig. 4:** Trash Enclosure Foundation Concrete Placement

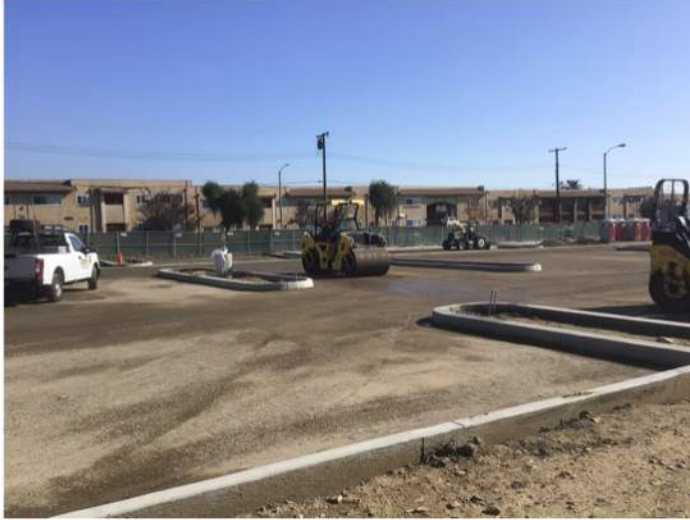
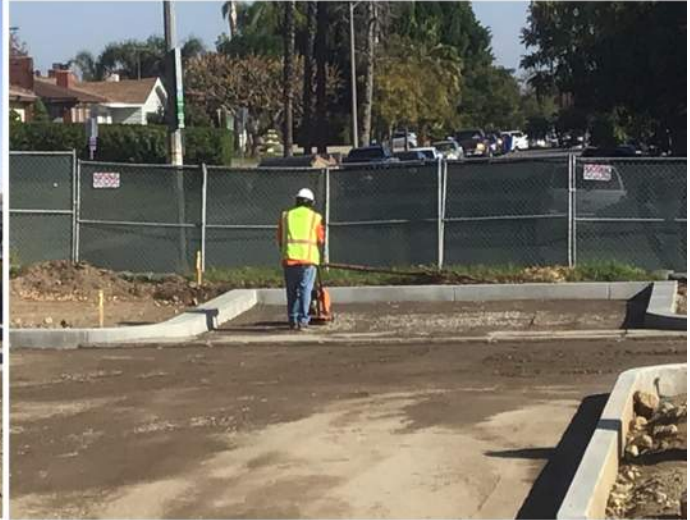
**Fig. 3:** Compaction of agg base

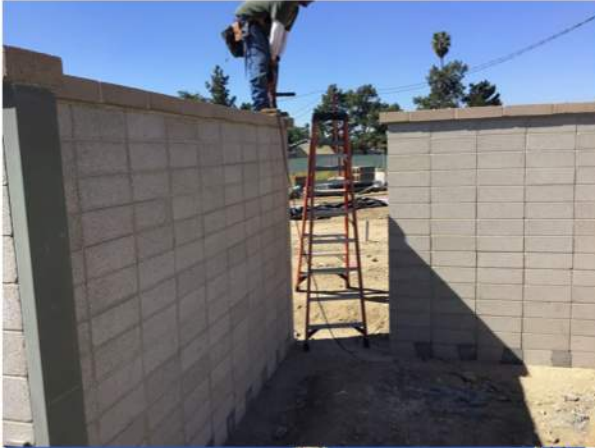
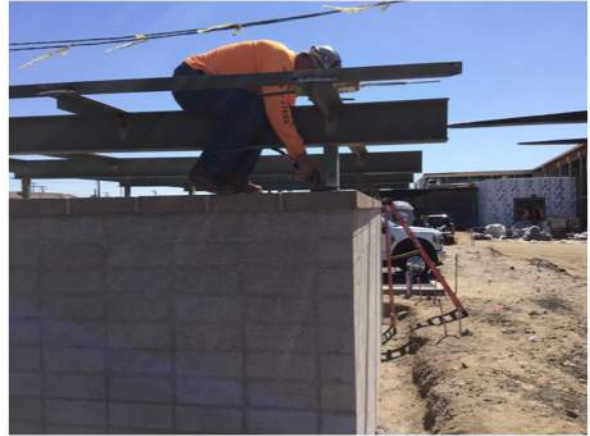
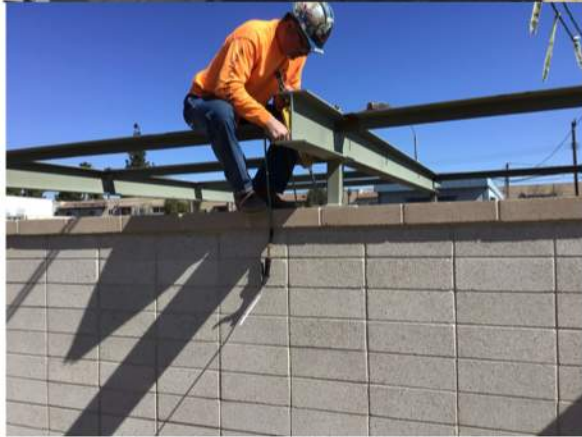
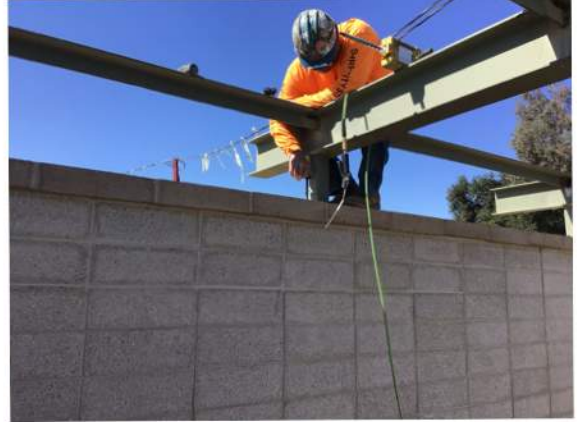
**Fig. 3:** Installation of Threaded Anchor Bolts

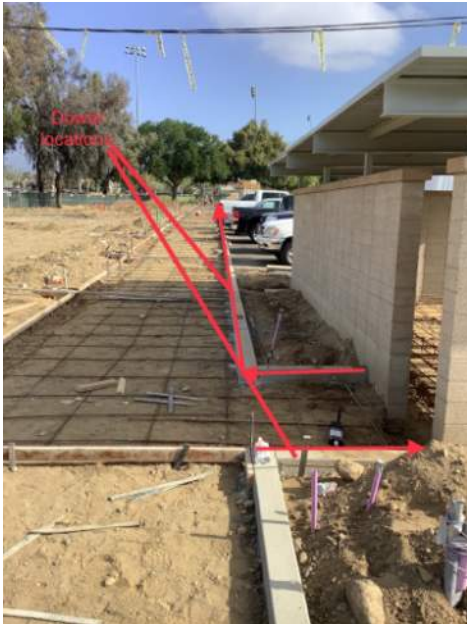
I observed the application of SIMPSON SET-XP22 EPOXY with an expiration date of 1/5/23 in approximately 100+ holes drilled into the curb along the western perimeter of the parking lot. All holes had a minimum embed of 3" and were brushed and blown out in accordance with ASTM standards. Holes were filled 3/4 with epoxy and #4s x 18" smooth steel dowels were placed at 30" o.c. As called out on DETAIL D of L2.1 of approved plans (see attached photos).

**Fig. 1:** Areas of dowel placement

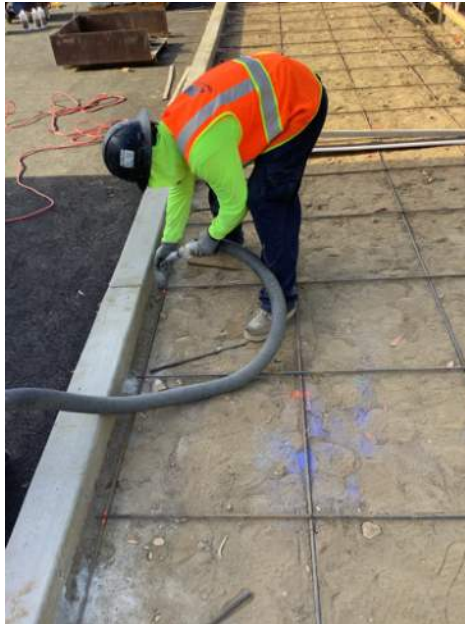
**Fig. 2:** Blowing out holes

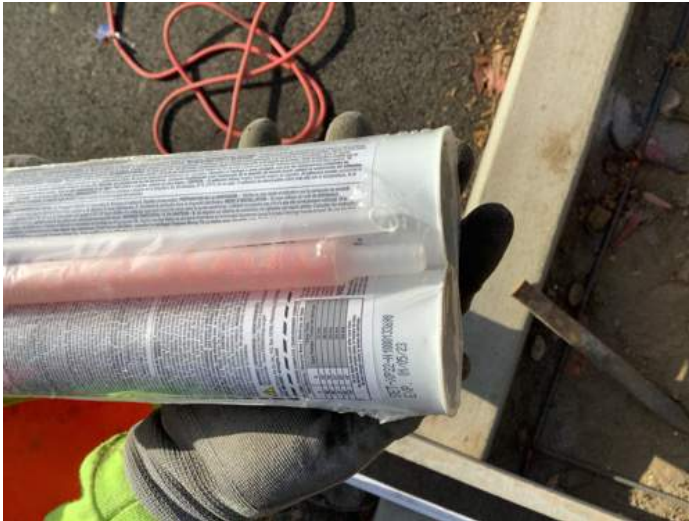
**Fig. 3:** Confirmed expiration date

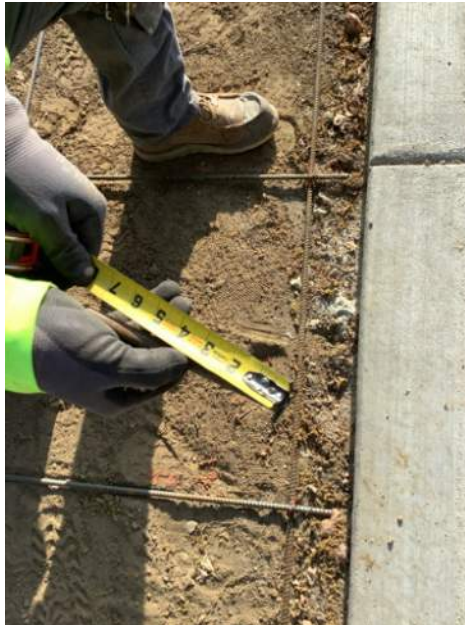
**Fig. 4:** Embed confirmation

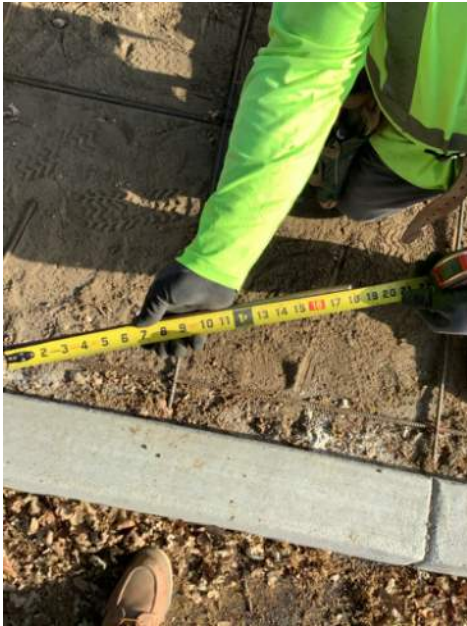
Fig. 5: Smooth dowel length confirmation

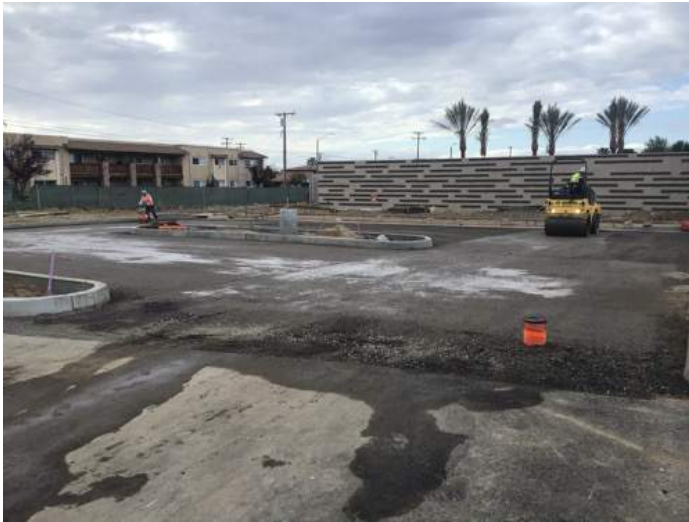
**Fig. 1:** Compaction Via Roller & Viber Plate

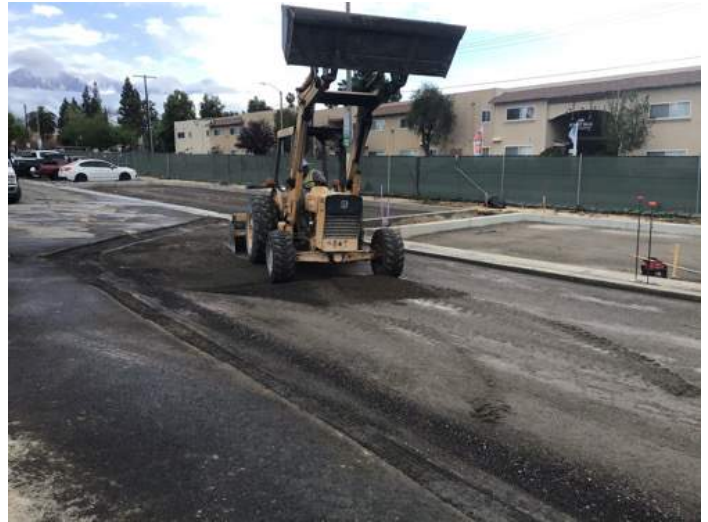
**Fig. 2:** Grading Via Skip Loader.

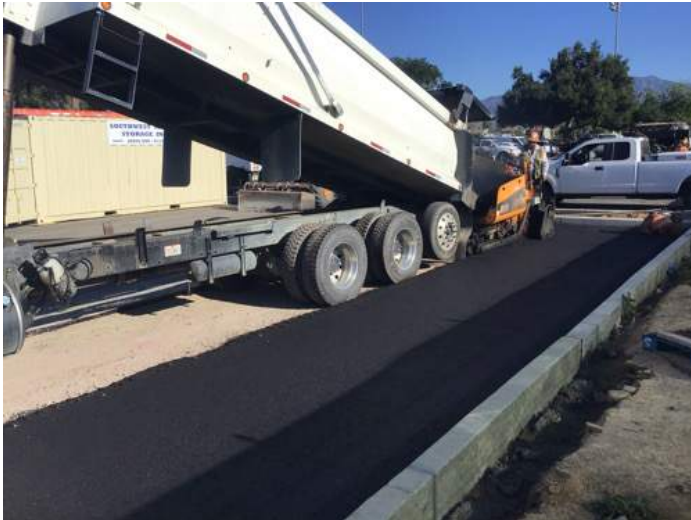
**Fig. 1:** Pave rig placement

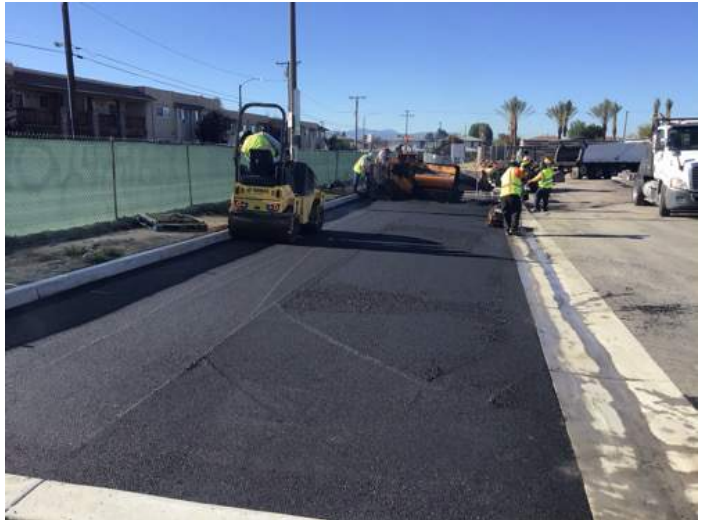
**Fig. 2:** Compaction efforts
